**Pleasant Bay Climate Action Adaptation Plan**

## **Selection of Case Study Sites and Establishment of Threshold Elevations**

June 2023

**Wright-Pierce**

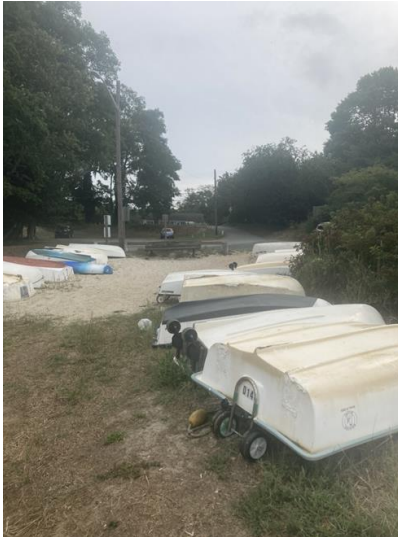
The most vulnerable aspects of this site are the pier and the boat storage area. The pier is inaccessible when water rises more than 4 to 5 feet above mean sea level, an event that may occur now under very extreme conditions but will happen with increasing frequency as sea level rises. The pier is only slightly higher than its access walkway and could be damaged by wave action with even smaller increases in average water level. Wave impacts will become more frequent as sea level rises and storms increase in intensity. The boat ramp can accommodate significant increases in water level and should still be functional even with water levels 5 feet higher than current conditions. The boat storage area will gradually shrink in usable area. The boat storage area’s unvegetated and sandy surface is particularly susceptible to erosion. Both the lower and upper parking areas are not likely to be inundated with sea level rise expected in the foreseeable future.

A 2.5-foot rise in sea level would result in inundation of the pier at every high tide. Lesser amounts of sea level rise would have less frequent impacts to day-to-day operations.

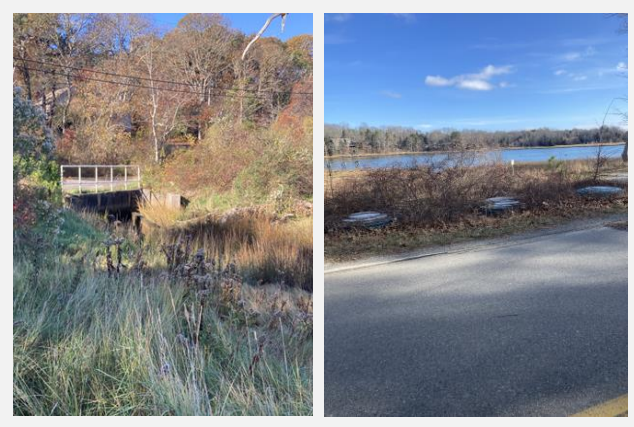
The beginning of the herring run is a concrete channel located below Herring Brook Way. This portion of the run already experiences high water impacts, where the water spills over the concrete channel walls, depositing fish on the exterior of the fishway. With future increases in sea level and more intense storms, it is likely that these problems will worsen. The herring run is also aging and is planned to be rehabilitated or upgraded in the coming year.

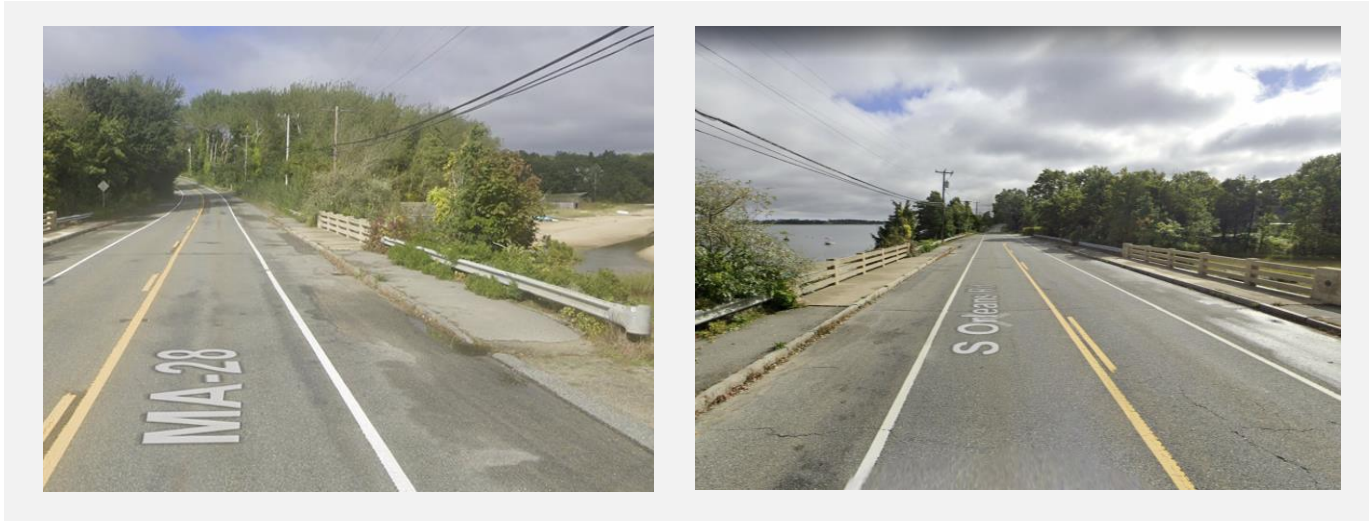
The pipe and pipe support elevations vary across the length of the bridge but are, at the lowest point, 12.6 feet (NAVD88). The bridge abutments are located at elevation 9.6 (NAVD88). For this reason, it is anticipated that the greatest risk to the infrastructure would be the condition of the existing pipe and any corrosion occurring within this extreme saline environment that could reduce the expected lifetime of the pipe material. However, as sea levels rise, the frequency of inundation will increase, and the bridge could see impacts from more frequent storm events. The storm surge at this location could exacerbate the corrosion of the pipe but is not anticipated to pose a significant threat to the structural integrity of the pipe or pipe supports because the pipe is supported within a utility bay tucked up above the bridge piers and abutments. Waves would travel across the underside of the bridge and would have a significant amount of their energy dispersed prior to reaching the protected pipe location. In general, if the bridge structure or road approaches were damaged by intense storms, the pipe could also be impacted. The analysis of bridge structural integrity was outside of the scope of this analysis.

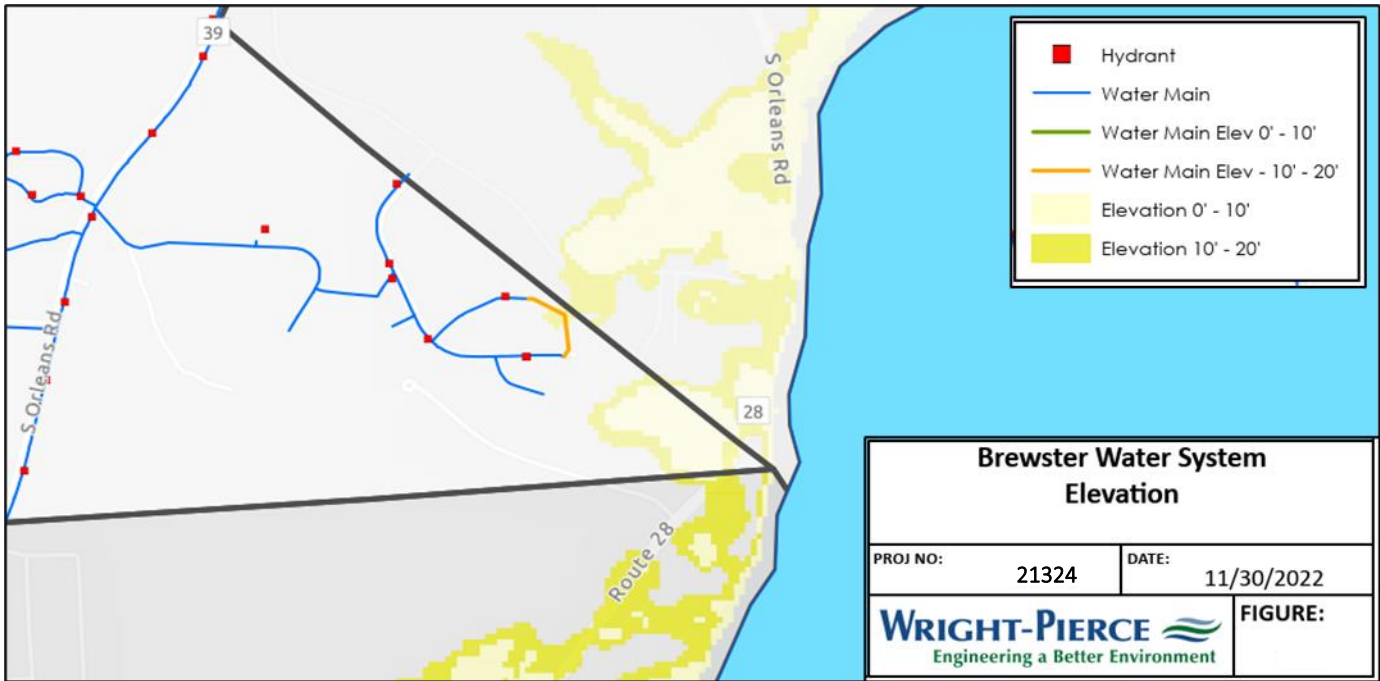
One of the water mains that the Town of Brewster owns and maintains is located near wetlands surrounding Tar Kiln Stream. This water main location can be seen in the below map, highlighted in orange. The lowest ground surface elevation at this location is approximately 14.5 (NAVD88), which would put the pipe a few feet below that at around elevation 10.5 (NAVD88). It is not anticipated that this pipe will be adversely impacted by gradual sea level rise for the foreseeable future. However, as sea levels rise, and storm surges increase, this low-lying area could be subject to erosion and possible wash-out of the water main.

There are two fire hydrants nearby this section of pipe, but the ground surface elevation in the area steeply slopes up to where the fire hydrants are located, lessening their risk of impacts by rising sea levels. However, this section of the water main is a loop system, so if the low portion were damaged, there could be pressure loss or other problems in the rest of the line, including the locations with the hydrants.

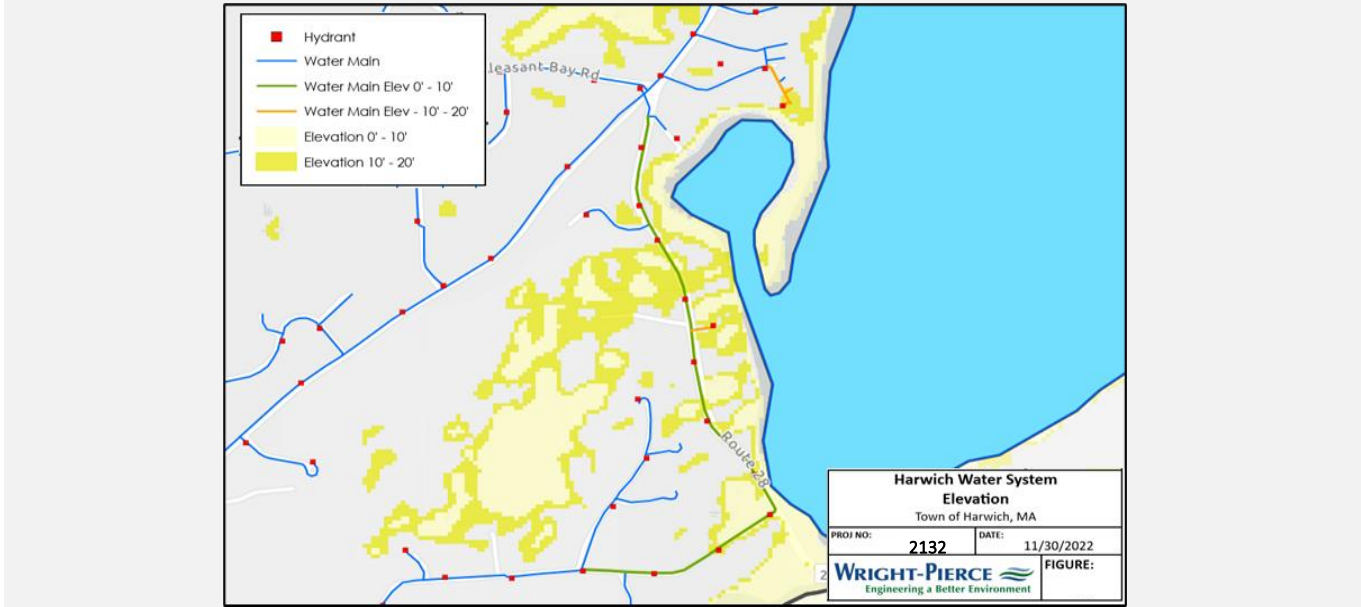
The road in this area could be impacted portions of each day with sea level rise of 3-4 feet, and infrequently with a rise of just 2 feet or from a major coastal storm. There are multiple hydrants nearby this section of pipe, with the lowest hydrant located at elevation 10. The locations of the hydrants on the road could be infrequently impacted during the highest astronomical tides if sea levels rose 6 feet. Conservative sea level rise projections developed by other members of the project team show that sea levels would not reach these elevations until late this century, or earlier if combined with wave action from coastal storms. This could restrict access to the hydrants along this portion of Route 28.

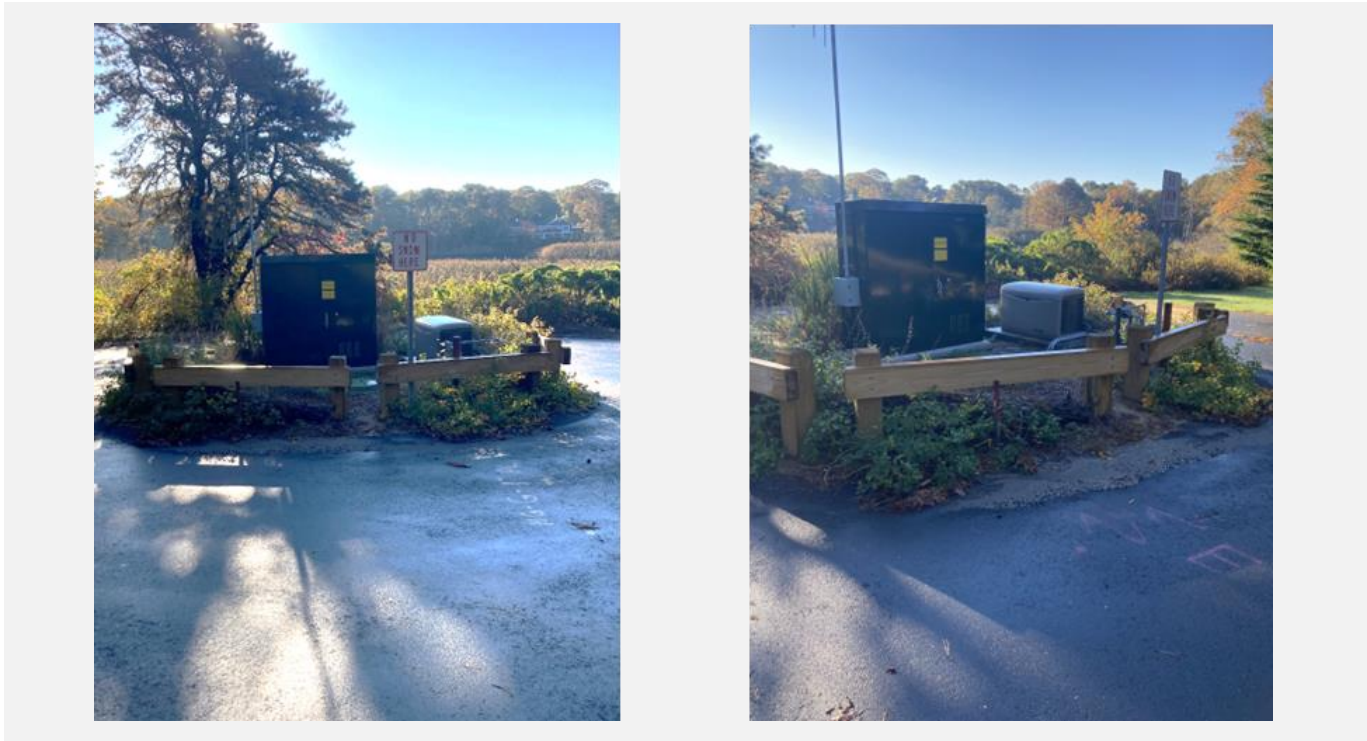
The station is immediately adjacent to Muddy Creek, which has a FEMA 100-year floodplain elevation in the area of 11 feet (NAVD88). The pump station electrical equipment and generator are situated at elevation 14 feet to be above the FEMA floodplain. Based on the available topographic data, the elevation of Muddy Creek is well below the elevation of the pump station and indicates that sea level rise itself would not be likely to impact this station within the planning horizon of the study. In addition, wave impacts are not anticipated because the station is located so far inland up Muddy Creek that waves would be attenuated before they reach this location.

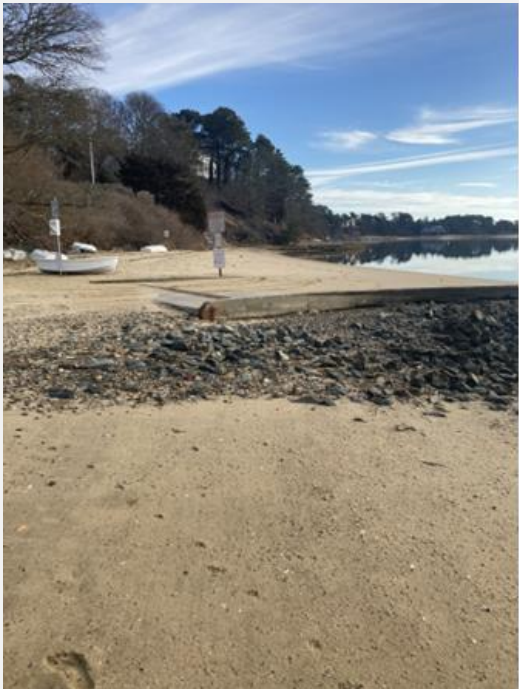
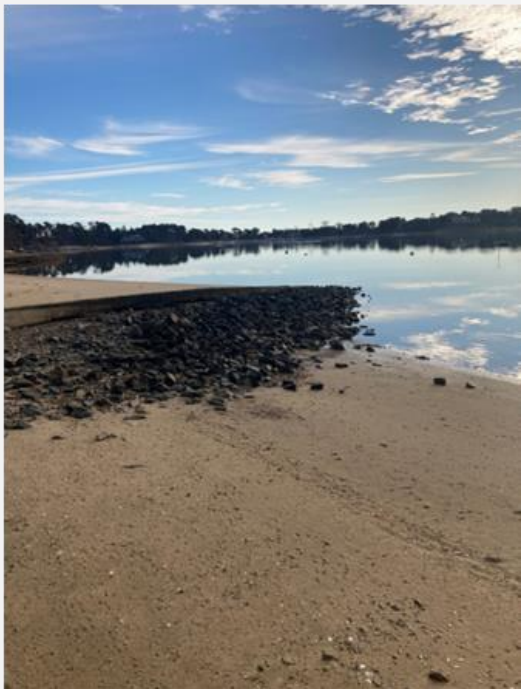
The Crows Pond Landing is a Town-owned boat ramp on Crows Pond, located off Fox Hill Road in Chatham. The landing consists of a concrete ramp that was installed in 1989, with riprap embankments. There is an unpaved parking area along the driveway of the landing entrance and there is a storage area for small boats on the beach in the area. The concrete ramp is located at elevations 0 to 3 (NAVD88) and the approach to the boat ramp area continues up the beach to the parking area at elevation 6.

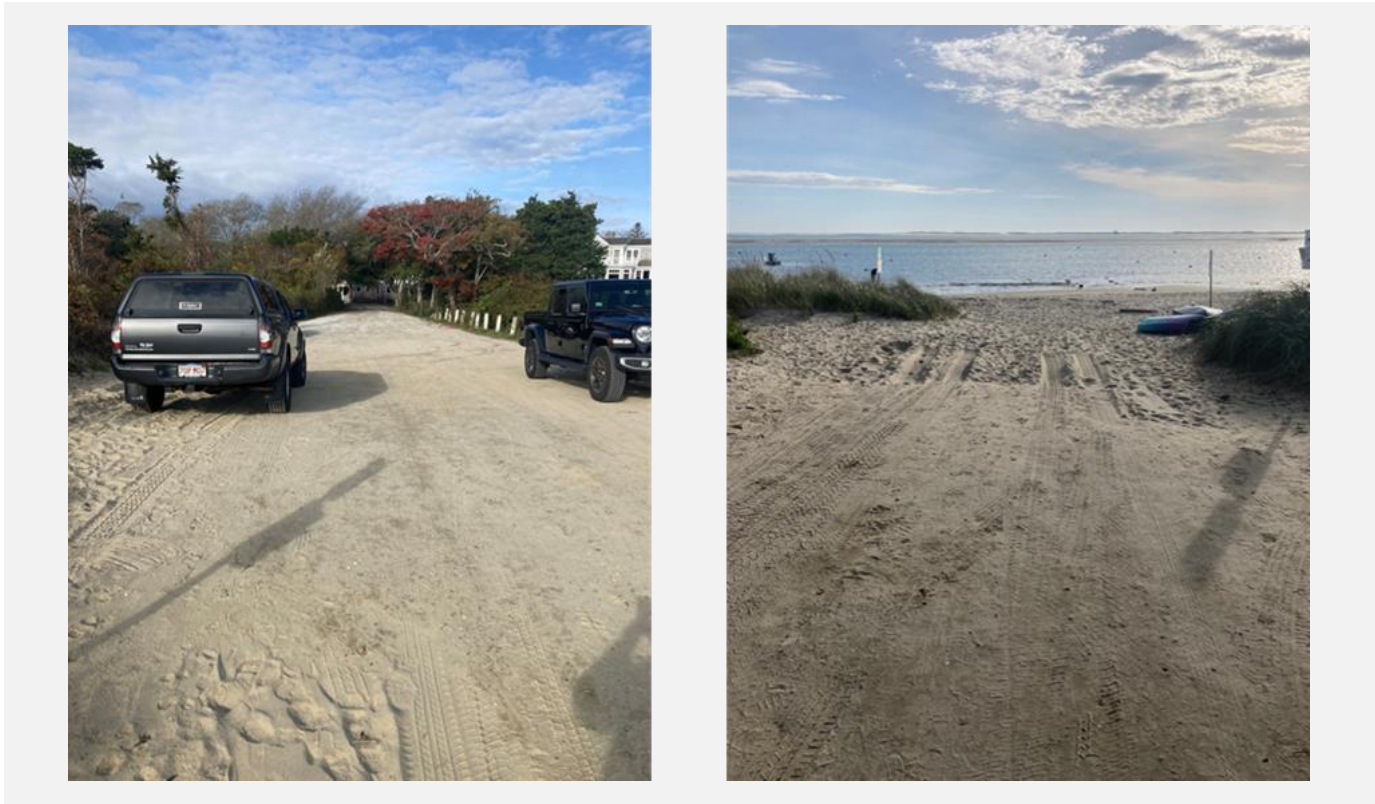
The boat ramp elevation ranges from 0 to approximately 9 across the site, with already frequent inundation due to the normal tidal cycles on the beach. With a rise in sea levels, the available length of the access road and the beachfront will be significantly diminished, as would be the area for parking, but the ramp can accommodate significant increases in water level and should still be functional even with water levels 5 feet higher than current conditions. There could also be frequent impacts to the boat storage areas in the next 10 or so years based on even conservative projections of sea level rise above the current mean high-water line. However, as sea levels rise, the frequency of inundation will increase.
