Muddy Creek Restoration Bridge Project Vegetation and Photographic Monitoring

Sustainable Environmental Solutions

Chatham, Massachusetts

January 2019

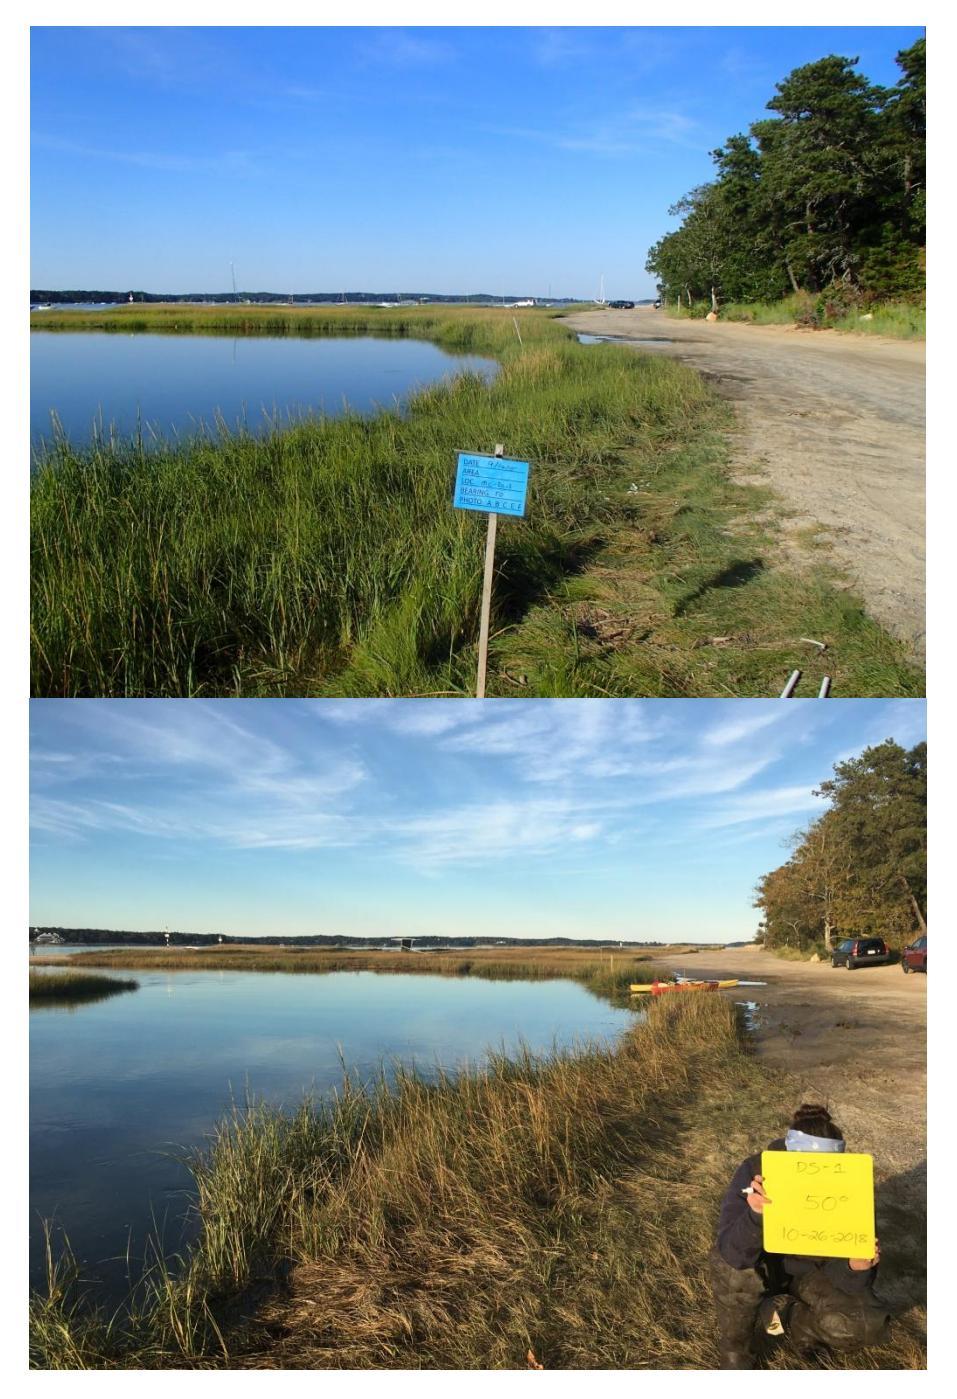
DS-1 50°, Top 2015, Bottom 2018

The photo station DS-1 is located downstream of the Route 28 Bridge, the farthest station on the east shoreline, and serves as a reference site. Three bearings were photographed at this station (50°, 260°, and 360°). At all bearings, a robust population of Saltwater Cordgrass is visible along the edge of the water. Outside of a slight browning, likely due to a 2018 sampling date later in the fall than the 2015 photo monitoring date, there does not appear to be change in vegetative cover.

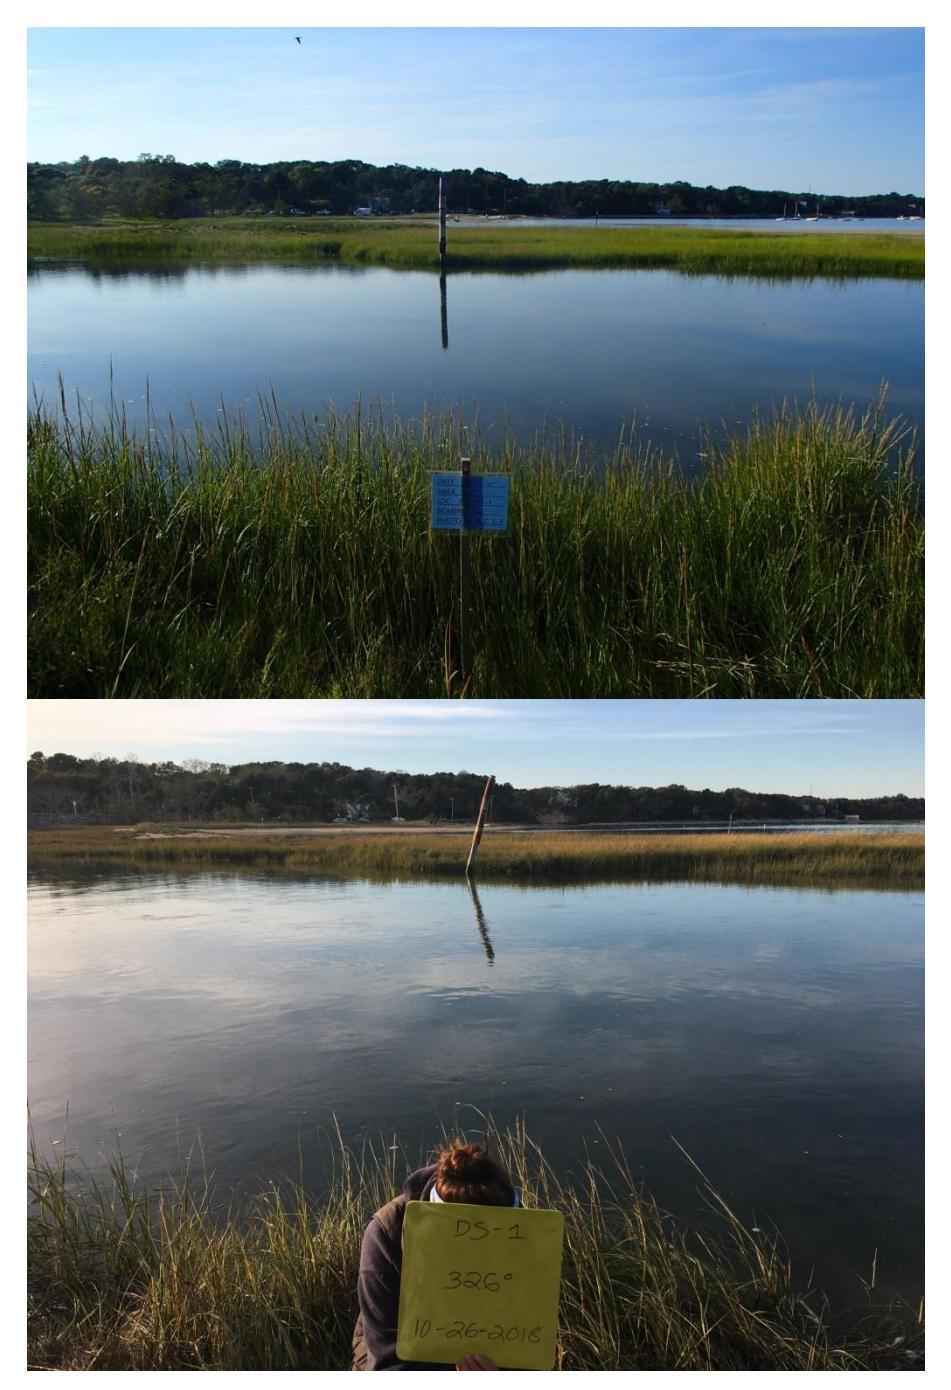
DS-1 360°, Top 2015, Bottom 2018

*The bearing is in fact 360°, not 326° as written on the dry-erase board in the photo.

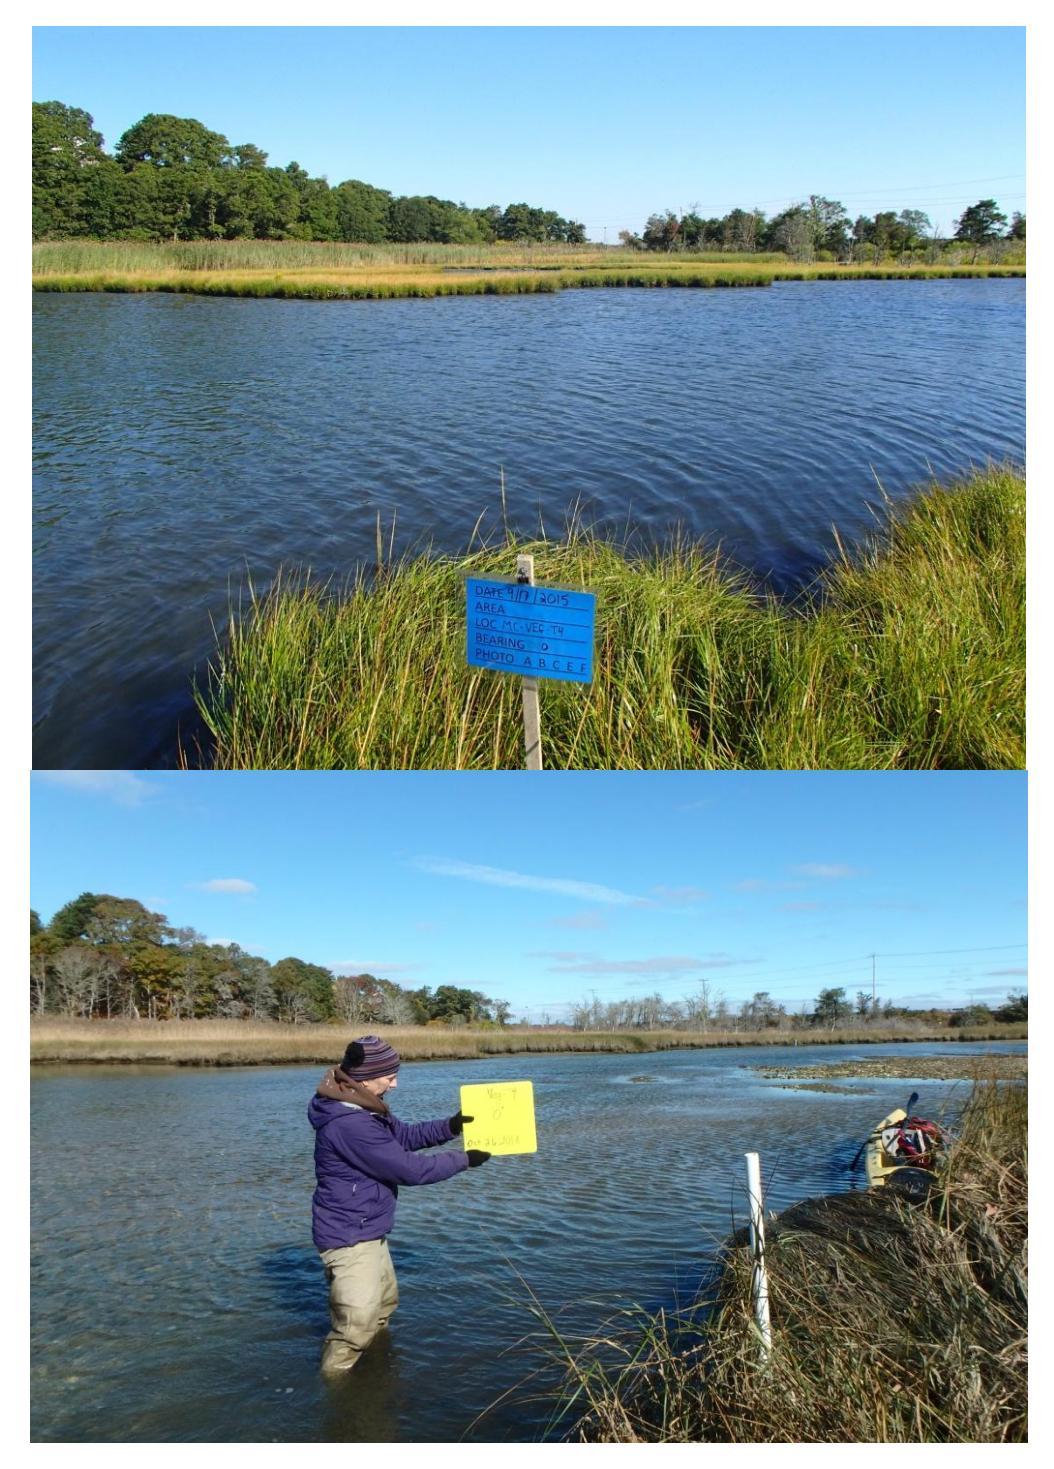
VEG-T4 0°, **Top 2015**, **Bottom 2018**

The photo station VEG-T4 is located just upstream of the Route 28 bridge, on the east shoreline. Five bearings were photographed at this station (0°, 70°, 140°, 240°, and 320°). Saltwater Cordgrass dominates the adjacent shoreline. At bearings 0°, 70° and 320° there is evidence of increased saltwater inundation. Salt intolerant vegetation bordering the creek has receded, opening the shoreline to increased light and snags for wildlife habitat. A reduction in Phragmites is visible at 140° just beyond the Cordgrass in the foreground. In addition, there appears to be new robust Saltwater Cordgrass growth in the foreground of 240°.

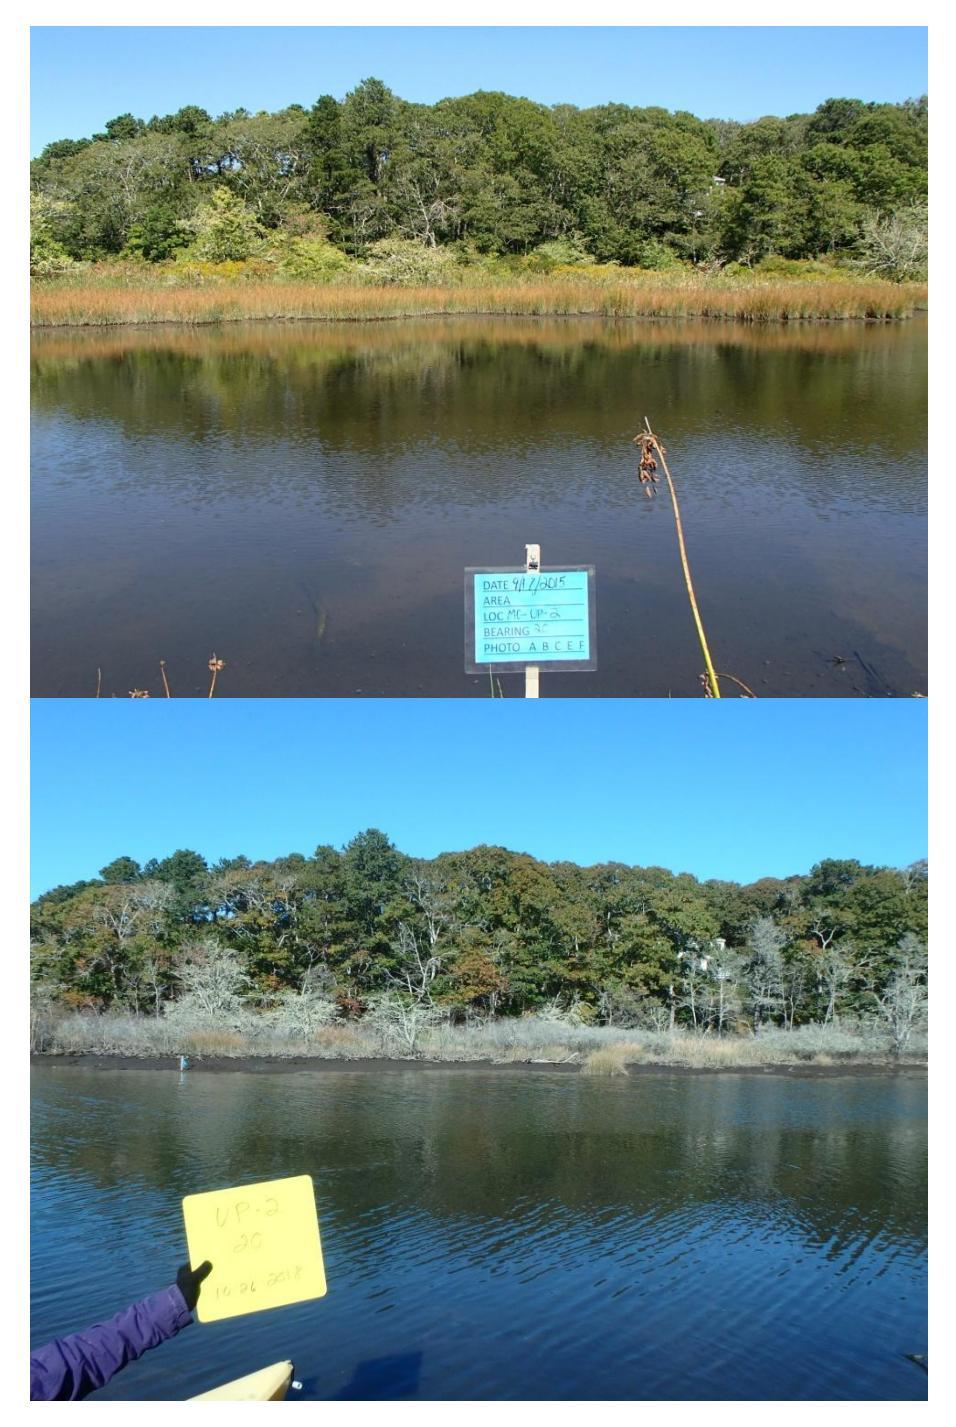
UP2 20°, Top 2015, Bottom 2018

The photo station UP2 is located in the upper basin of muddy creek, on the south shoreline. Eight bearings were photographed at this station, including 20°, 70°, 110°, 140°, 210°, 260°, 310°, and 340°. At each bearing there is evidence of a dramatic increase in saltwater inundation. Mudflats have replaced vegetative cover, for example, in the foreground at 140°, 210°, 260°, and 310°. Salt intolerant vegetation bordering the creek has significantly receded, leaving unvegetated mudflats (20°, 70°, 110°, and 340°).
