2016 Post-Construction Monitoring of the Muddy Creek Restoration Project Harwich and Chatham, Massachusetts

Applied Coastal Research and Engineering, Inc. 766 Falmouth Road, Suite A-1 Mashpee, MA 02649

January 10, 2017

Prepared for: Towns of Harwich and Chatham, MA

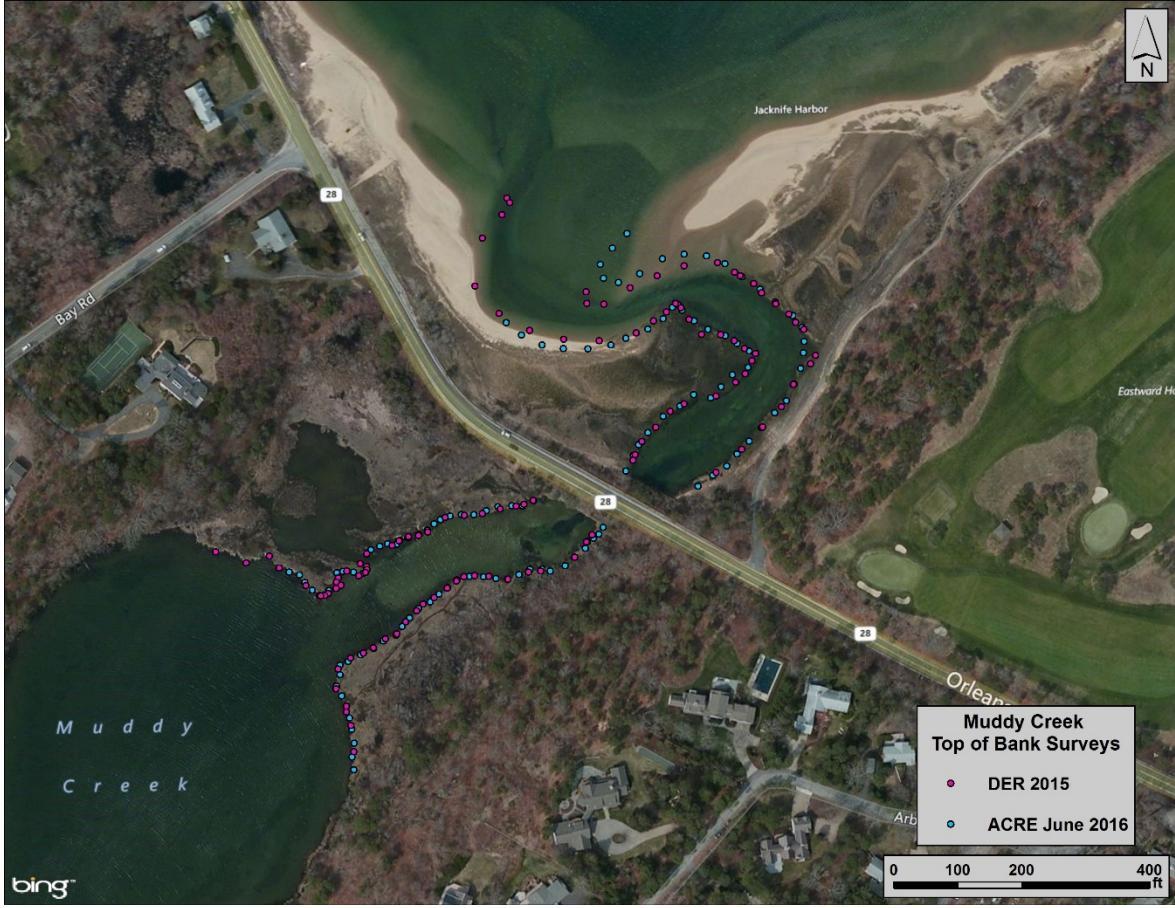
Figure 1 shows the channel banks in the Fall of 2015 (pre-construction) and June of 2016 (post-construction). The top of bank position remained relative stable over the winter, as well as after the restoration of tidal flow through one half of the channel on February 11, 2016 and the full channel on April 1, 2016. Subsequent to the construction of the new bridge and restoration of full tidal flow, there has been some minor shifting in the channel entrance adjacent to Pleasant Bay. These shifts were expected due to the seasonal changes in wave climate on western Pleasant Bay and resulting changes in littoral transport along the coastline and inlet mouth. The inner and outer tidal channels remained in approximately the same positions over the 8-month period. Figure 2 shows the channel banks in the Fall of 2015 (pre-construction) and November of 2016 (post-construction). A comparison of the post-construction movement, June to November, is

Figure 1. Fall of 2015 (pre-construction) and June of 2016 (post-construction) measured top of bank positions. The measurements are overlaid on a composite 2014 aerial photograph (Bing, 2014) of Muddy Creek. Pleasant Bay is seen in the upper portion of the photo.

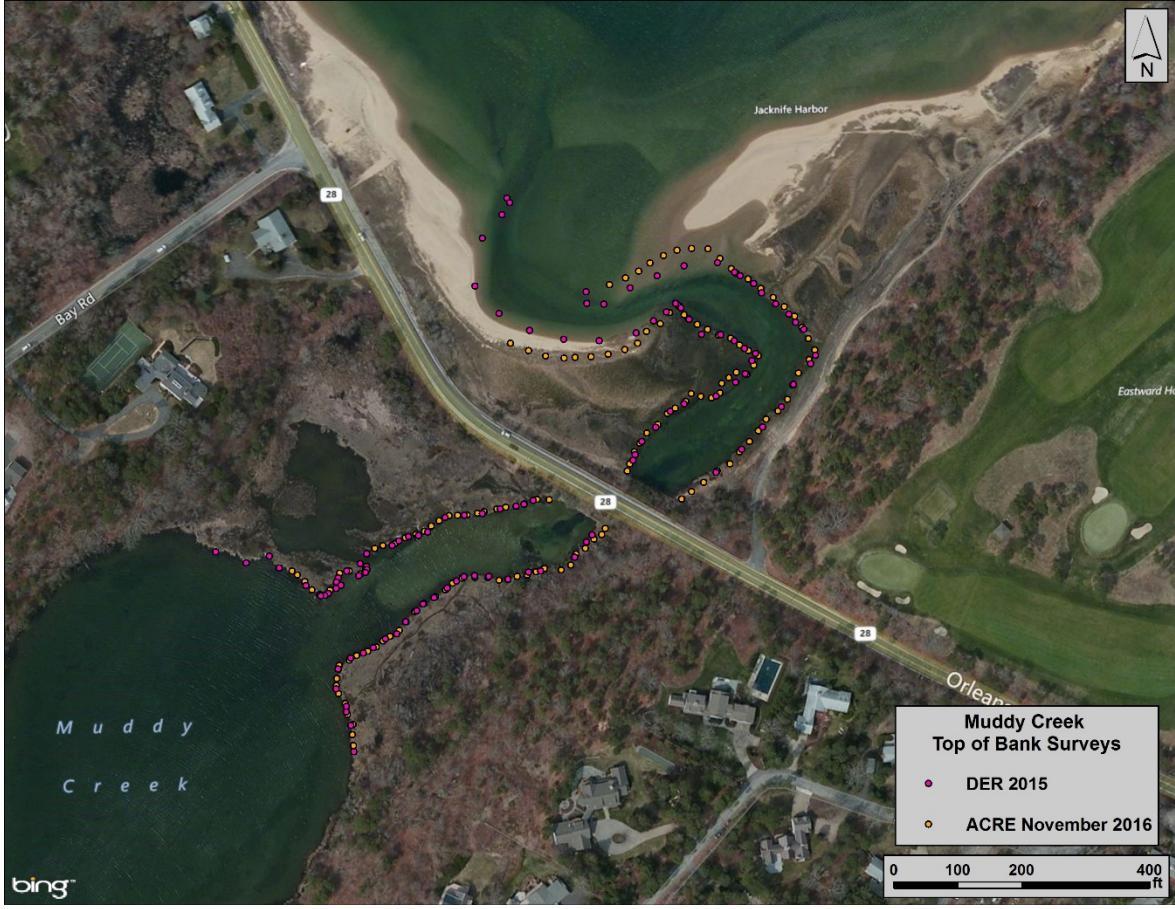
Figure 2. Fall of 2015 (pre-construction) and November of 2016 (post-construction) measured top of bank positions. The measurements are overlaid on a composite 2014 aerial photograph (Bing, 2014) of Muddy Creek. Pleasant Bay is seen in the upper portion of the photo.

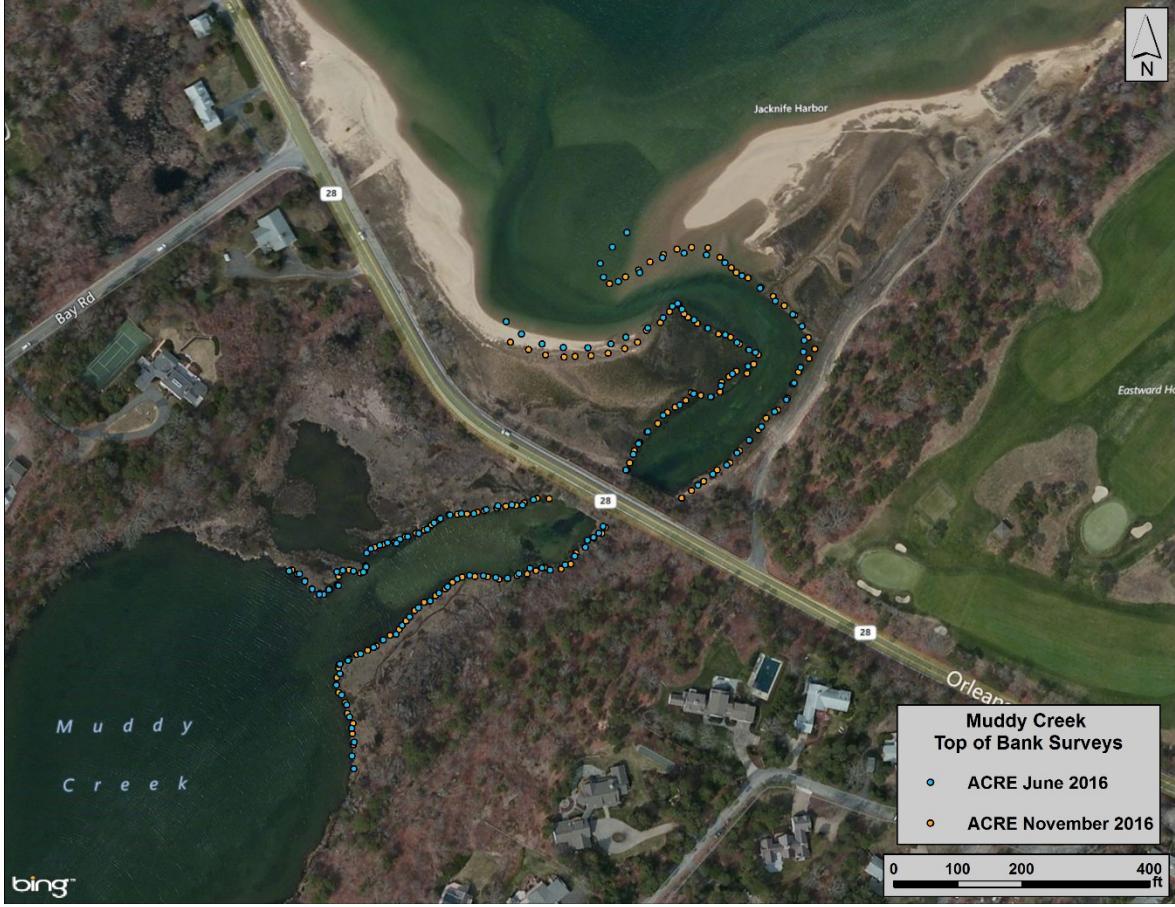
shown in Figure 3 and a composite of all the bank surveys is presented in Figure 4. Overall the bank position remained relatively stable with no pronounced movements in the meanders or channel, except for the mouth of the inlet along the Pleasant Bay shoreline.

Figure 3. June of 2016 and November of 2016 measured top of bank positions. The measurements are overlaid on a composite 2014 aerial photograph (Bing, 2014) of Muddy Creek. Pleasant Bay is seen in the upper portion of the photo.

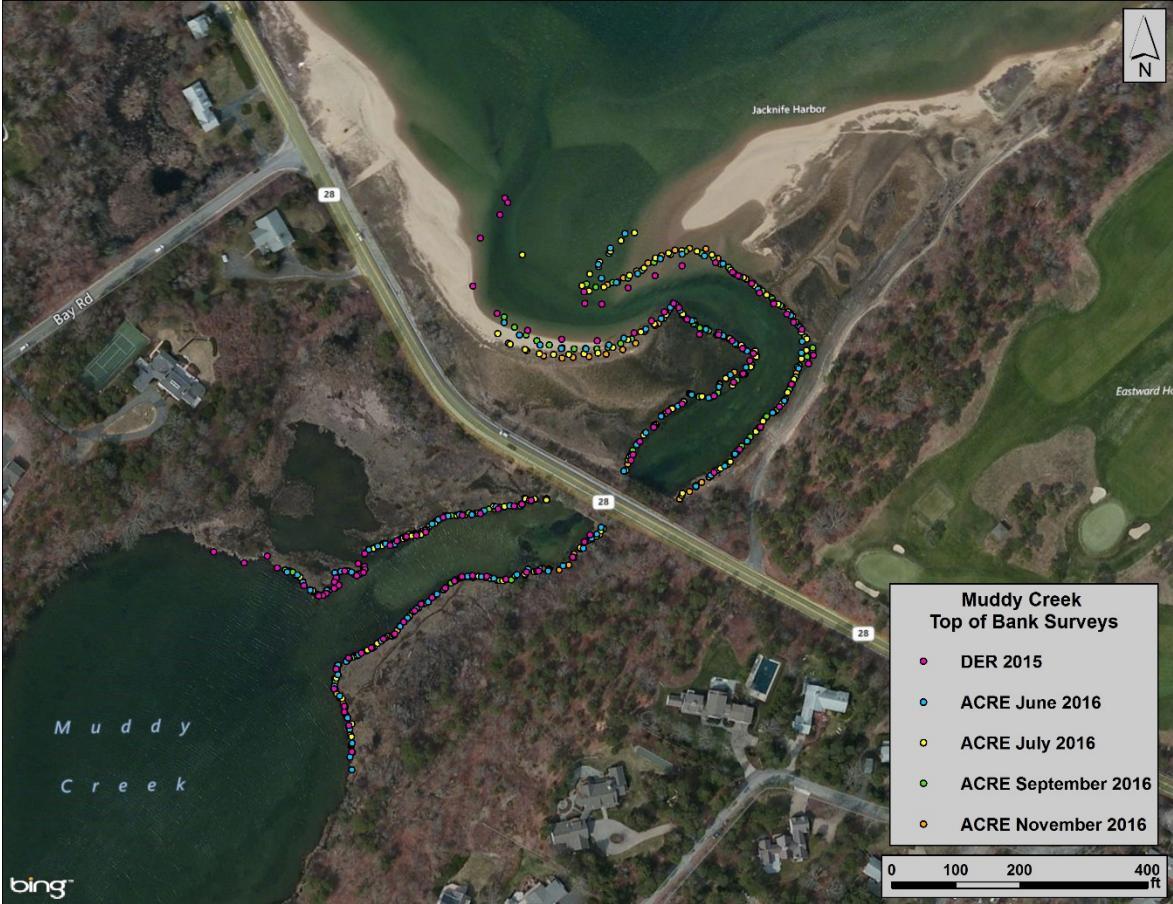
Figure 4. Composite of all the measured top of bank positions. The measurements are overlaid on a composite 2014 aerial photograph (Bing, 2014) of Muddy Creek. Pleasant Bay is seen in the upper portion of the photo.

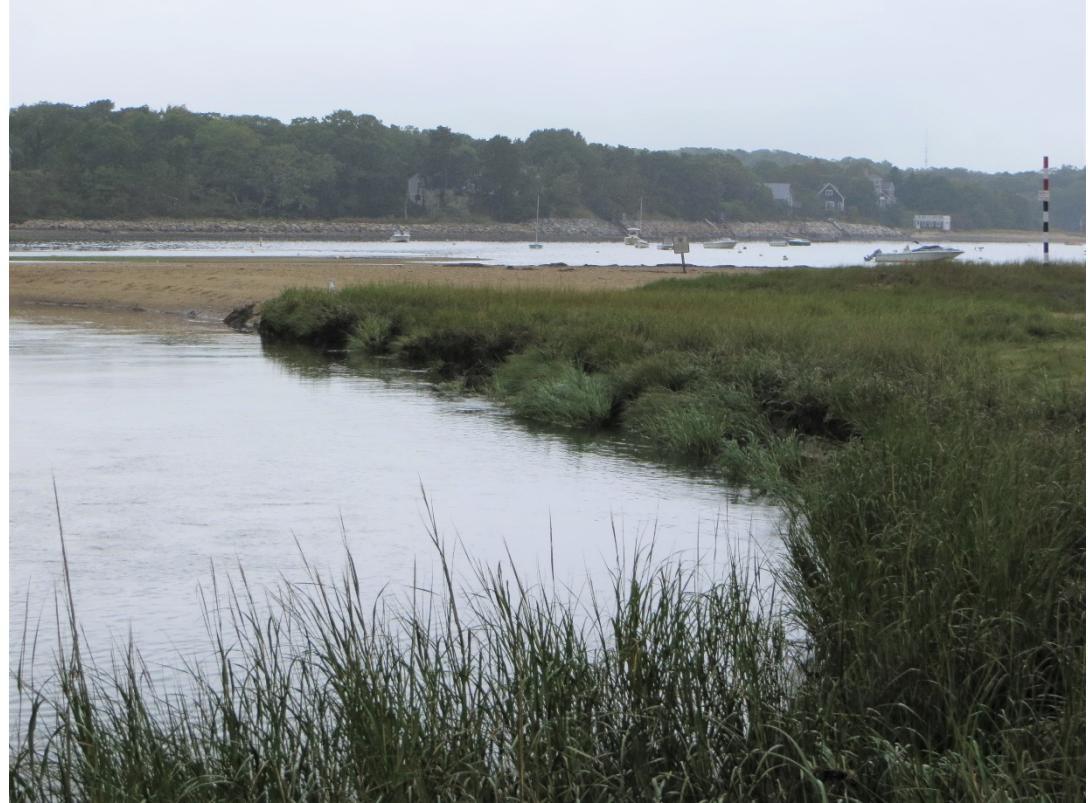
Figures 1 through 4 do not illustrate specific areas where the marsh bank is slowly being undercut and shifting the channel landward as a result of the increased tidal flow scouring the outside of the channel bends. Figure 5 shows evidence of site-specific bank erosion where thin areas (1-4 feet in thickness) of marsh bank were observed cleaving away from the marsh surface and slowly settling into the channel as tidal currents eroded the material. The areas where the bank is being undercut are highlighted in red in Figure 6. The erosional areas are predominately located at channel bends, where the complex nature of the tidal flows caused by curvature effects generate secondary currents. The secondary currents occur in the plane normal (across channel towards the marsh banks) to the primary flow direction (along channel the axis). The secondary currents appear at bends due to skewing of a portion of the cross-stream vorticity into the along-stream direction. The main, skew-induced secondary cell drives fast, nearsurface water outwards at a bend, and carries slow, near-bed water inwards. The high intensity outward flow scours sediment along the face of the channel bank, while the near-bed return flow carries sediment to the inside of the bend where it is deposited as the flow velocities decrease. The changes in channel geometry resulting from the secondary flows can be clearly observed in the cross-sectional plots presented in Section 3. The areas highlighted in blue in Figure 6 were lower in elevation than the surrounding marsh plain prior to the opening of the bridge. These areas remain low and have experienced minor bank erosion along the channel face, but have remained stable over the monitoring period.

Figure 5. Muddy Creek tidal channel downstream (seaward) of Route 28 where the marsh bank has been observed cleaving away from the marsh surface.

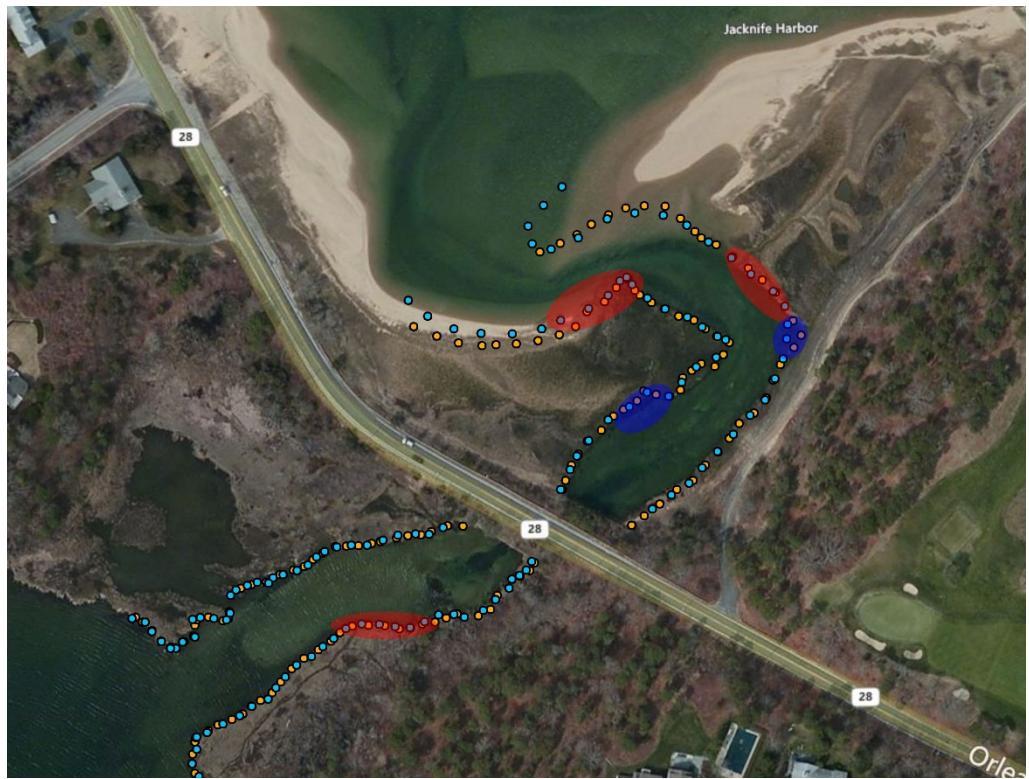
Figure 6. Red areas represent areas where bank erosion has been noted over the monitoring period. Blue areas represent marsh plain that was lower than the adjacent marsh plain prior to construction but have not exhibit significant bank erosion.

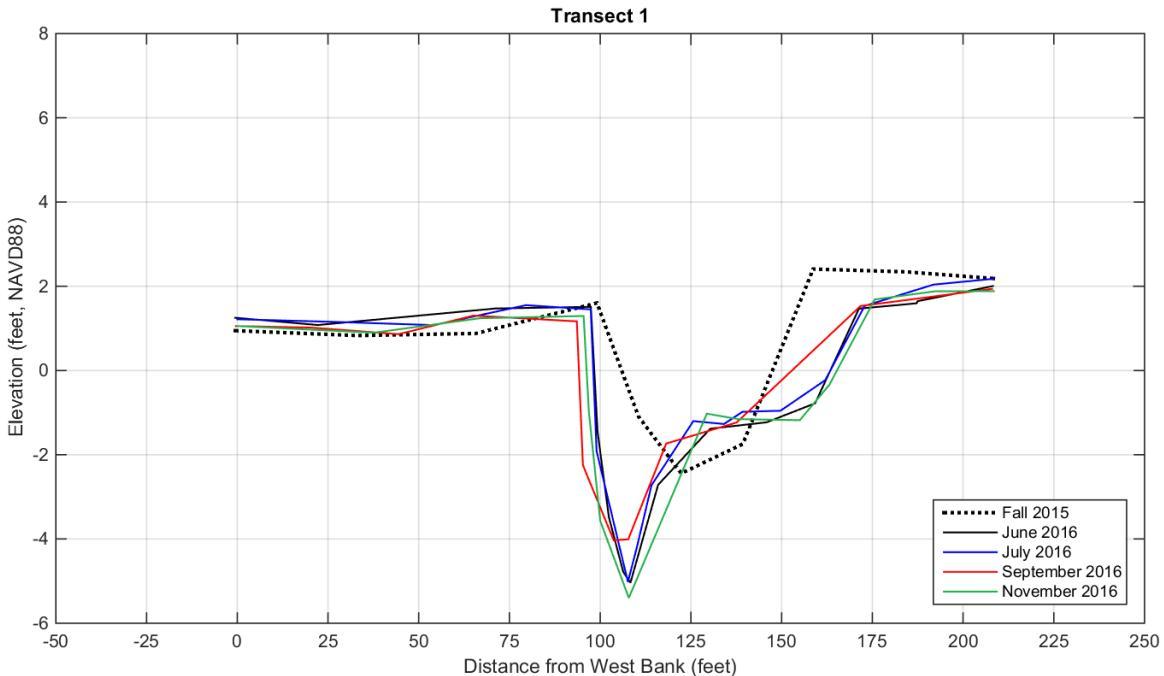
Transect 1 (Figure 8) shows approximately a 3-foot increase in channel depth and shift southward of the main conveyance pathway along the southern edge of the channel. The increase in depth around the outside of the bend has resulted in bank being undercut and loss of salt marsh along the edge of the marsh plain. The channel position and depth has been relatively stable over the post-construction monitoring surveys and is expected to remain so with some minor adjustment as the system continues to respond to the changes in tidal flow and winter storms. Transect 2 (Figure 9) had a large amount of deposition on the inside of the channel bend which is predominately fine to medium grained sand. Transects 3 and 4 (Figures 10 and 12. respectively) had similar trends, the outside bend of the channel deepened due to the increase in flow, while the inside of the channel cross section accreted sediment. The channel geometry at Transect 10 (Figure 11) has the same characteristics as Transects 3 and 4 which are downstream and upstream. The channel bottom at Transect 5 (Figure 13) accreted due to sediment deposition. During both the flood and ebb tide, sediment was deposited in response to the flow velocities decreasing as the channel straightened and widened. Transect 11 (Figure 14) reflects the channel geometry upstream of the bridge at Transect 6 (Figure 15). The main conveyance channel in centered in the cross section, aligned with the bridge opening.

Figure 8. Cross-channel monitoring Transect 1. Distance are relative to the West Channel Bank and datum elevations are given relative to NAVD88.

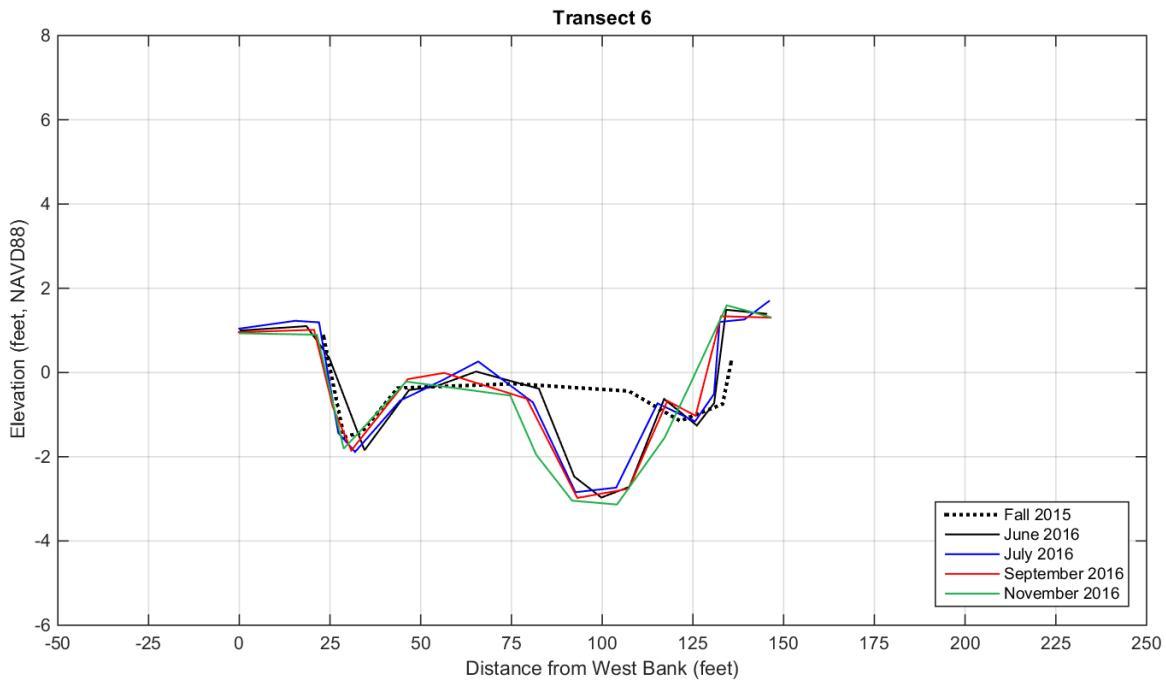
Upstream of the bridge, Transect 6 (Figure 15) developed a new conveyance channel centered along the bridge opening. The channel connects and extends the scour hole that existed immediately upstream of the causeway prior to the restoration

Figure 15. Cross-channel monitoring Transect 6. Distance are relative to the West Channel Bank and datum elevations are given relative to NAVD88.

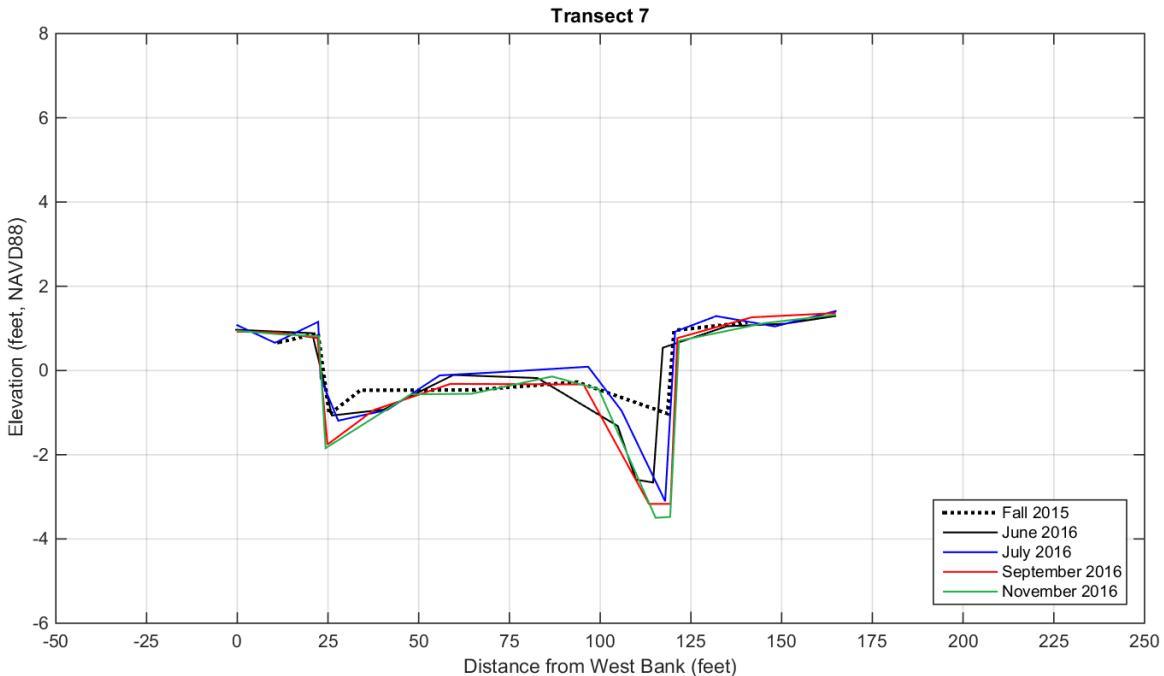
and is a response to the increased flood tides. A similar response was observed at Transect 7 (Figure 16), the southern channel widened and deepened along the marsh edge due to the increase in the flood tide volume and velocity. Transect 8 (Figure 17) remain stable and did not show any significant transitions in channel geometry, while Transect 9 (Figure 18) accreted as the flood tide shoal extended and transitioned upstream due to the scouring of channel sediment immediately upstream of the bridge.

Figure 16. Cross-channel monitoring Transect 7. Distance are relative to the West Channel Bank and datum elevations are given relative to NAVD88.

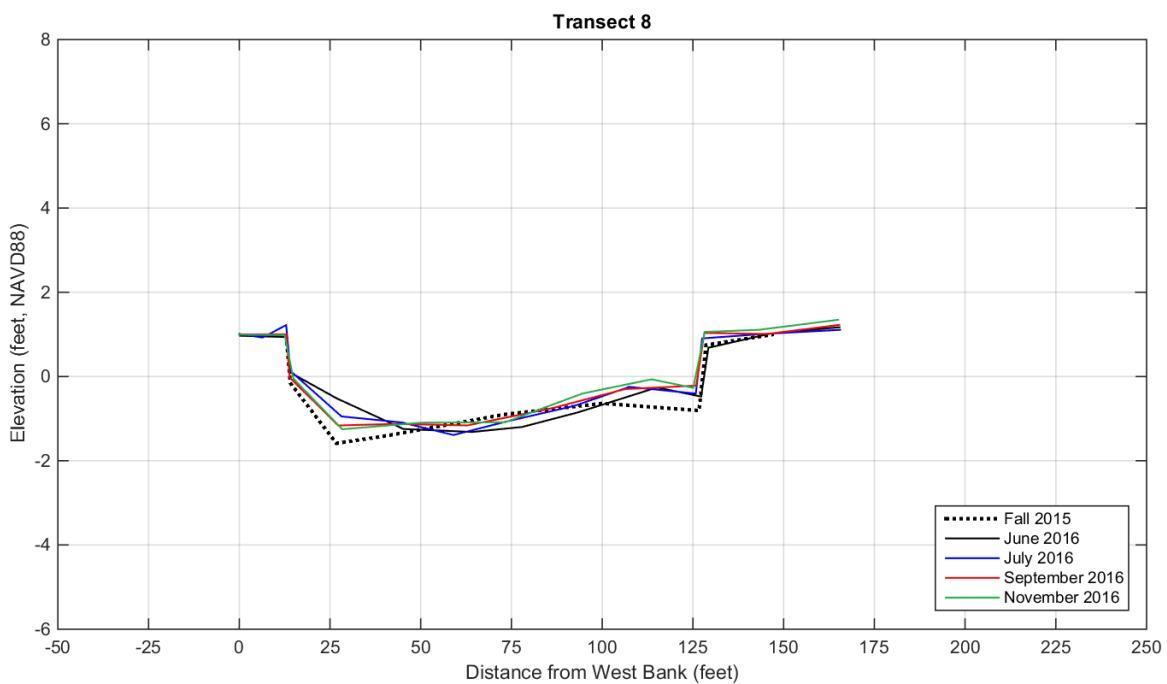
Figure 17. Cross-channel monitoring Transect 8. Distance are relative to the West Channel Bank and datum elevations are given relative to NAVD88.

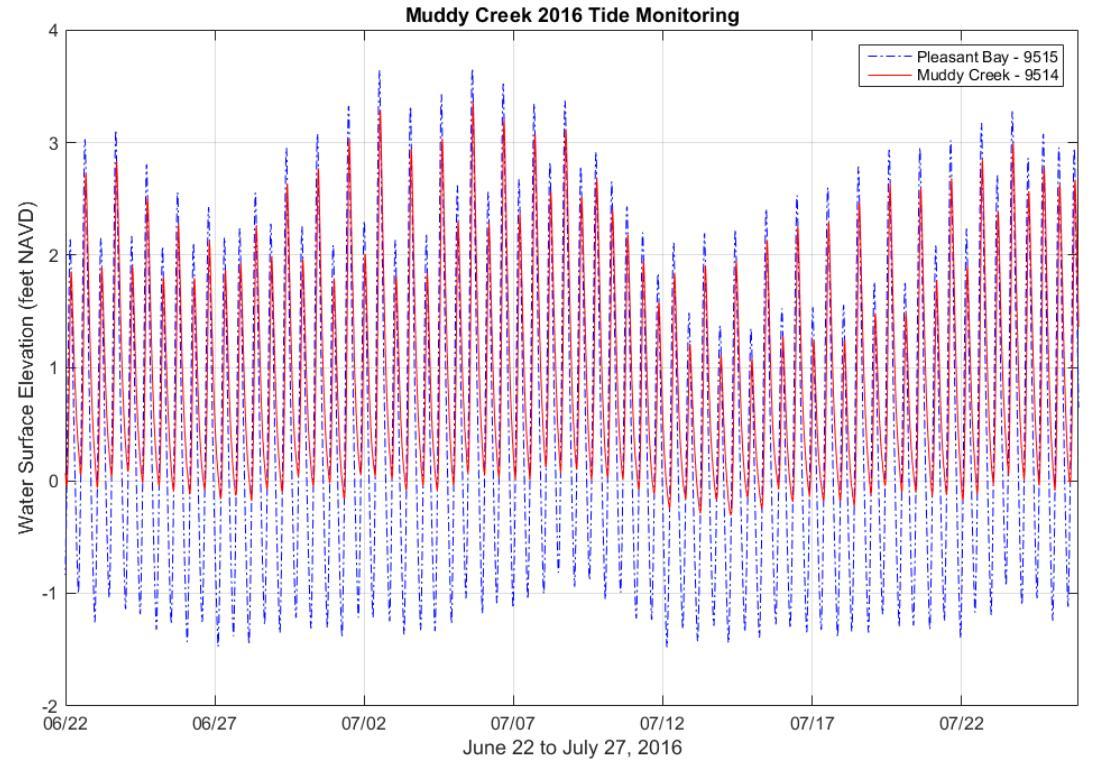
Plots of the tide data are shown in Figure 20, for the 34-day deployment. The spring-to-neap variation in tide can be seen in this plot. Examining the plot shows that offshore the tide reached its maximum spring tide range of approximately 4.8 feet on July 6th. Six days later the neap tide range was smaller, approximately 3.3 feet. A visual comparison of the two gage records in Figure 21, shows that there is a reduction in the tide range as the tide propagates from Pleasant Bay into Muddy Creek. The loss of amplitude with distance from the inlet channel through the bridge is described as tidal attenuation. Frictional mechanisms dissipate tidal flow energy, resulting in a reduction of the height of the tide. Tide attenuation is accompanied by a time delay (or phase lag) in

Figure 20. Plots of observed tides for the Muddy Creek, Chatham and Harwich, MA, for the 34-day period between June 1, 2016 and July 16, 2016. The blue line shows tide offshore in Pleasant Bay. The red line shows the tide inside Muddy Creek upstream of the new Route 28 Bridge. All water levels are referenced to the NAVD 88.

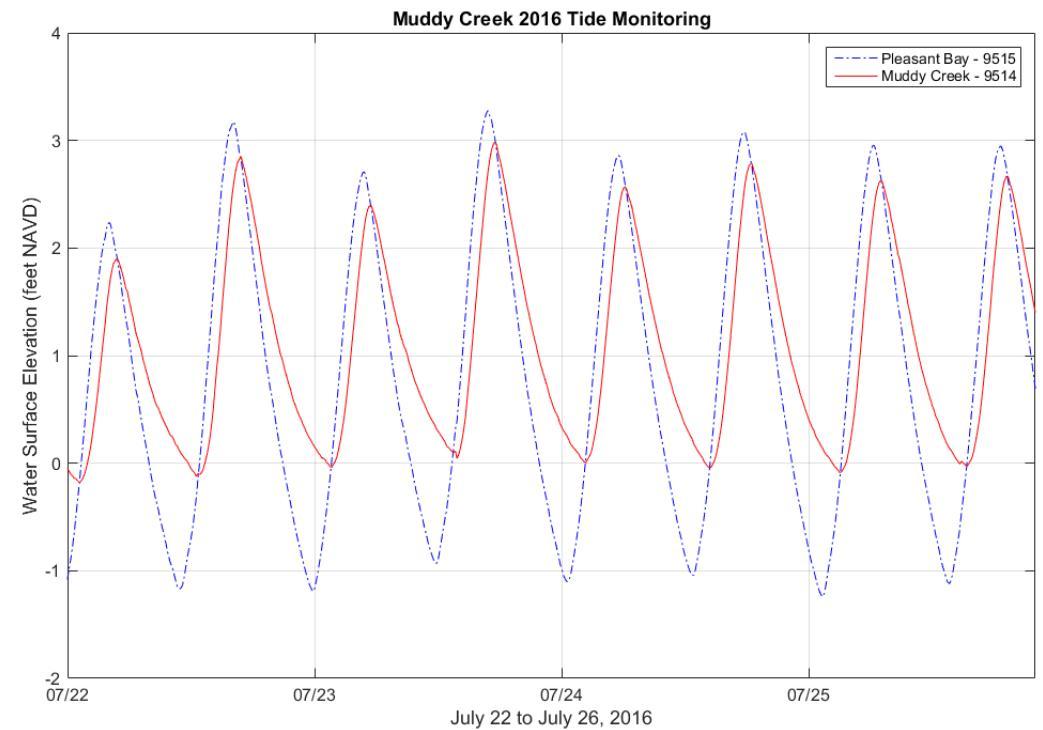
the time of high and low tide (relative to the offshore tide). The lag can be visually observed on the flood and ebb tide between Pleasant Bay and Muddy Creek as shown in Figure 21.

Figure 21. Plot showing three tide cycles in Pleasant Bay and upstream of the new Route 28 Bridge in Muddy Creek.

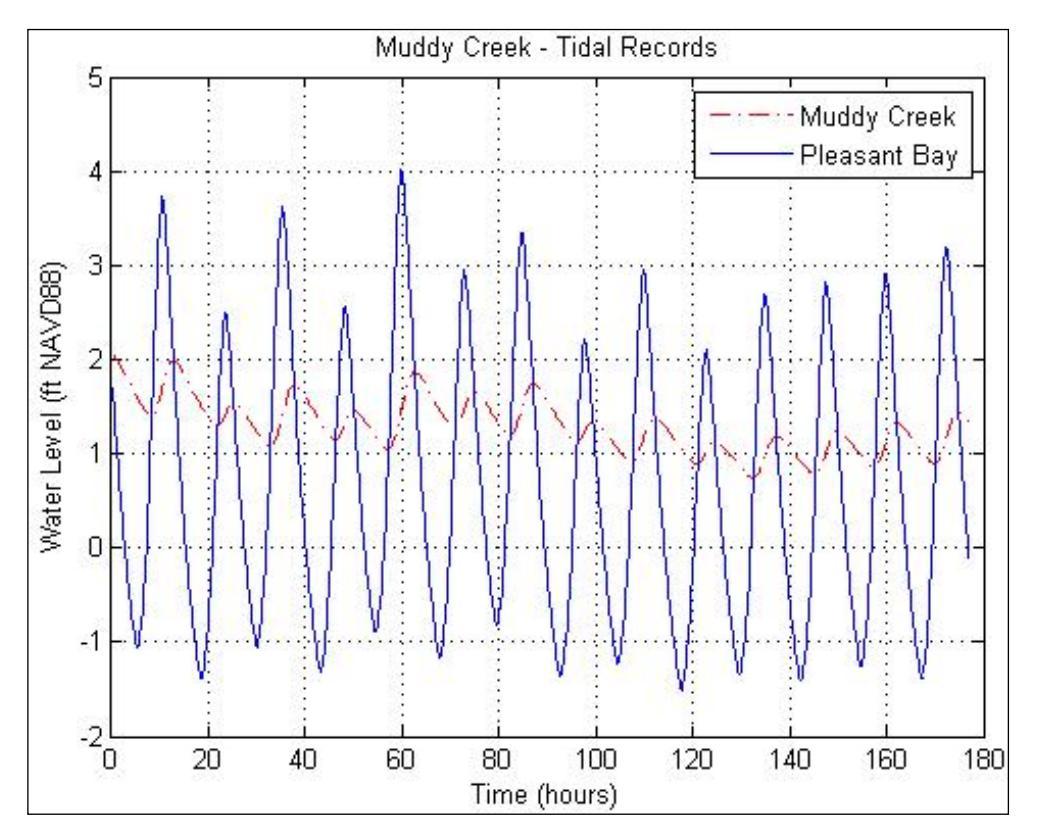
To examine the influence the recently constructed Route 28 Bridge has had on the tides entering and exiting Muddy Creek, the tide datums from the 2009 study which examined various opening alternatives for Muddy Creek are presented in Table 4. The 2009 tidal signal within Pleasant Bay had a slightly larger amplitude range relative to the 2016 dataset. The changes in tidal amplitude are due to differences in tidal forcing over the short monitoring periods, transformation and evolution of the tidal inlets into Pleasant Bay from the Atlantic Ocean, and variability in meteorological forcing over the monitoring periods. The key difference upstream of the Route 28 causeway is the significant increase in tidal amplitude from 2009 to 2016. The mean tidal range went from 0.5 feet in 2009 to 2.3 feet in 2016. Which is a 1.8-foot increase in mean tidal range (MHW to MLW) and 2.1-foot increase in peak tidal range (MHHW to MLLW) and within Muddy Creek due to the improved channel opening (Table 5). A visual comparison also shows the significant increase in amplitude (height between high and low tide), Figure 21 shows the tidal variations with the new constructed bridge and Figure 22 shows the historic tidal variations with the stone box culverts.

Figure 22. Tide gage records from November 2009 (pre-construction) upstream and downstream of the Route 28 culvert. In 2009, Pleasant Bay was connected to Muddy Creek through a pair of stone box culverts approximately 2.5-feet wide, 3.75-feet in height, and 100-feet in length.
