THE MASSACHUSETTS ESTUARIES PROJECT

BACTERIA TMDL FOR MUDDY CREEK

Report # MA96-51-2004-01

*Chatham & Harwich Massachusetts
Cape Cod Watershed*

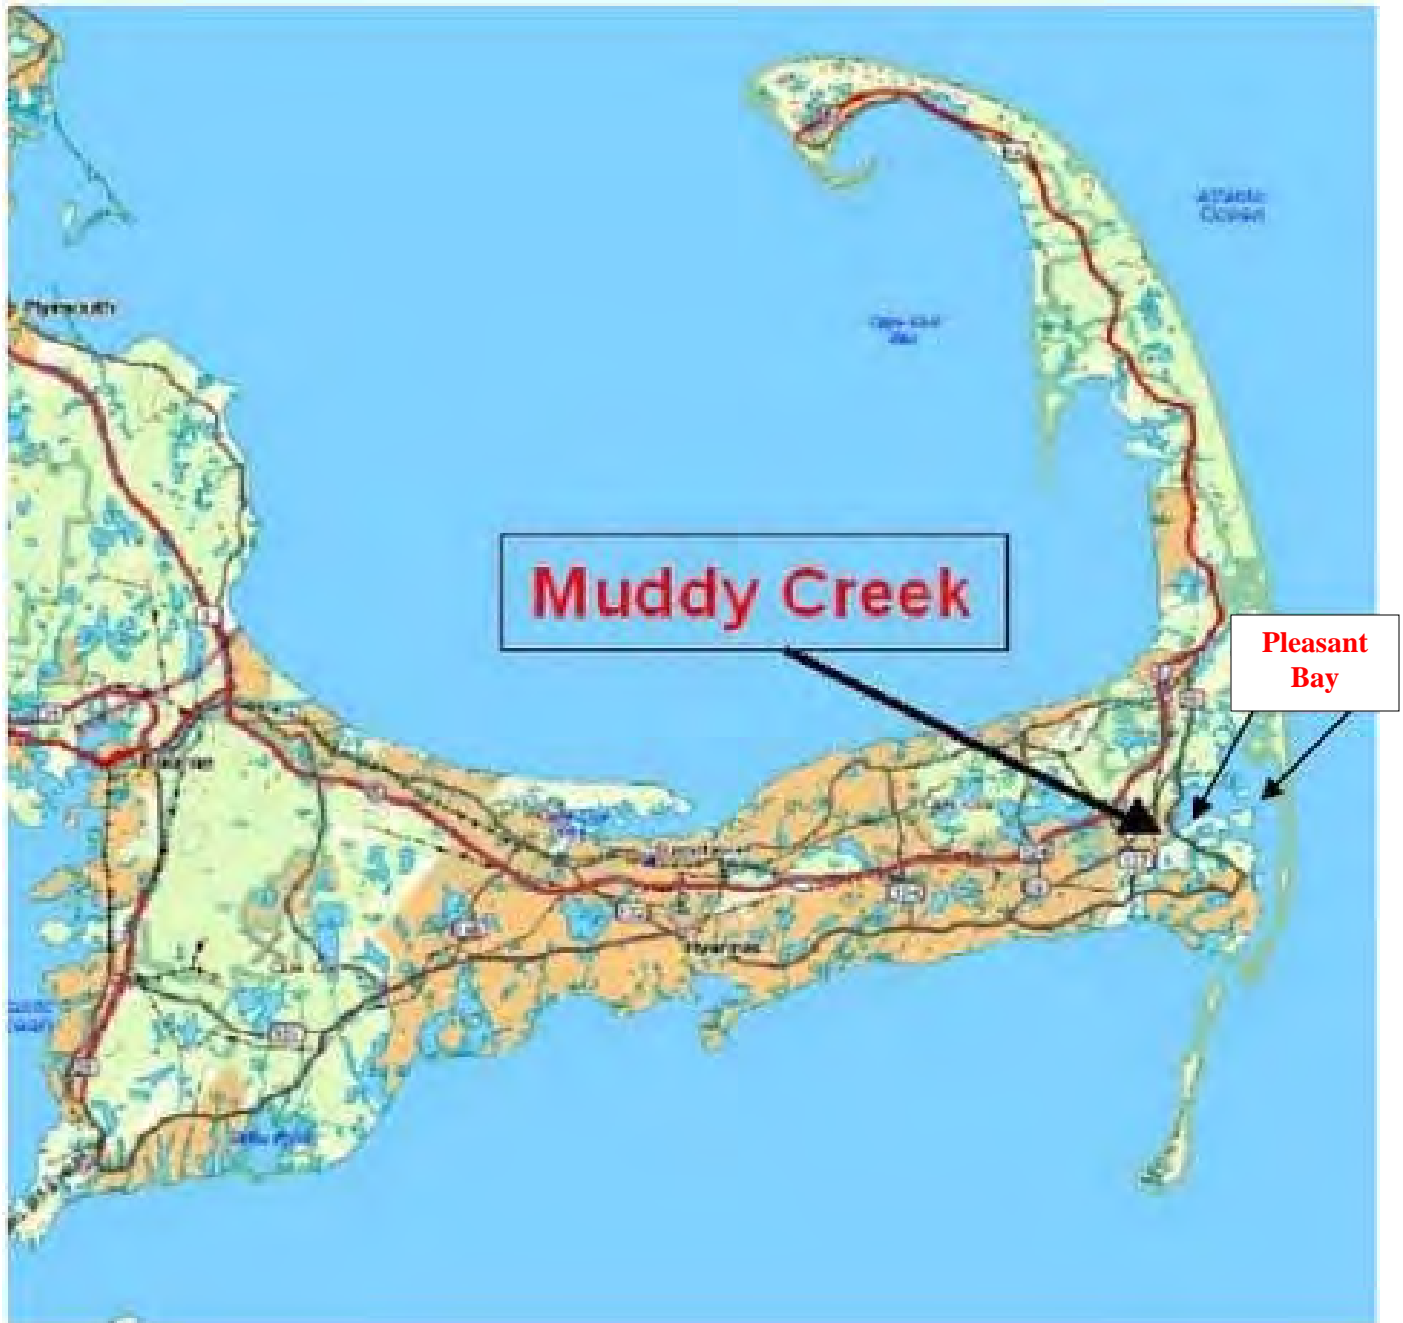
Figure II-1. Location of the Muddy Creek system, Cape Cod, Town of Chatham, MA.

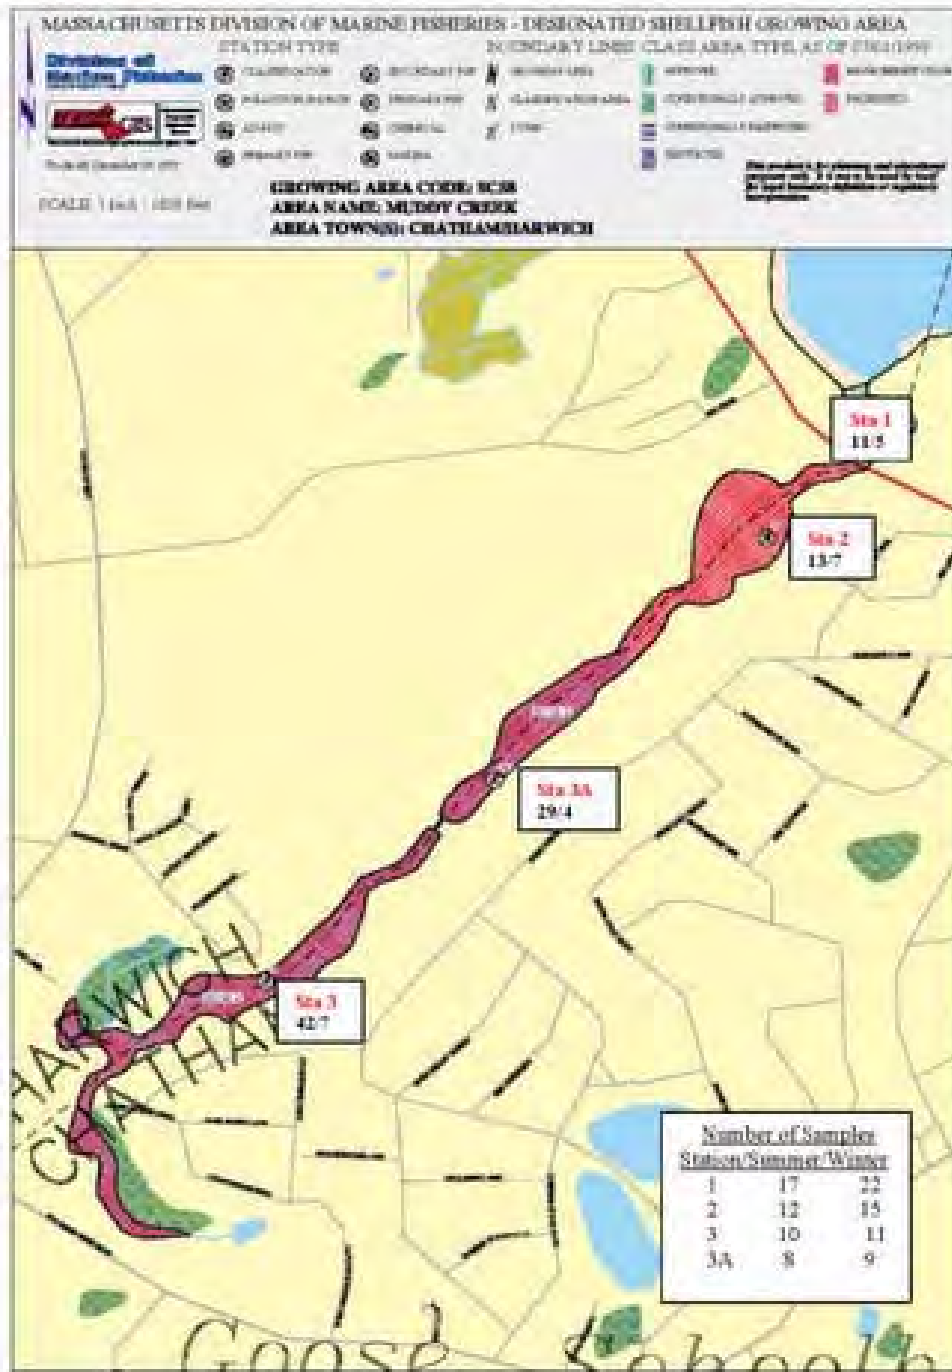
Figure V-1 Summer and winter fecal coliform bacteria counts (CFU/100 mLs), 1985-1995. Numbers indicate geometric means for summer/winter from samplings by Massachusetts Division of Marine Fisheries.

During the winter months of the 1985-1995 sampling period, there were 57 sampling events (Figure V-1). Winter geometric means for fecal coliform bacteria were lower than summer means at all stations and were less than the water quality standard of 14 CFU/100 mL. *None of the winter samples at any of the stations exceeded the water quality standard of 43 CFU/100 mL* (Figures V-1, V-4a, Table V-2a). The ratio of the summer geometric mean the winter mean ranged from 1.8 at Station 2 to 7.8 at Station 3A. Therefore, *summer concentrations appear to be 2 to 8 times higher than winter concentrations* (Table V-2a).

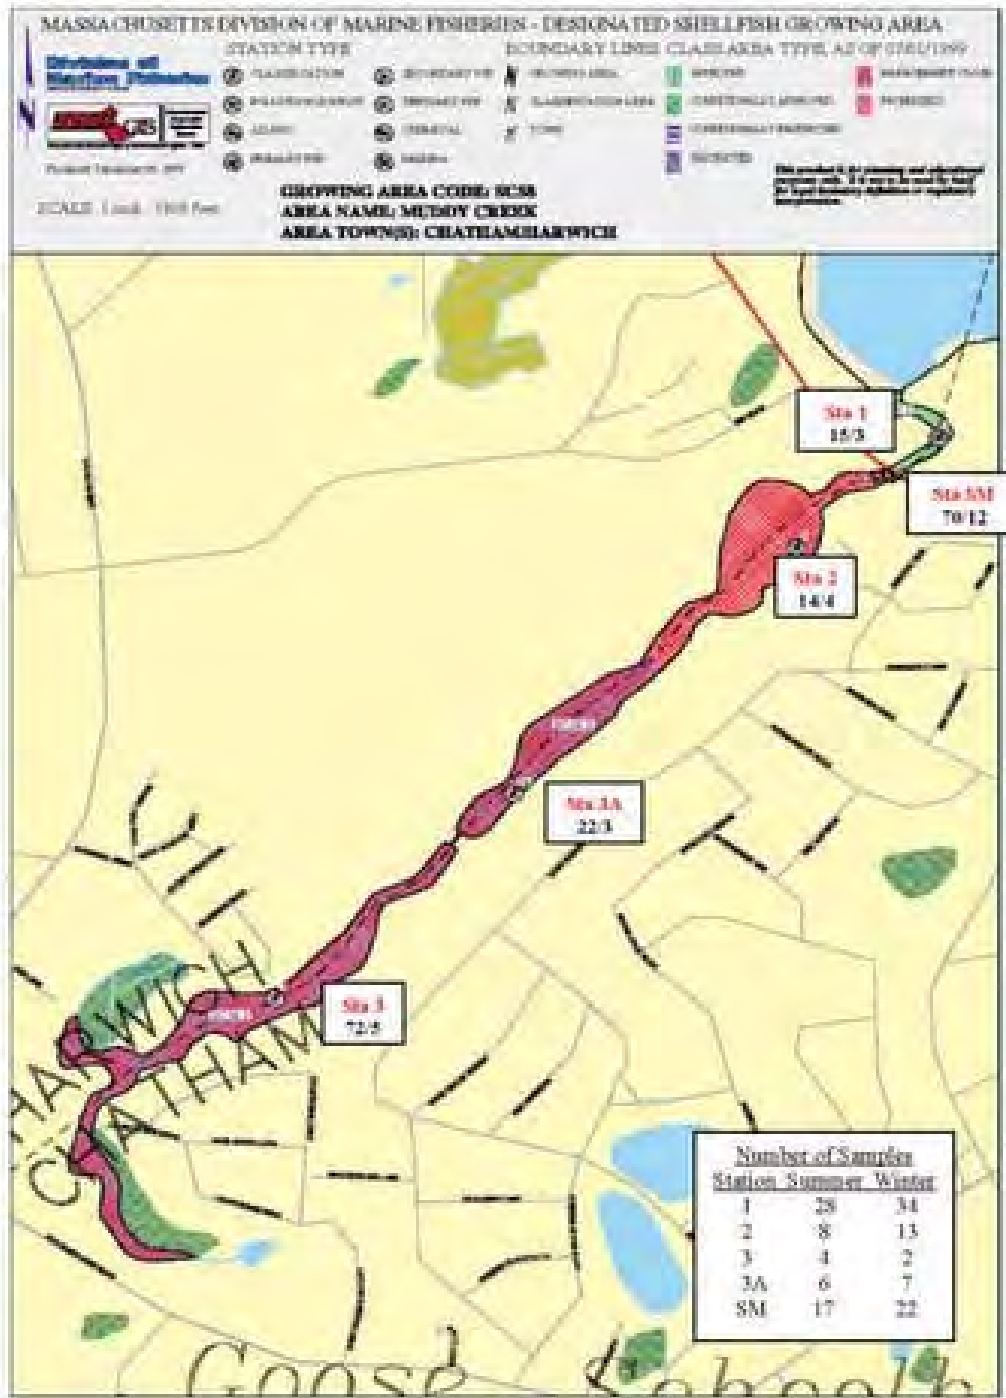
Figure V-2 Summer and winter fecal coliform bacteria counts (CFU/100 mLs), 1996-2003

Numbers indicate geometric means for summer/winter samplings by Massachusetts Division of Marine Fisheries, Town of Chatham Water Quality Department and SMAST (SM).

In the 1996-2003 sampling period, a total of 78 fecal coliform samples were taken at all stations during the winter. All geometric means were lower than the water quality standard of 14 and were significantly lower than summer means, ranging from 3 CFU/100 mL at Stations 1 and 3A to 12 CFU/100 mL at Station SM (Figures 2, V-4b, Table V-2a). Only at Station SM were more than 10% of the samples greater than the water quality standard of 43 CFU/100 mL (Table V2a). The ratio of summer to winter geometric means ranged from 3.2 at Station 2 to 13.7 at Station 3, indicating that *fecal contamination in the summer was approximately 3-14 times higher than the winter*.

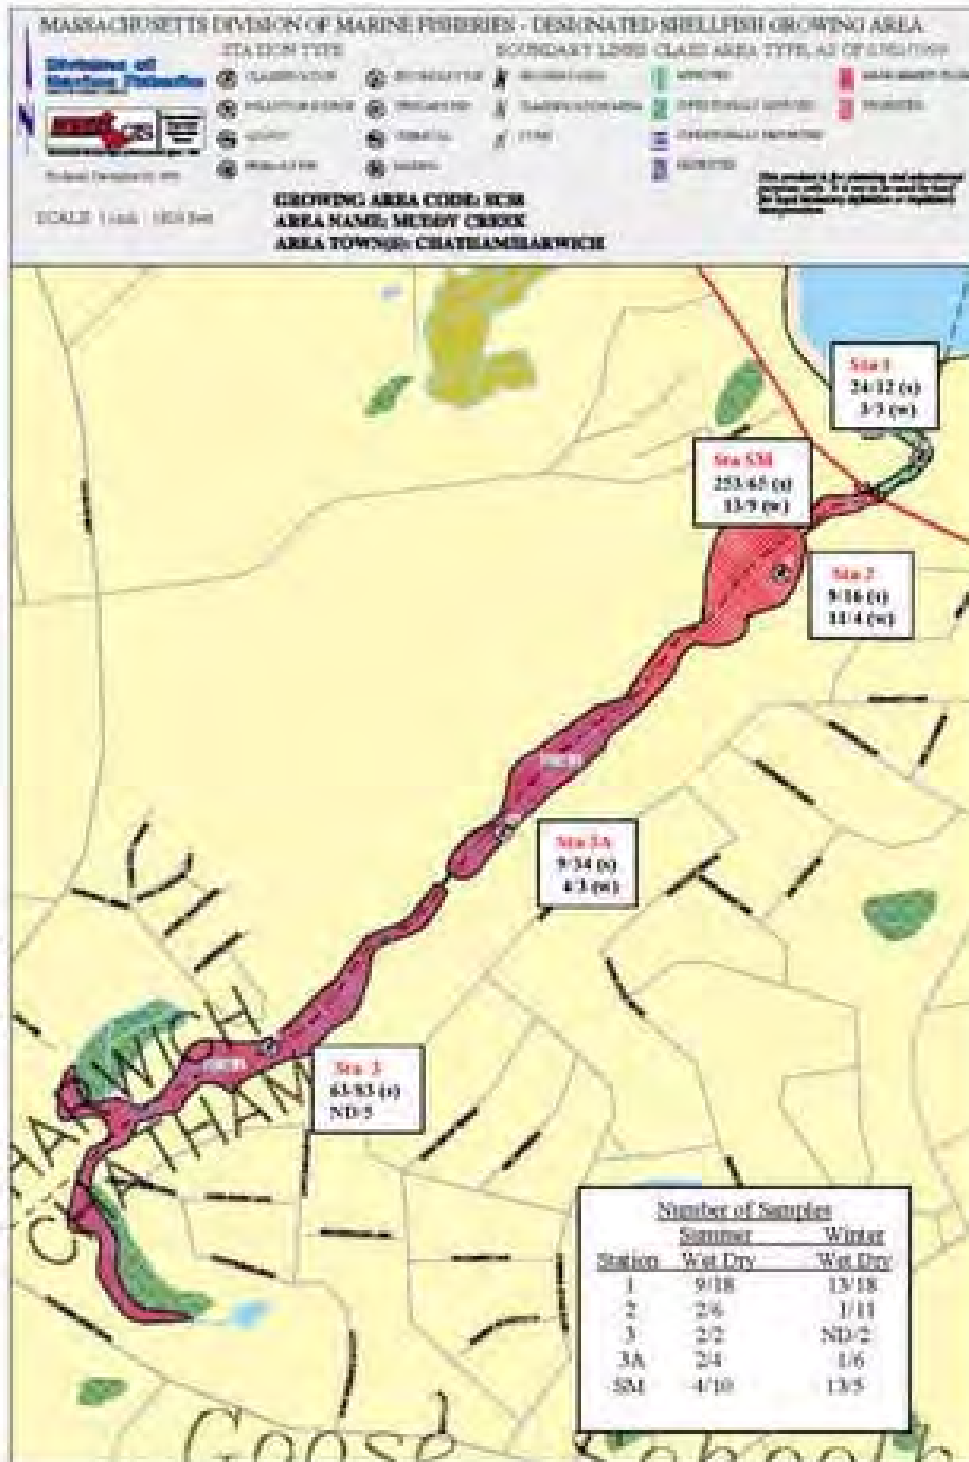
Figure V-3 Wet and Dry fecal coliform bacteria counts (CFU/100 mLs), 1996-2003.

Numbers indicate geometric means of wet/dry data for summer (s) and winter (w) samplings by DMF, Town of Chatham and SMAST.

Given the temporal distribution and number of samples during the years 1996-2003, it was possible to evaluate wet versus dry weather bacterial levels. Samplings were separated into wet and dry events based on the total rainfall for the 3 days prior to sampling (dry weather < 0.25 inches of rainfall > wet weather). A total of 19 wet samples and 40 dry samples were taken during the summer for fecal coliform. A total of 28 wet and 42 dry samples were taken during the winter (Figure V-3, Table V-2a). For the summer, wet geometric means ranged from 9 CFU/100 mL at Stations 2 and 3A to 253 CFU/100 mL at Station SM. Dry means ranged from 12 CFU/100 mL at Station 1 to 83 CFU/100 mL at Station 3 (Figures V-3 and V-6a). Wet means exceeded the water quality standard of 14 CFU/100 mL at Stations 1, 3 and SM. Dry means exceeded the standard at Stations 2, 3, 3A and SM (Table V-2a). More than 10% of samples at all stations for both wet and dry sampling were above the water quality standard of 43 CFU/100 mL (Table V-2a). The ratio of wet to dry geometric means ranged from 0.3 at Station 3A to 3.9 at SM. *Wet inputs were significantly greater than dry inputs at Stations 1 and SM only.* These results indicate that non-runoff sources are the dominant players in the upper basin and upper portion of the lower basin (Stations 2, 3, and 3A) and that runoff is a dominant player in the region of the tidal inlet and Route 28 (Stations 1 and SM).

For winter samplings, wet weather geometric means ranged from 3 CFU/100 mL at Station 1 to 13 CFU/100 mL at Station SM (there were no samples taken at Station 3 and only single samples were taken at Stations 2 and 3A). Dry geometric means ranged from 3 CFU/100 mL at Station 1 to 9 CFU/100 mL at Station SM (Figures V-3, V-6a, V-6b, Table V-2a). *In the winter, none of the geometric means for wet or dry samples exceeded the water quality standard of 14 CFU/100 mL and only at Station SM for both wet and dry samplings did more than 10% of samples exceed the water quality standard of 43 CFU/100 mL* (Table V-2a). Ratios of wet to dry means ranged from 1.2 at Station 1 to 2.9 at Station 2, indicating that wet bacterial inputs during the winter were 1-3 times dry inputs (Table V-2a). These results support the source indications found in the summer analysis, above.
