Environmental Monitoring Report

Muddy Creek Restoration Bridge Project

August 2017

Environmental Monitoring Report Muddy Creek Restoration Bridge Project

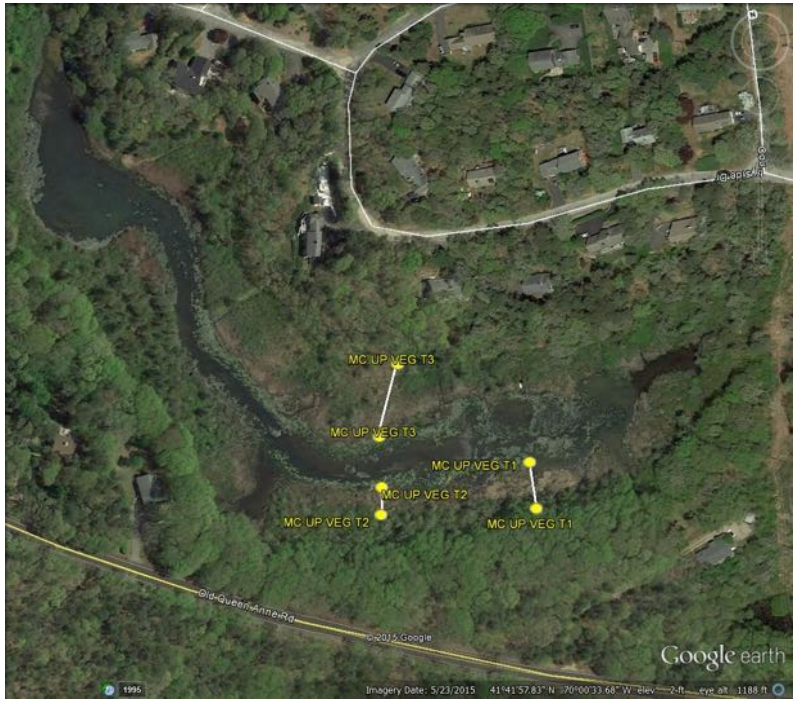
Figure 2: Vegetation transects within the upper basin of Muddy Creek

Pre-Project: Species composition was determined by the line-intercept method (Barbour et al. 1987²). Transects were established and surveyed by MassDER during the fall of 2015 and end-points permanently marked with 3.5-foot lengths of ½” PVC pipe set into the marsh. A total of eight transects were established: three transects in the upper basin, one in the middle basin, three in the lower basin, and a single reference transect located downstream of Route 28 Bridge (Figures 2-4). Where applicable, vegetation transects established in 2011 by Baxter & Nye Associates for permitting purposes were re-established. Transect lengths varied, but were generally 50m and were oriented perpendicular to Muddy Creek from the edge of the marsh creek toward adjacent upland.

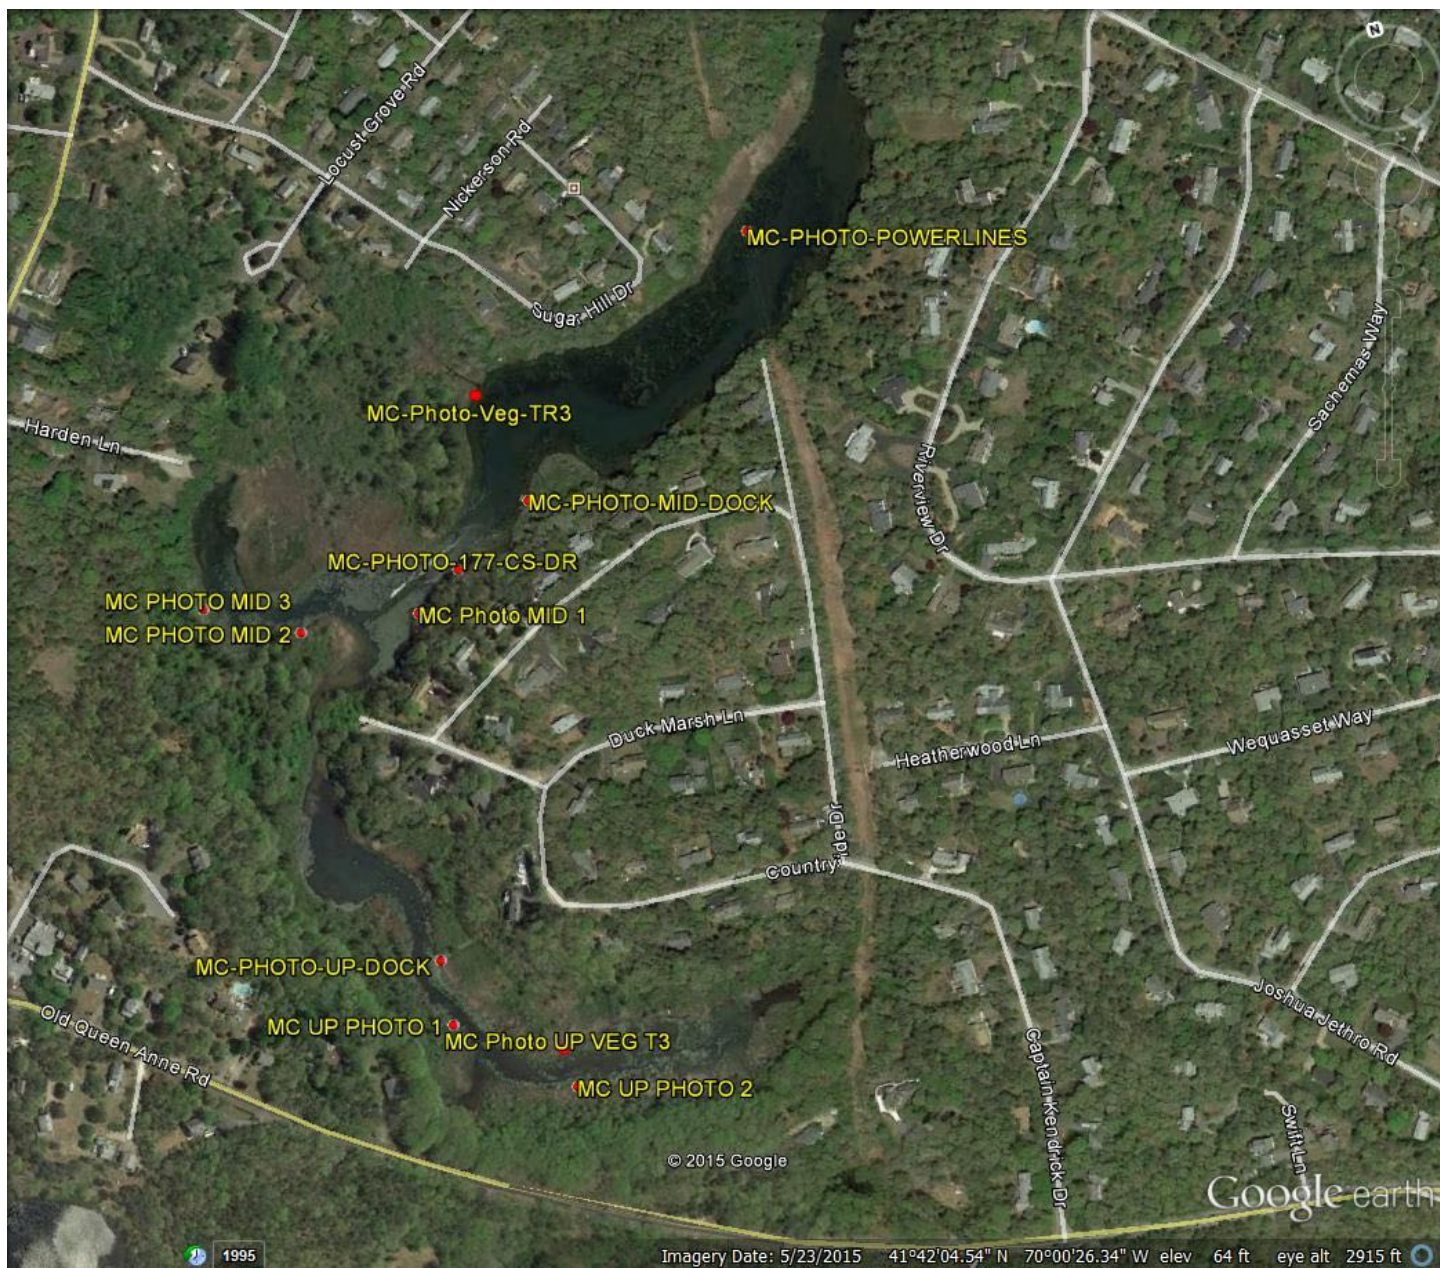
Pre-Project: Eighteen photo stations were established and monitored by MassDER and USFWS during fall 2015 as a means to qualitatively assess marsh vegetation change overtime (Figures 5 and 6). Photo stations were marked with PVC pipe or wooden stakes, the location recorded with RTK GPS, and attending photos labeled accordingly: Station ID-(Orientation)-Date. A Site Identification Card (8.5" x 11"), placed in the camera field of view was used to provide a permanent record within each image of the photo location, camera orientation, and date.

Figure 6: Photo monitoring stations within the upper reaches of Muddy Creek. Not illustrated is the point location on the relic cranberry berm located mid-basin.

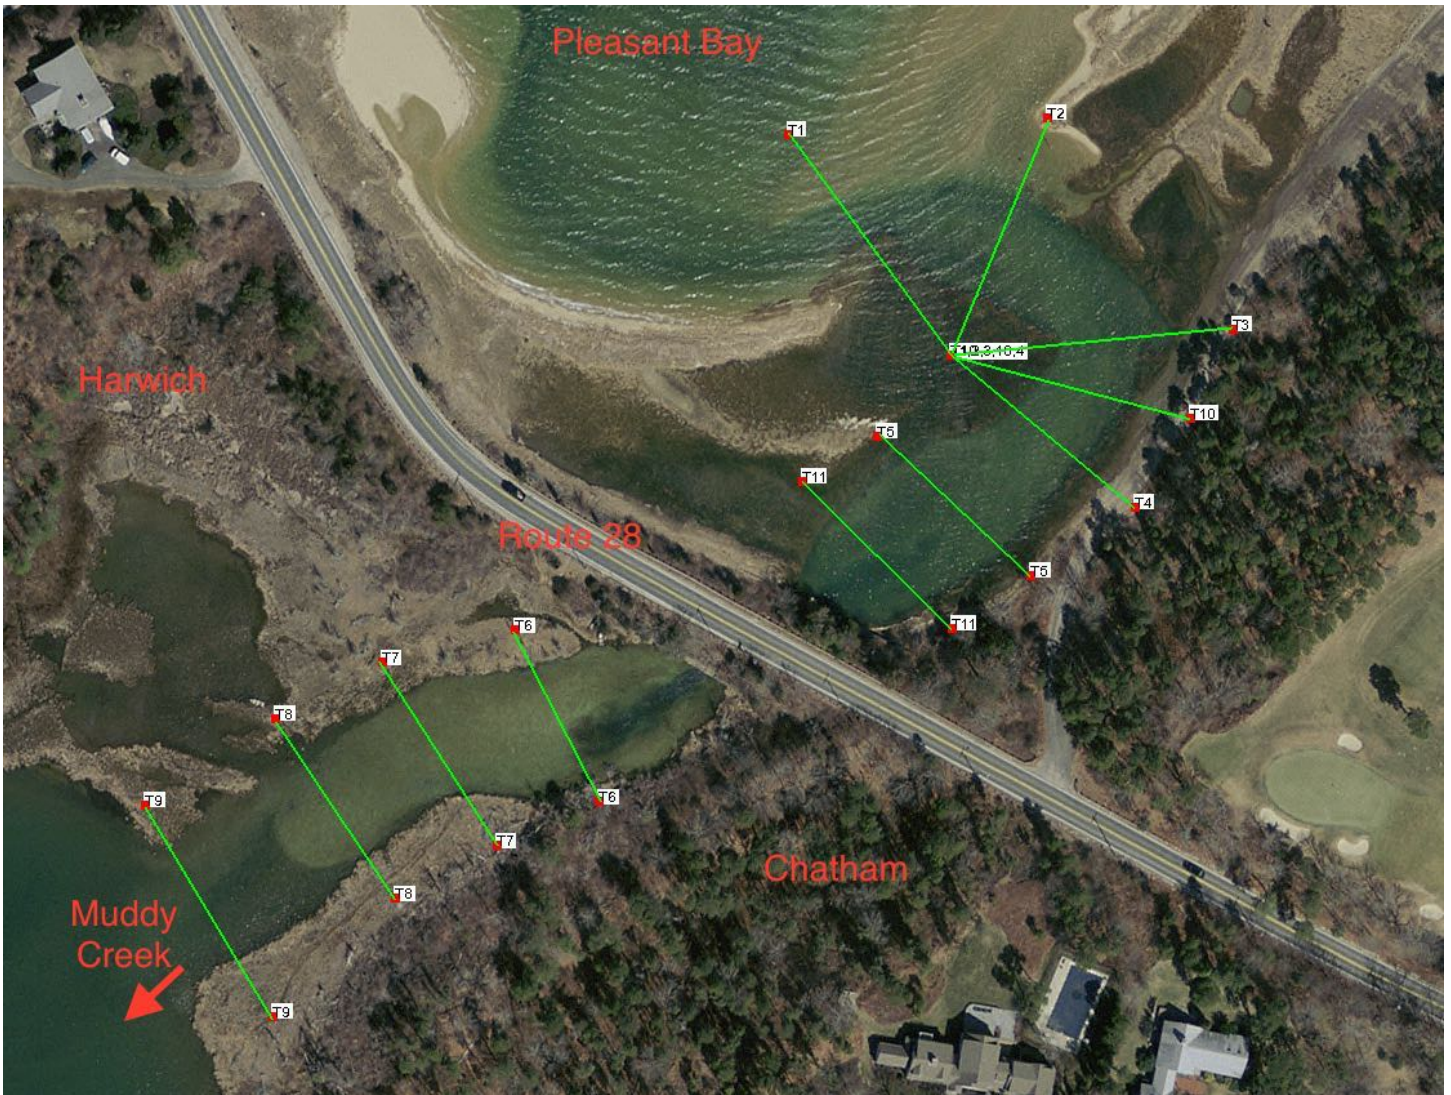
Figure 7: Chanel bathymetry monitoring – transects and planform survey conducted in 2016

Post-construction: Transect measurements along the pre-established eight transects, and two additional transects seaward of Route 28, were taken in June, July, September, and November 2016 by Applied Coastal Research and Engineering using an RTK-GPS unit (Figure 7). A minimum of ten points across the channel,

bank-to-bank, were recorded. The additional 2 transects in the vicinity of the Jackknife Beach access road were added, along with additional topographic data associated with the slope adjacent to the roadway. The locations of the additional transects were determined based on observations of bank slumping during the first survey. Measurements of channel bank location, at minimum 25-foot intervals, provided another means to monitor channel migration. A final report on the data collected, in comparison with pre-construction measurements, is found in Appendix A.

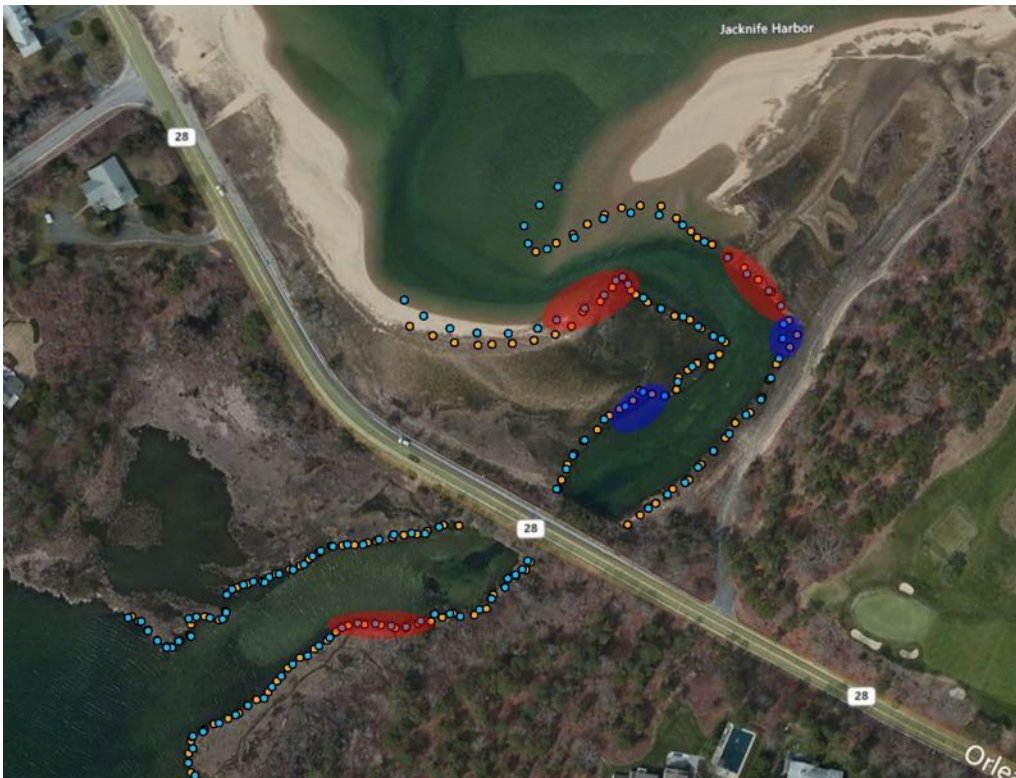
Figure 8. Minor bank slumping has been noted over the monitoring period. Areas of bank slumping are shown in red. Blue areas represent marsh plain that was lower than the adjacent marsh plain prior to construction but have not exhibited significant bank slumping (Applied Coastal Research and Engineering, 2016)

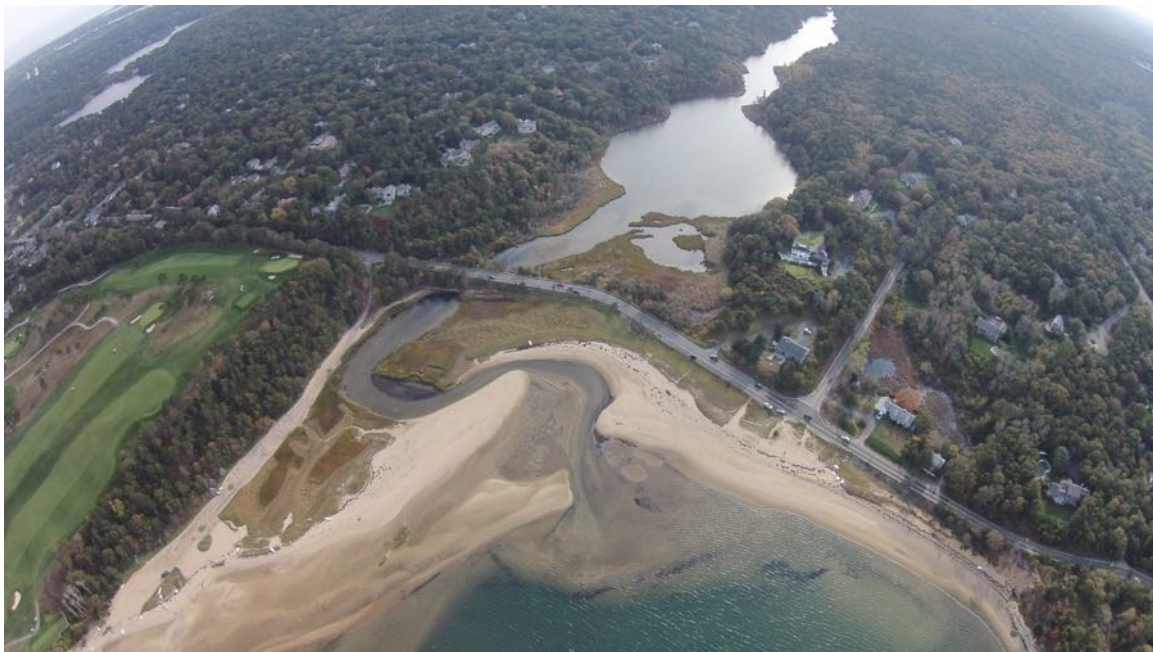
Figure 9: Aerial photo of Jackknife and Muddy Creek taken by Greg Berman (WHOI Sea Grant/Barnstable County Extension Service).

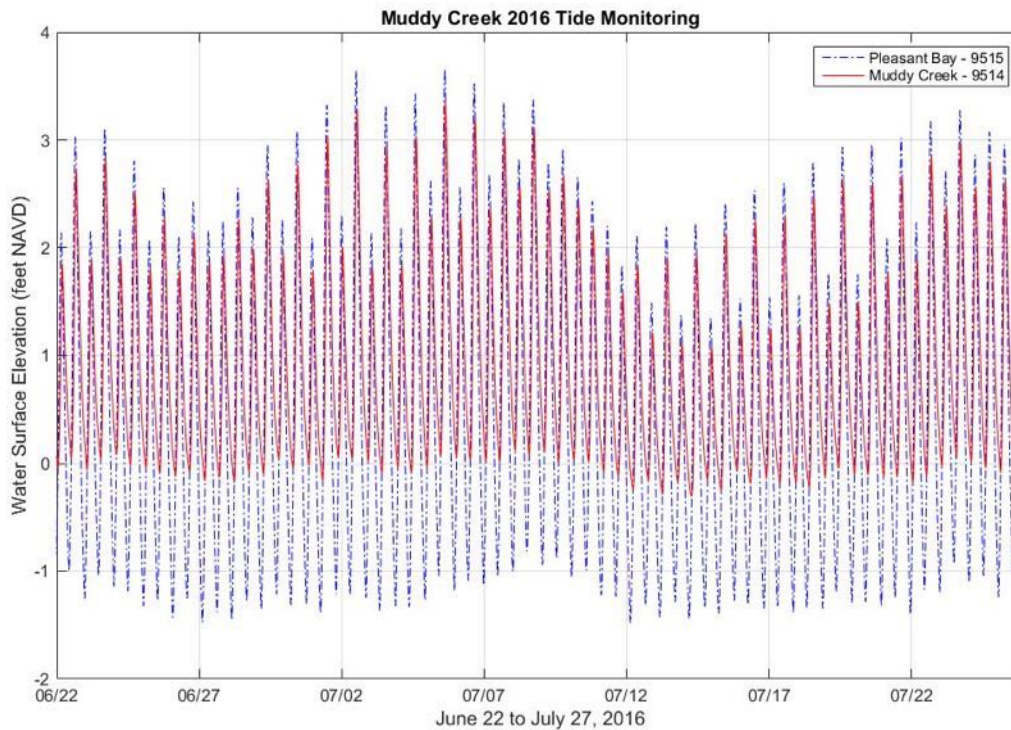
Plots of the tide data from are shown in Figure 2, for the 34-day deployment. The spring-to-neap variation in tide can be seen in this plot. Examining the plot shows that offshore the tide reaches its maximum spring tide range of approximately 4.8 feet on July 6th. Six days later the neap tide range is smaller, approximately 3.3 feet. A visual comparison of the two gage records in Figure 3, shows that there is a reduction in the tide range as the tide propagates from Pleasant Bay into Muddy Creek. The loss of amplitude with distance from the inlet channel through the bridge is described as tidal attenuation. Frictional mechanisms dissipate tidal flow energy, resulting in a reduction of the height of the tide. Tide attenuation is accompanied by a time delay (or phase lag) in the time of high and low tide (relative to the offshore tide). The lag can be visually observed on the flood and ebb tide between Pleasant Bay and Muddy Creek as shown in Figure 3.

Figure 2. Plots of observed tides for the Muddy Creek, Chatham and Harwich, MA, for the 34-day period between June 1, 2016 and July 16, 2016. The blue line shows tide offshore in Pleasant Bay. The red line shows the tide inside Muddy Creek upstream of the new Route 28 Bridge. All water levels are referenced to the NAVD 88.

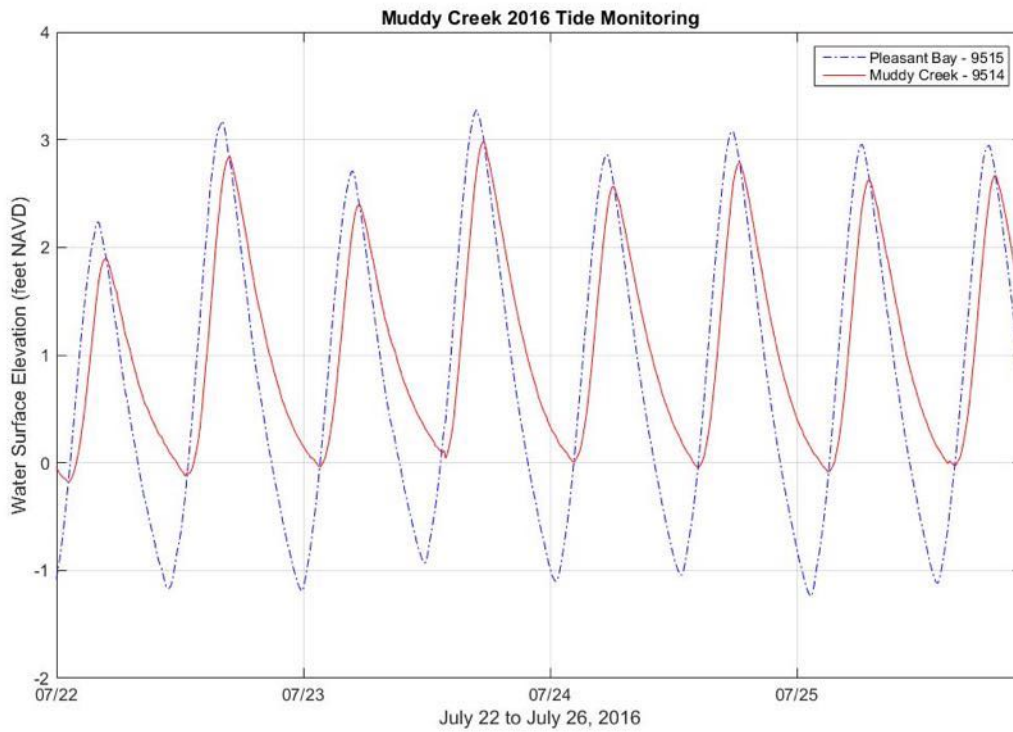
Figure 3. Plot showing three tide cycles offshore in Pleasant Bay and within Muddy Creek upstream of the new Route 28 Bridge.

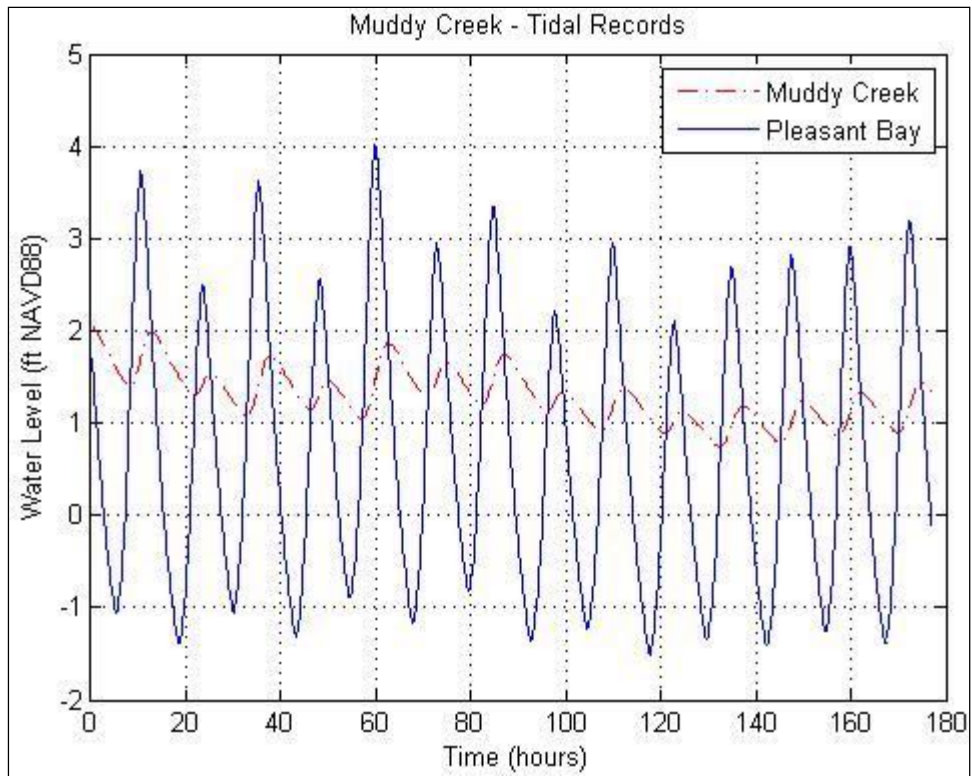
To examine the influence the recently constructed Route 28 Bridge has had upon the tides entering and exiting Muddy Creek, the tide datums from the 2009 study which examined various opening alternatives for Muddy Creek are presented in Table 3. The 2009 tidal signal within Pleasant Bay had a slightly larger amplitude range relative to the 2016 dataset. The changes in tidal amplitude are due to differences in tidal forcing over the short monitoring periods, transformation and evolution of the tidal inlets into Pleasant Bay from the Atlantic Ocean, and variability in metrological forcing over the monitoring periods. The key difference upstream of the Route 28 causeway is the significant increase in tidal amplitude from 2009 to 2016, there is approximately a 2.1 foot increase in tidal range within Muddy Creek due to the improved channel opening. A visual comparison also shows the significant increase in amplitude, Figure 3 shows the tidal variations with the new constructed bridge and Figure 4 shows the historic tidal variations with the stone box culverts.

Figure 4. Tide gage records from November 2009 for instruments deployed both upstream and downstream of the Route 28 culvert along Muddy Creek. In 2009, Pleasant Bay was connected to Muddy Creek through a pair of stone box culverts. The stone box culverts were approximately 2.5-feet wide, 3.75-feet in height, and 100-feet in length.

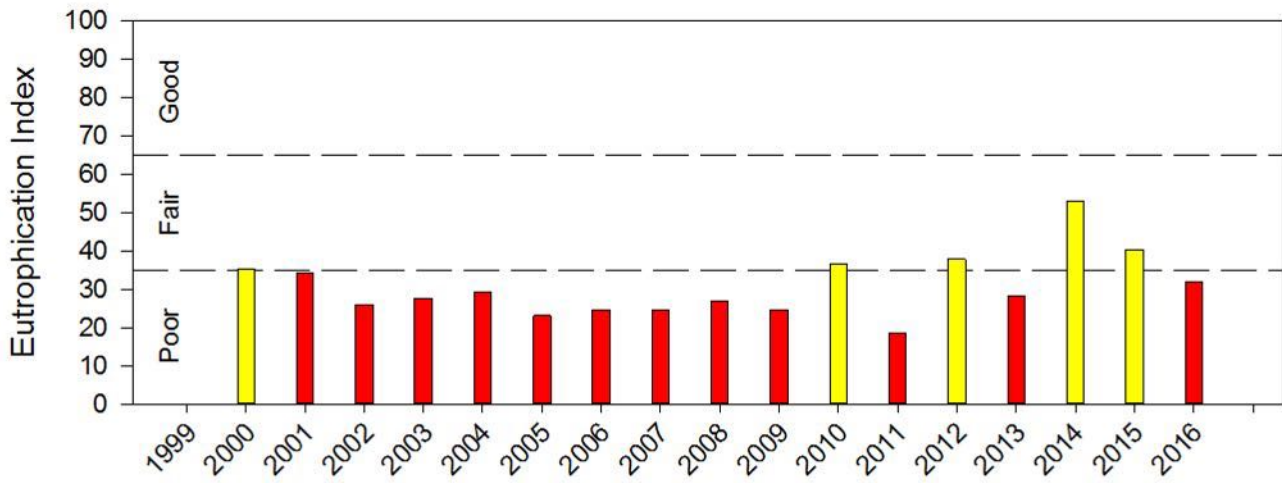
Muddy Creek (PBA-5)

Post-construction: Appendix C contains figures for dissolved oxygen, eutrophication index, total nitrogen, pigment concentrations and salinity for monitoring stations in upper (PBA 5A) and lower (PBA 5) Muddy Creek from 2000-2016. These data include only one post-construction monitoring season.

- TN decreased from the prior year at both 5 and 5A. The change in TN at station 5 doesn't appear significant. TN at station 5A is lowest level observed. There was no significant change in N species breakdown from prior years.
- Pigment concentrations went up at both stations. A similar trend was observed at other Pleasant Bay stations and so it is likely due to a factor such as weather and is unrelated to the bridge.
- While the range of DO values narrowed, levels were not inconsistent with prior years.
- Salinity was the area where the most significant changes were observed.
