Pleasant Bay Living Shorelines

**Nature-based
Approaches for
Shoreline and Salt Marsh
Restoration at Jack Knife
Beach, Chatham, MA**

Technical Report

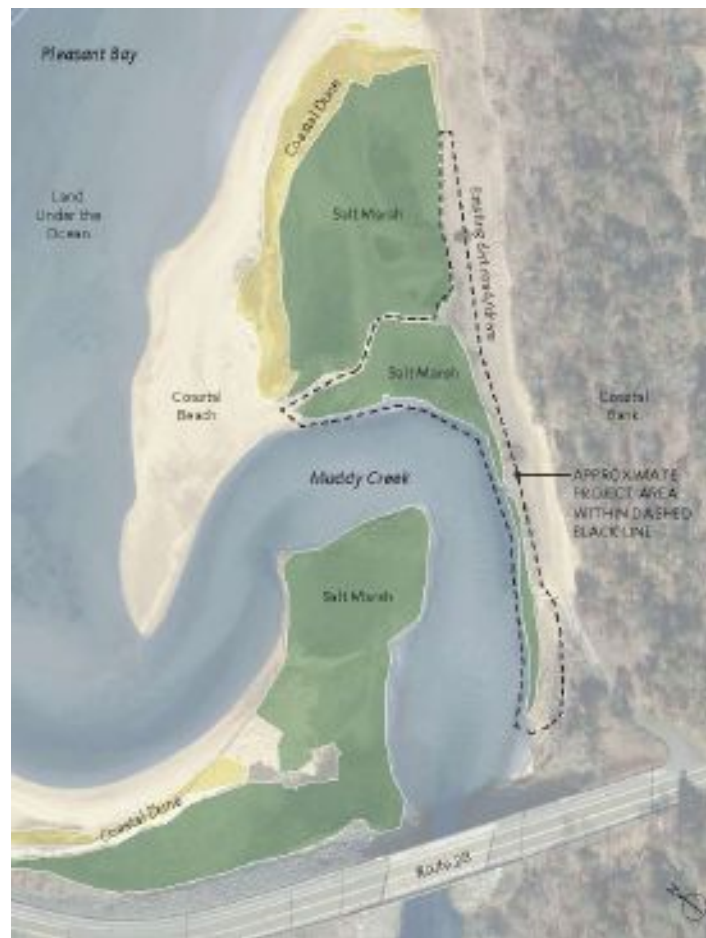
Figure 3.1 Salt Marsh and regulatory resource areas along Jack Knife Beach.

Edge of the salt marsh was delineated and flagged across the entire Jack Knife Beach complex east of Route 28 on November 7, 2020 by Wilkinson. The low coastal dunes adjacent to the salt marsh were located and flagged. Flagging was then surveyed by Applied Coastal using a Leica Viva GS08 GNSS receiver RTK network rover coupled with a Leica Viva CS15 3.5G Data Collector system. The survey data was collected in Massachusetts State Plane Coordinates Horizontal Datum and North American Vertical Datum of 1988 (NAVD88). The delineated salt marsh boundary is shown in Figure 3.1, along with the project area being considered for solutions to restore and minimize losses to the salt marsh.

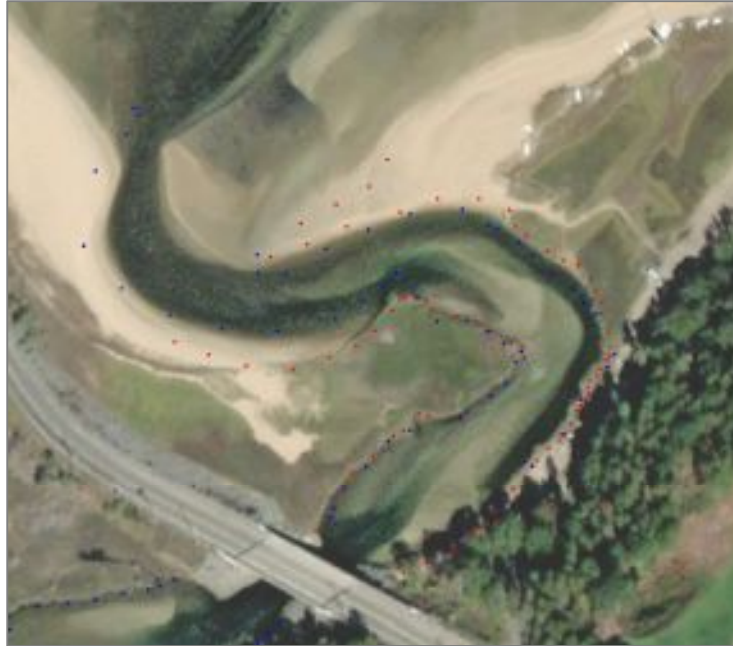
Figure 3.2 Measured bank position in 2015 (blue markers) and 2021 (red markers).

The seaward crest of the salt marsh was surveyed along the tidal channel during the November 2020 field evaluation. A series of four bank surveys were conducted in 2016 (Applied Coastal 2017) as part of the Route 28 bridge construction monitoring program conducted by the Pleasant Bay Alliance and once in 2015 prior to construction by Massachusetts Division of Ecological Restoration. The addition of updated bank survey, provides the ability to identify areas of movement in the channel and examine if there has been sustained migration or movement in the channel over the past 4 years. The results from the comparison of bank surveys are shown in Figure 3.2 which shows the bank crest positions between 2015 and 2021. Changes in shoreline position have been presented in Figure 3.3 through graphical representation of calculated annual erosion/accretion rates between the 2016 and 2020 surveys. The rates of change are calculated along shore perpendicular transects illustrated in the figure. The northern shoreline of the channel has experienced erosion range from 0.5 to 1.5 feet per year, the erosion of the

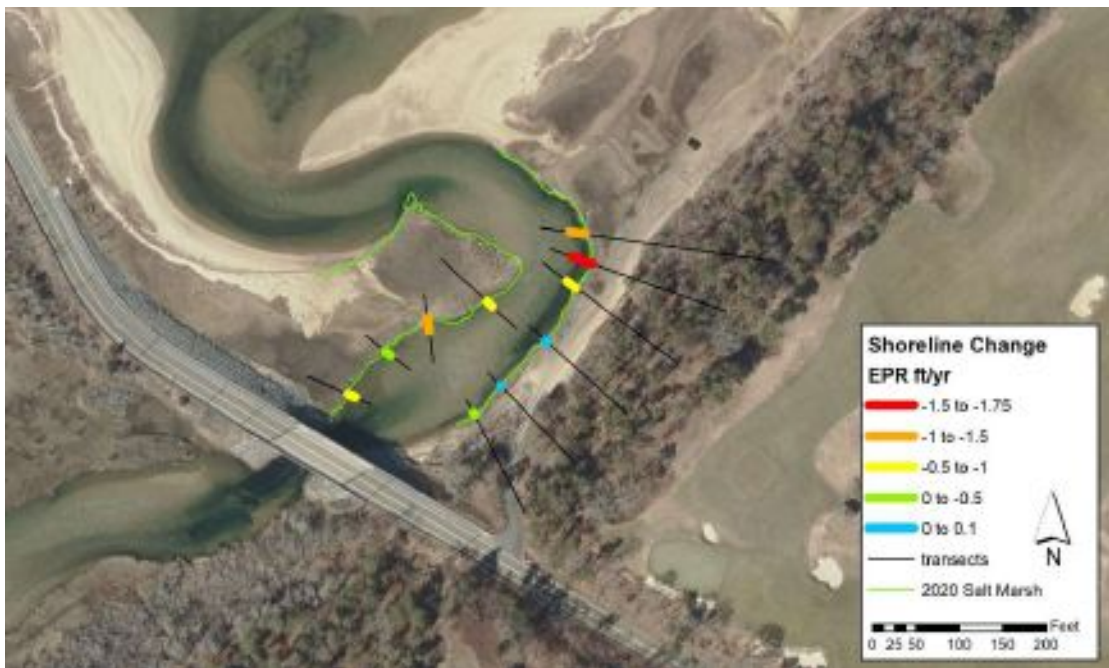
Figure 3.3 Shoreline erosion rates along the inlet channel to Muddy Creek between 2016 and 2020.

salt marsh along the shoreline is attributable to intensification in ebb tide currents associated with increases in tidal prism upstream of Route 28. Additionally, the marsh surface was also noted in 2016 as being lower in elevation than the adjoining marsh. The low elevation relative to the surrounding marsh increases the likelihood of prolonged inundation and drowning of the vegetation and loss of root systems to help stabilize the peat soils. The southern side of the tidal channel shows that the channel immediately after the bridge has remained stable with minimal change in shoreline position. The survey data does not illustrate the undercutting of the bank that is occurring along this stretch of salt marsh. Undercutting was measured from the bank face and ranged from 0.5 - 1.6 feet, as shown in Figures 3.4 and 3.5. At the time of the November 2020 survey, a fissure in marsh peat surface was observed running parallel to the tidal channel. Over the next two-months the undercutting continued and gravity caused the peat surface to collapse into the tidal channel as shown in Figures 3.6 and 3.7. The calculated erosion rates in Figure 3.3, do not illustrate or predict the episodic erosion resulting from the undercutting due to the relative short time interval between surveys relative to the episodic erosion occurrences. Shoreline change data shows a significant amount of erosion occurring around the first 90-degree bend downstream from the Route 28 bridge. Analysis of erosion rates range from 0.5 to 1.75 feet/year. Erosion was observed in this area during the 2016 monitoring program. The marsh plain in the bend was noted to be lower in elevation than the surrounding marsh, making the salt marsh vegetation more susceptible to prolonged inundation and erosion. The edge of the marsh activity retreated during the 2016 6-month monitoring period, so it is foreseeable that erosion has continued resulting in the loss of salt marsh on the outside bend of the tidal channel.

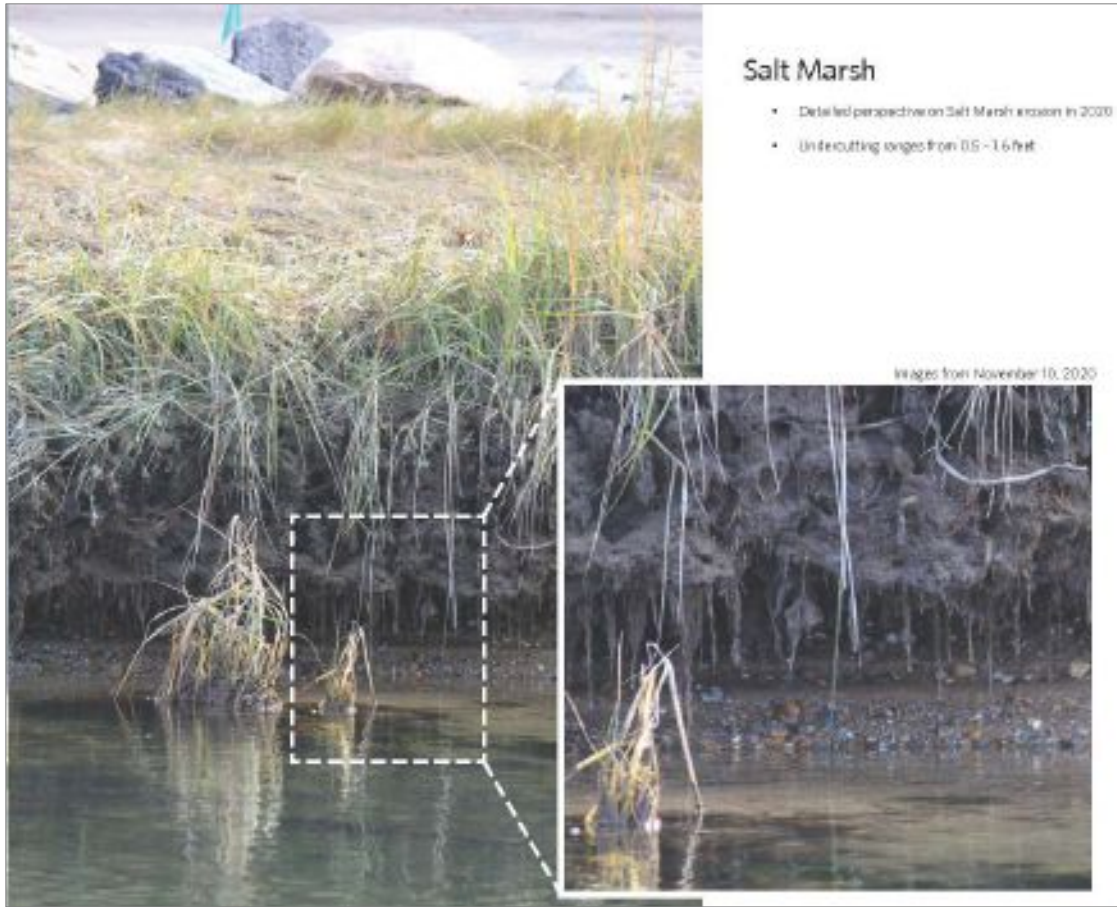
Figure 3.4 Detailed perspective of the peat bank undercutting along the tidal channel on November 10, 2020.

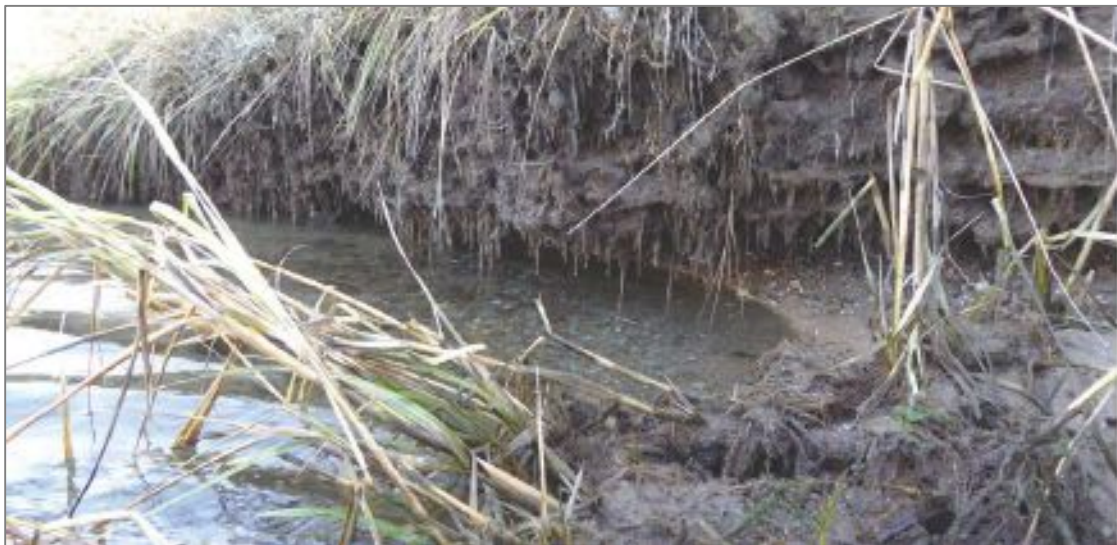
Figure 3.5 Detailed perspective of the peat bank undercutting along the tidal channel on November 10, 2020.

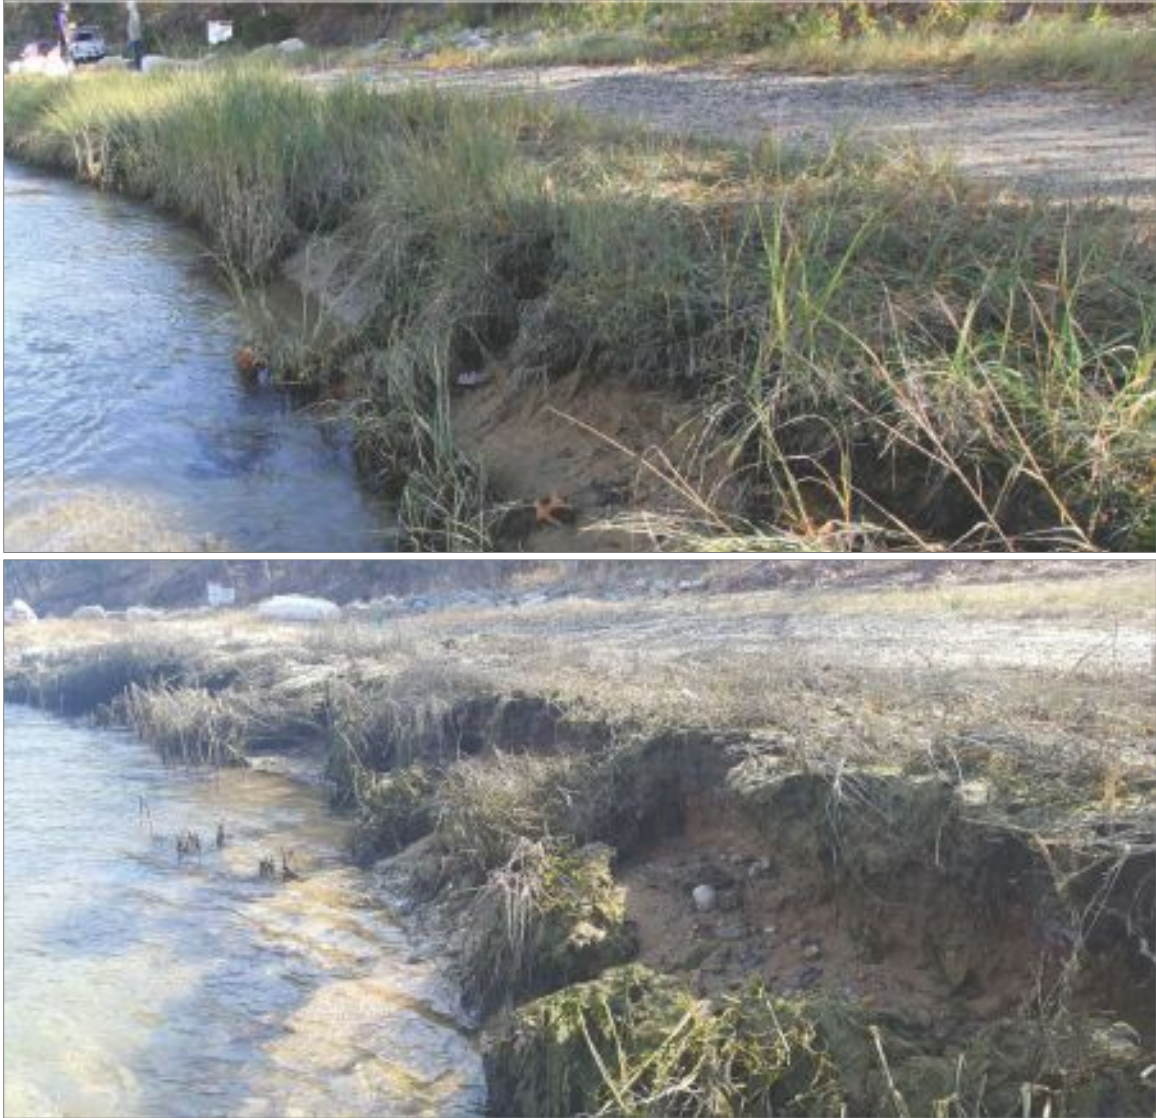
Figure 3.7 Photographs of the collapse of salt marsh bank between November 10, 2020 to March 31, 2021

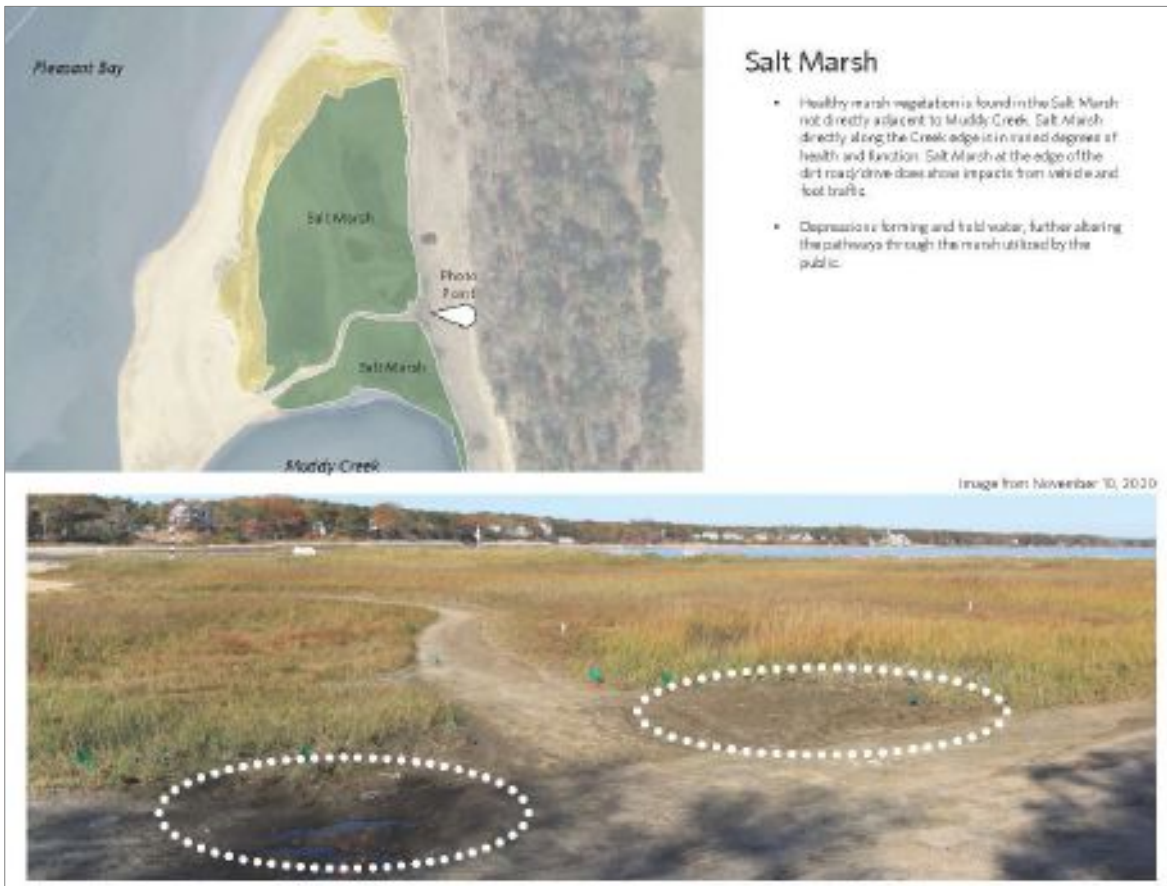
Figure 3.8 A unvegetated areas of highly impacted salt marsh adjacent to the parking area. The areas have been depressed by tires and collect water during high tides and rainfall events resulting in the loss of salt marsh vegetation.

During two site visits to Jack Knife Beach in November 2020 and March 2021 a number of different areas of concern were noted which need to be addressed as part of the restoration process to prevent continued degradation and loss of salt marsh. These factors are related to the usage of Jack Knife beach and are related to vehicle passage and parking, foot traffic and trampling of marsh vegetation, and launching of paddle craft over the salt marsh. Vehicle passage and parking along the backside of Jack Knife Beach has resulted in damage to the landward salt marsh edge and will be important to address during the development of alternatives. The Town of Chatham has taken steps to minimize the damage by setting large stones to prevent vehicles from crossing into the salt marsh, however additional measures need to be considered to provide more prominent visual barriers to protect the marsh edge. Visual barriers could also be effective in minimizing the public from straying from access pathways onto the vegetated marsh. Signage could also provide educational information and directions on ways to minimize damage, for example a signed and marked area for the launching and recovery of paddle craft could minimize the

usage of marsh surface by recreational users looking to minimize the distance from their vehicles and the water. These concerns are further illustrated in the following series of photographs of unintended recreational impacts to the salt marsh.

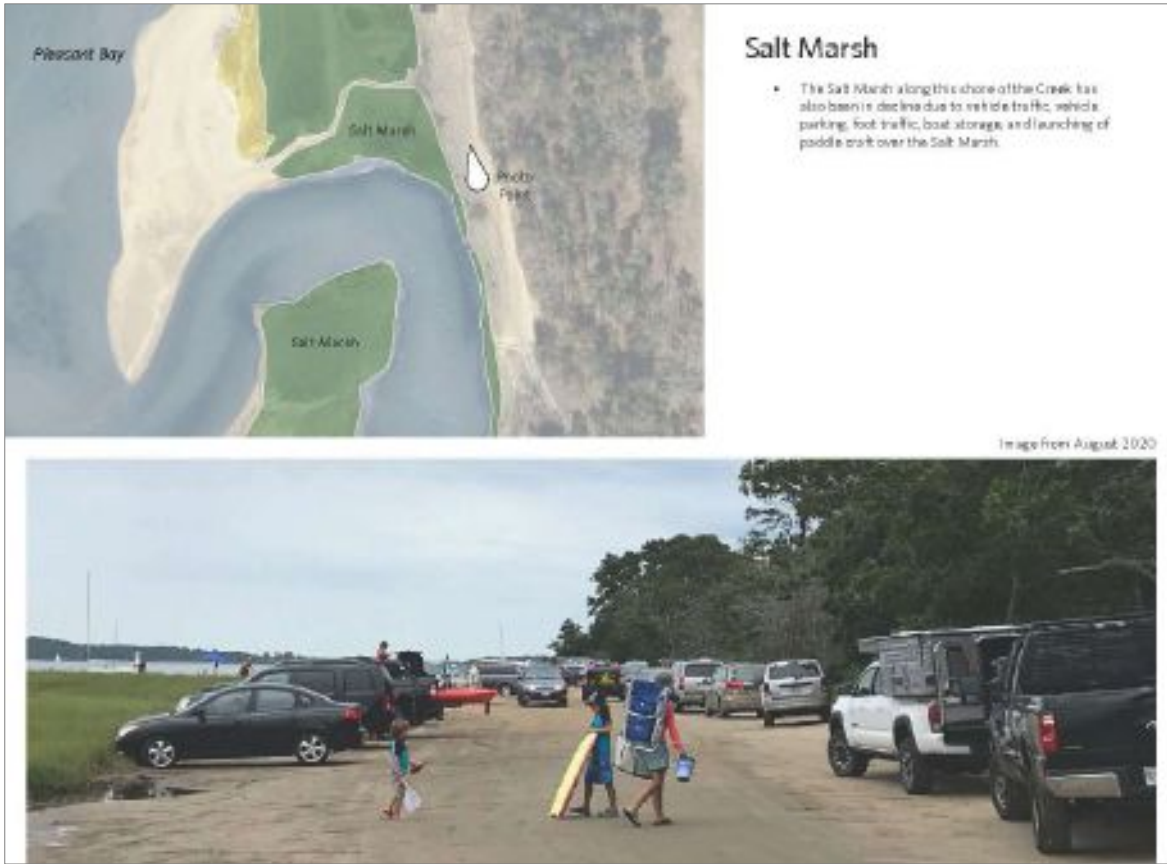
Figure 3.9 Photograph representing the heavy public usage of the Jack Knife recreational area during the summer. The lack of boundaries between the salt marsh and parking areas has resulted in unintended parking and passage on vegetated salt marsh surface. A unvegetated area of highly impacted salt marsh adjacent to the parking area has been depressed by tires holding standing water on the left side of the photograph.

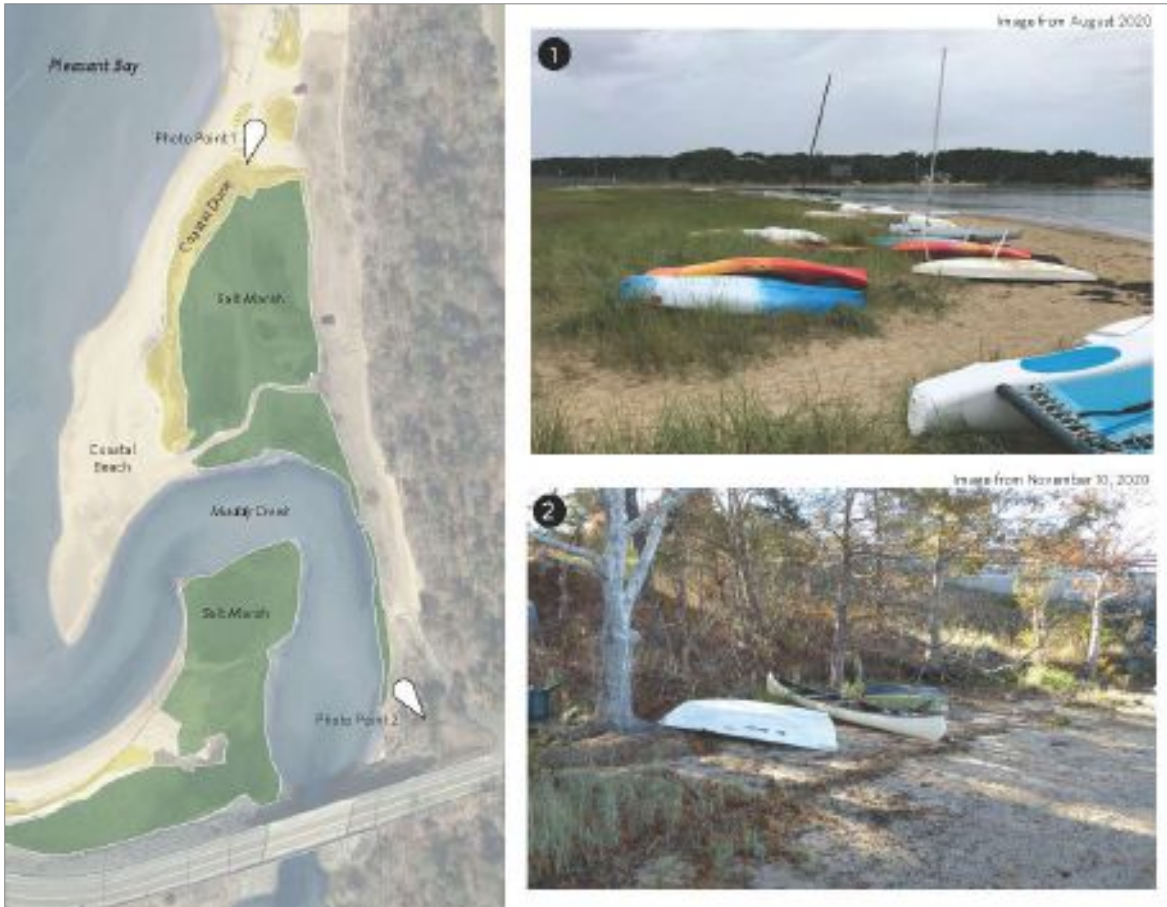
Figure 3.10 Illustration of the heavy public usage of the Jack Knife recreational area during the summer. Boats have been left on fringing areas of salt marsh vegetation. The lack of designated boat racks and boundaries between the salt marsh and the public recreational spaces has resulted in unintended damage to the salt marsh surface.

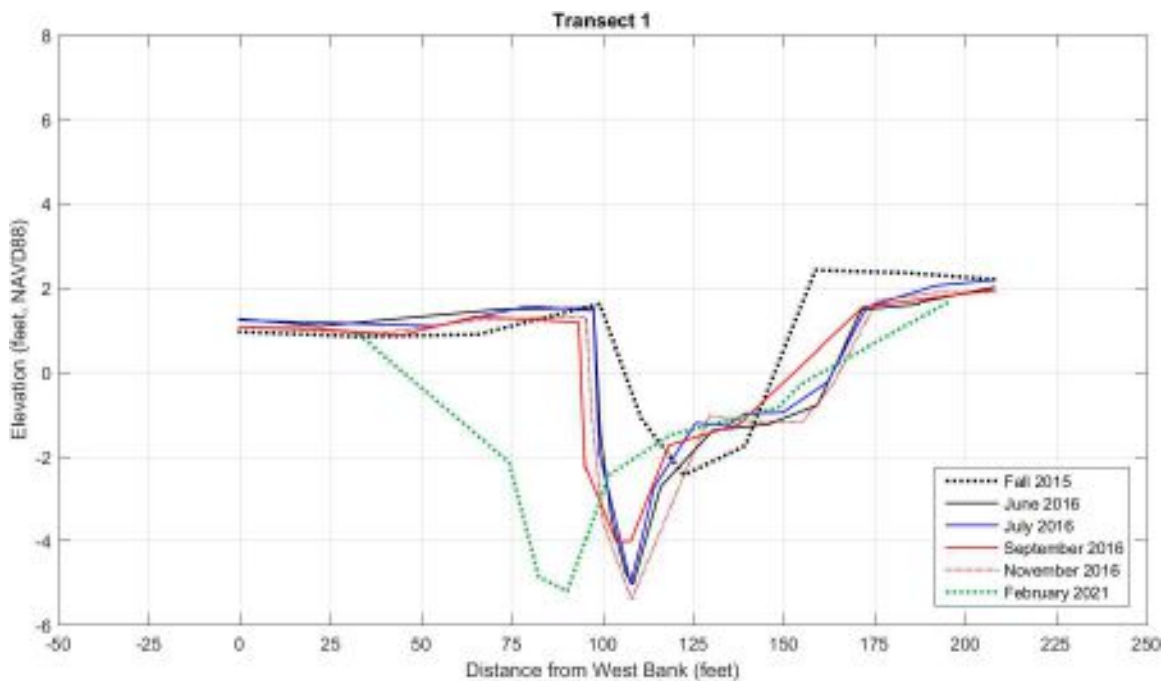
Figure 3.12 Cross-channel monitoring Transect 1. Distance are relative to the West Channel Bank and datum elevations are given relative to NAVD88.

Plots of the cross-channel profile data are presented in Figures 3.12 through 3.18. The transect plots are presented from Pleasant Bay progressing upstream toward the Route 28 bridge. The numerical sequence of the transect order is presented in Figure 3.11. Each cross-section figure shows the data from the Fall of 2015 pre-construction survey and the June, July, September, and November 2016 post-construction surveys (There is no pre-construction survey data for Transects 10 and 11) and the February 2021 updated conditions survey.

The focus of examining the transect data is to look for sustained changes in channel geometry which could be attributed to degradation or losses in the marsh. Transect 1 is closest to Pleasant Bay and depending on the stage of the tide and storm surge levels is open to wave energy from a Nor'easter type storm event. The cross-sectional profiles for Transect 1 are shown in Figure 3.12, the data from 2021 shows a significant shift in the channel to the south. This can also be seen in the plan view of the bank data shown in Figure 3.2. A review of historic aerial photographs shows that the inlet to Muddy Creek has historically oscillated in position as the ebb shoal and shoreline shifted, likely driven by Nor'easter storm events. Similar shifts in inlet position should be expected to continue into the future. Review of Transect 2 (Figure 3.13) shows that the cross-section has not experienced any significant shifts similar to Transect 1, but it does show a significant retreat of the eastern marsh bank. The eastern edge of the channel has contained the main flow conveyance channel since 2016, the higher magnitude flows in this section of

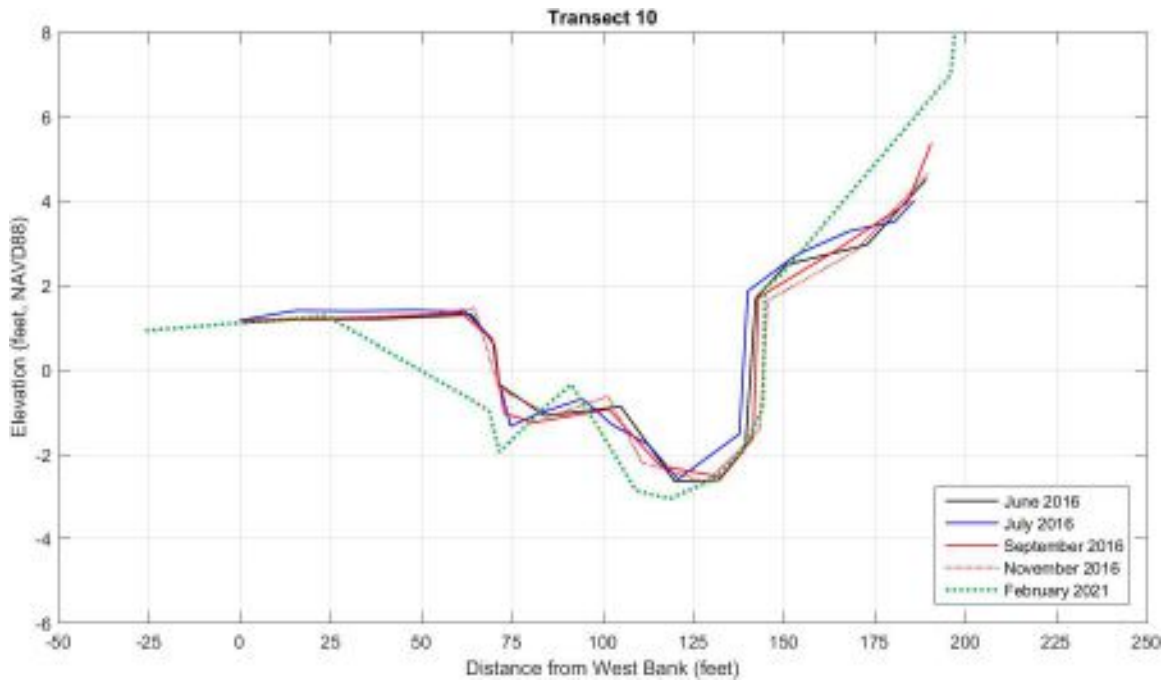
Figure 3.15 Cross-channel monitoring Transect 10. Distance are relative to the West Channel Bank and datum elevations are given relative to NAVD88.

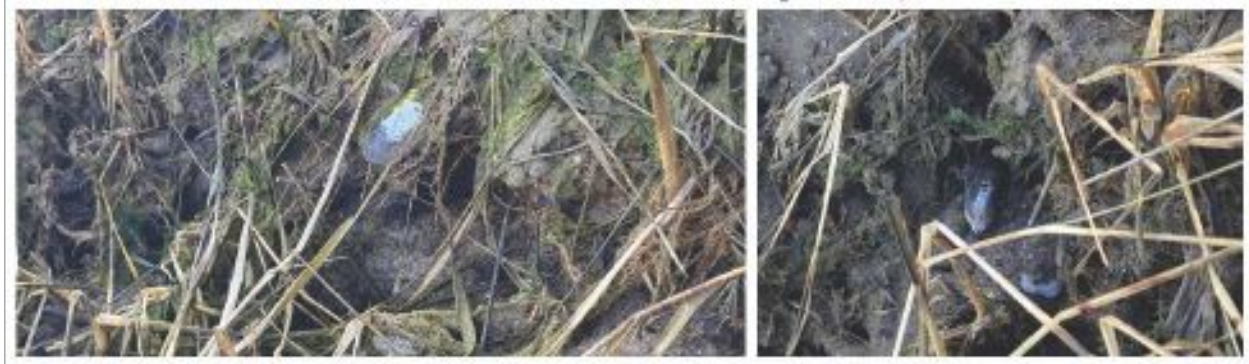
Figure 3.19 Ribbed mussels were also observed within the Salt Marsh. Images below were taken within the project area March 11, 2021.

Town of Chatham DNR Shellfish Division conducted a shellfish survey of Muddy Creek on April 14, 2021. The survey area was limited to Chatham waters within Muddy Creek. The survey did not locate significant abundance of shellfish in the project area. The survey report noted there were no indications of siphon holes which would indicate live soft-shell clams, quahogs (*Mercenaria mercenaria*) and/or razor clams (*Ensis directus*) within the project area. The most abundant shellfish resource in Muddy Creek were sub-legal quahogs, in addition to ribbed mussels attached to peat, blue mussels, single sea clam, legal quahog, and oyster (Chatham DNR, 2021). Figure 3.19 shows ribbed mussels attached to the peat bed along Muddy Creek.

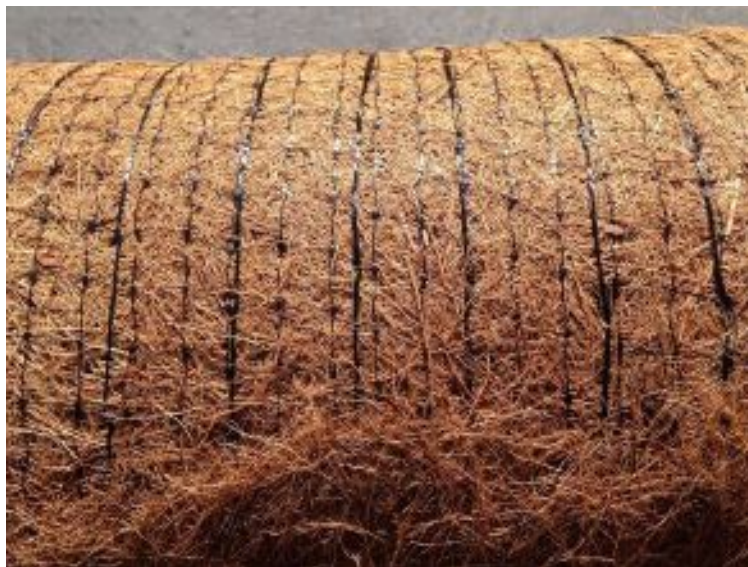
Figure 4.1. Coconut fiber log with synthetic reinforcement (Photo Credit: An-Wil Inc.)

- Erosion protection – Good - synthetic fiber rolls and envelopes are similar to natural fiber alternatives above in function and use. However, various forms of synthetic material are utilized to increase the design life of the material. This is advantageous when utilized in higher current or wave environments where the natural fibers break down before the vegetation can fully mature and establish root systems. In some applications the synthetic fiber is blended with natural fabrics to enhance longevity, and example is shown in Figure 4.1.

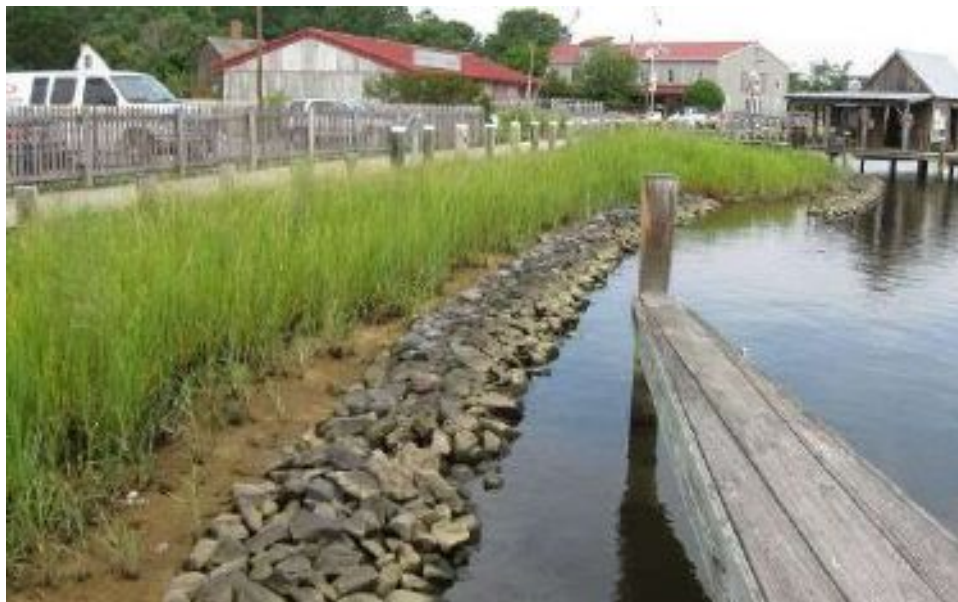
Figure 4.2 A low rock sill fronting a salt marsh restoration constructed along the eastern shore of Maryland using NOAA grant funding (Photo Credit: Chesapeake Bay Trust and NOAA).

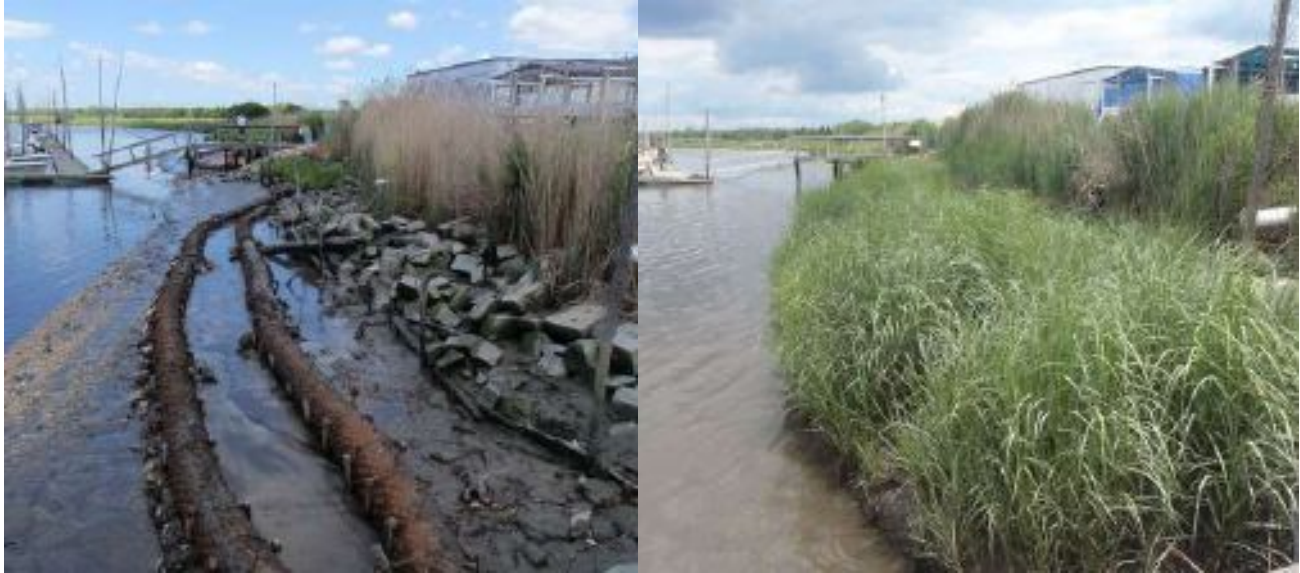
Figure 4.3 Installation of living shoreline in Delaware Bay with rock sill and core logs with the addition of oyster shells along seaward edge. Restoration site 1-Year after installation. (Photo Credit: Delaware Department of Natural Resources)

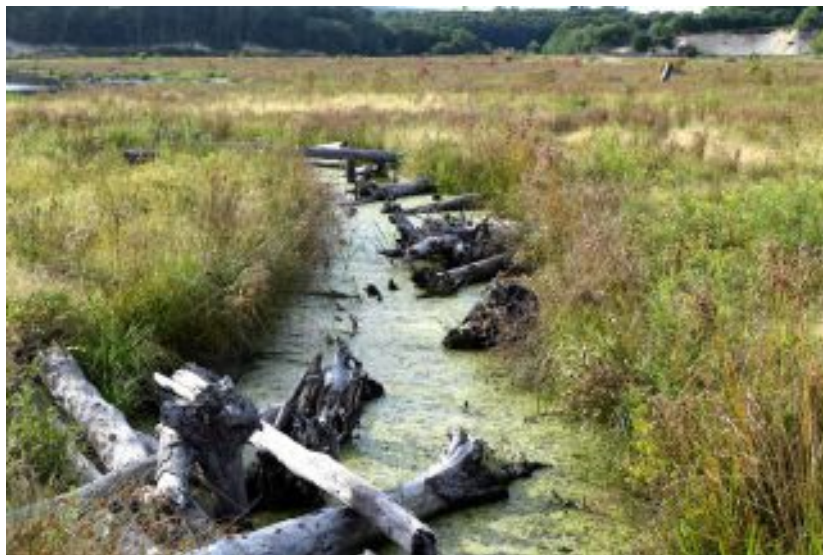
Figure 4.5 Tidmarsh Farms River & Wetland Restoration. The restoration utilized approximately 3,000 pieces of large woody debris into the stream restoration (Photo Credit: Mass Audubon).

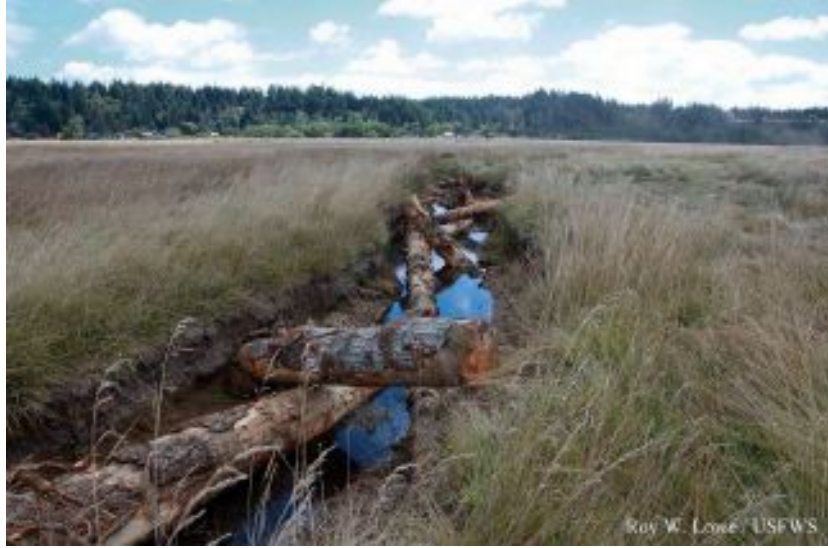
Figure 4.6 Bandon's Ni-les'tun Marsh restored 400 acres of diked and drained pasture into a vibrant tidal marsh. The project created over 5 miles of new tidal channels and doubled the acreage of tidal marsh habitat in the estuary (*Photo Credit: Roy Lowe, USFWS*).

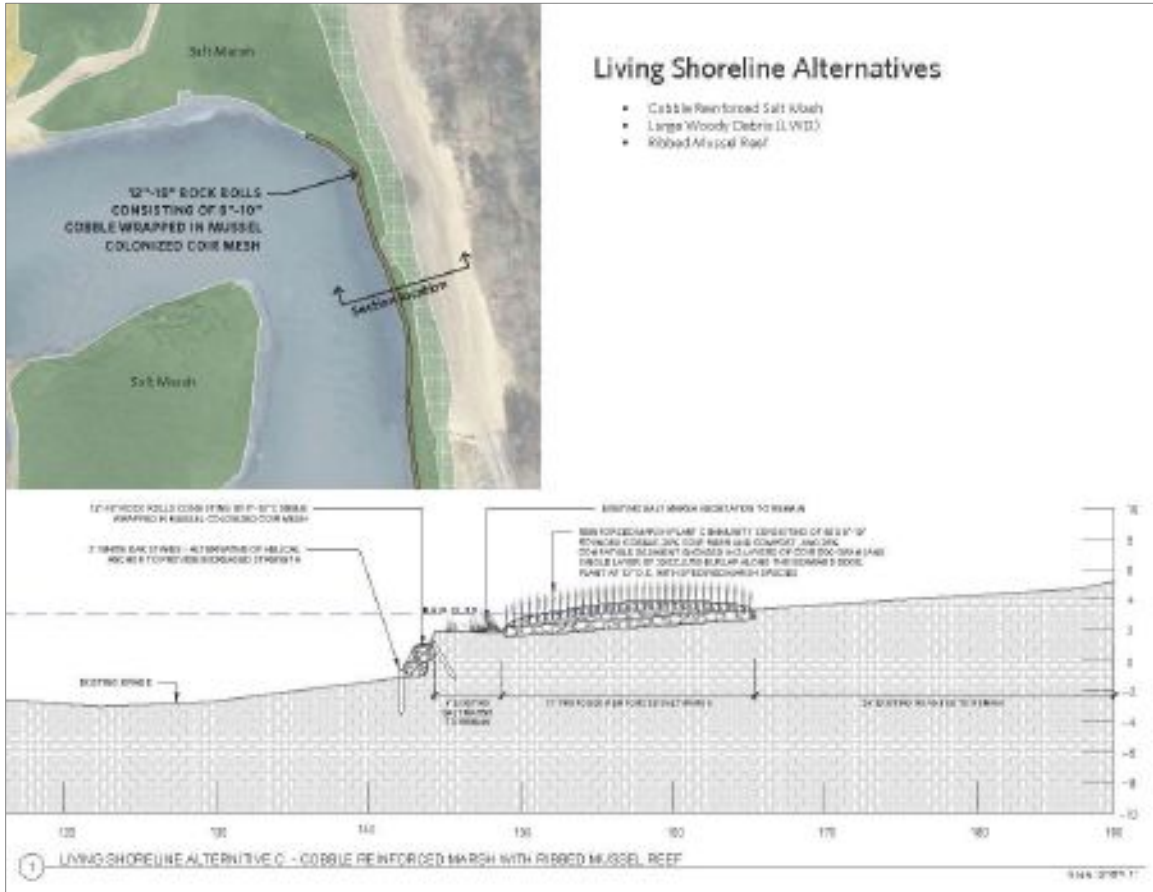
Figure 4.8 Typical cross-section of a Cobble Reinforced Marsh with ribbed mussel reef.

The use of ribbed mussels is similar to the use of oysters to improve habitat and overall water quality. Paired with the cobble reinforced marsh, the restoration components will help to ensure sustainability and longevity of the eroding marsh bank. The use of ribbed mussels needs to consider the influence of the tides and effects of prolonged exposure to air and freezing temperatures so the use of mussels would occur between the mean low water (MLW) or the bottom of the channel and mean high water (MHW). Muddy Creek has adequate salinity and dissolved oxygen for growing conditions, and ribbed mussels are found within the system upstream of Route 28. The concept of anchoring of the ribbed mussels to coir fabric has already been proven in preliminary tests. In informal test that Wilkinson conducted with the Massachusetts Maritime Academy aquaculture laboratory, mussels were found to readily and effectively colonize natural coir fabric within an aquaculture tank environment. The byssal threads of the ribbed mussel was found to readily colonize coir fabric. 8-10" cobble stones could be used to form an 12-18" rock roll where the mussel colonized coir fabric could be wrapped around the cobble stones, which would serve as both ballast and a long-term anchor medium for the mussels after the coir fabric naturally biodegrades.
