**Pleasant Bay Climate Action Adaptation Plan**

## **Selection of Case Study Sites and Establishment of Threshold Elevations**

June 2023

**Wright-Pierce**

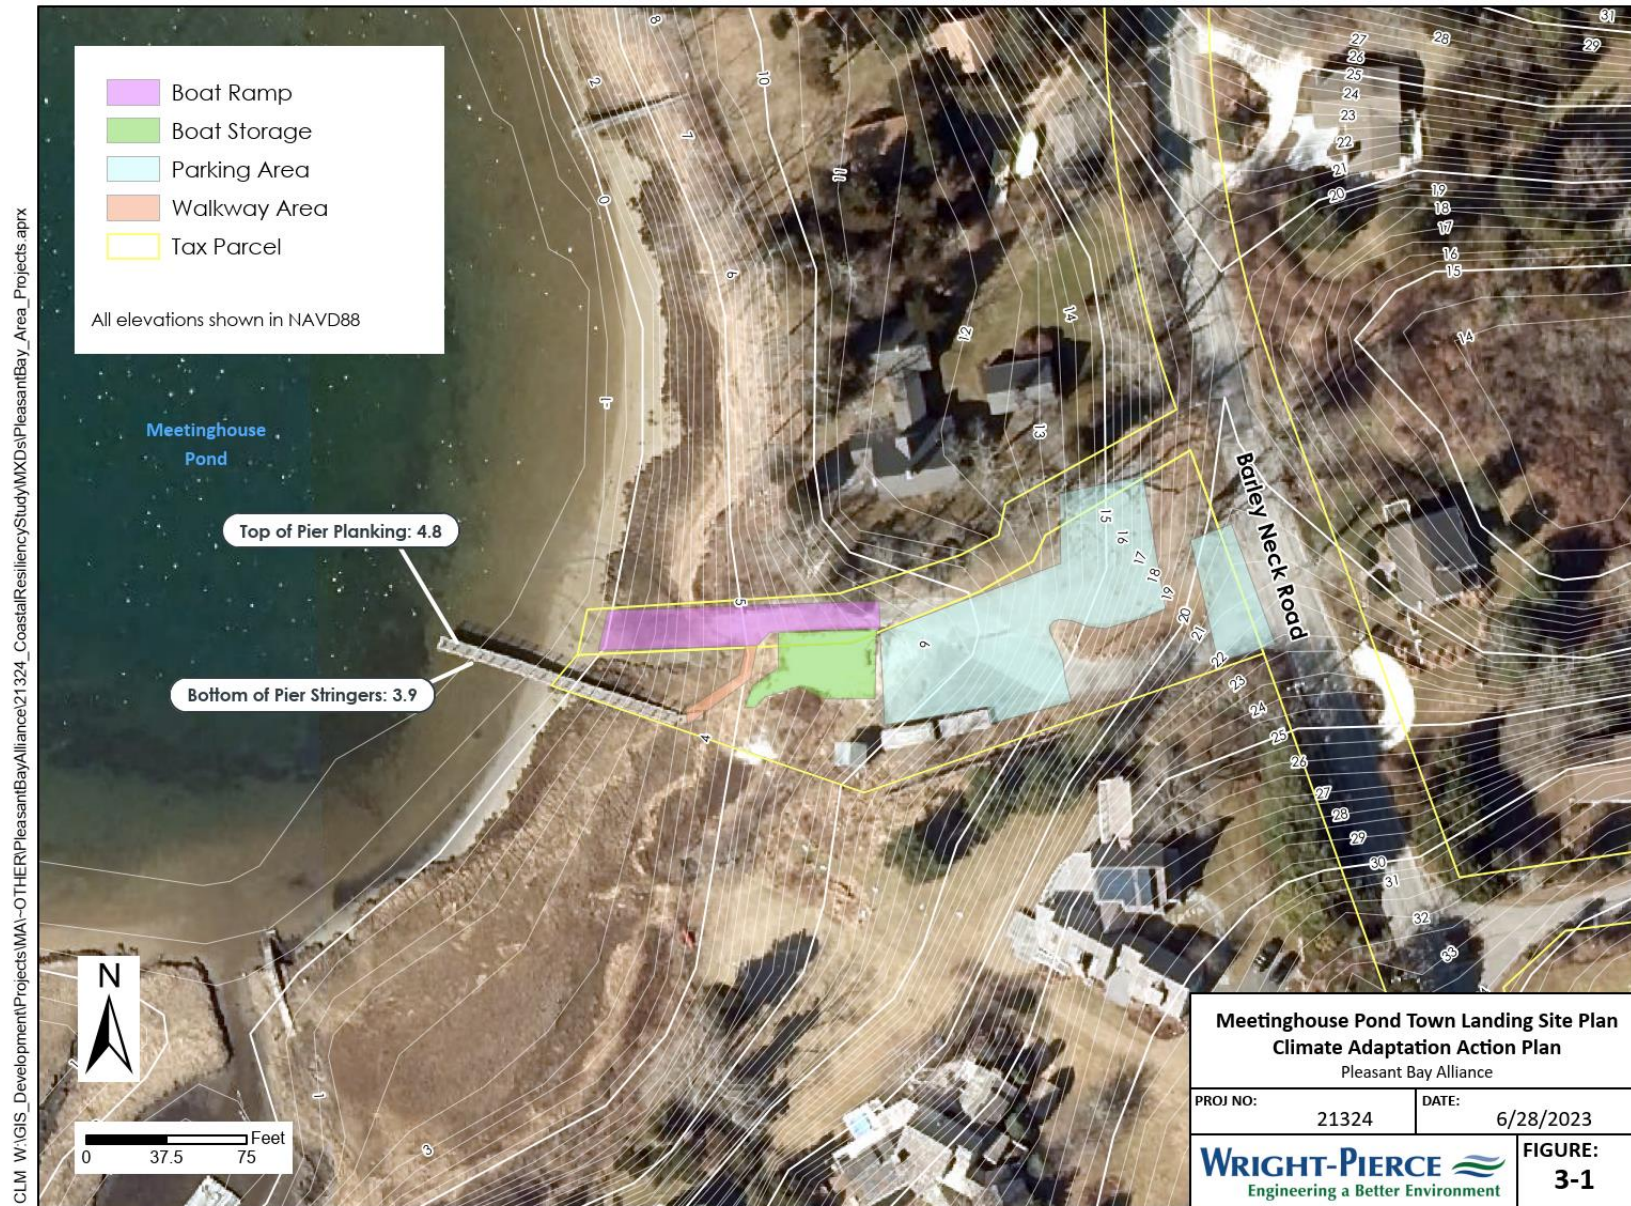
The most vulnerable aspects of this site are the pier and the boat storage area. The pier is inaccessible when water rises more than 4 to 5 feet above mean sea level, an event that may occur now under very extreme conditions but will happen with increasing frequency as sea level rises. The pier is only slightly higher than its access walkway and could be damaged by wave action with even smaller increases in average water level. Wave impacts will become more frequent as sea level rises and storms increase in intensity. The boat ramp can accommodate significant increases in water level and should still be functional even with water levels 5 feet higher than current conditions. The boat storage area will gradually shrink in usable area. The boat storage area’s unvegetated and sandy surface is particularly susceptible to erosion. Both the lower and upper parking areas are not likely to be inundated with sea level rise expected in the foreseeable future.

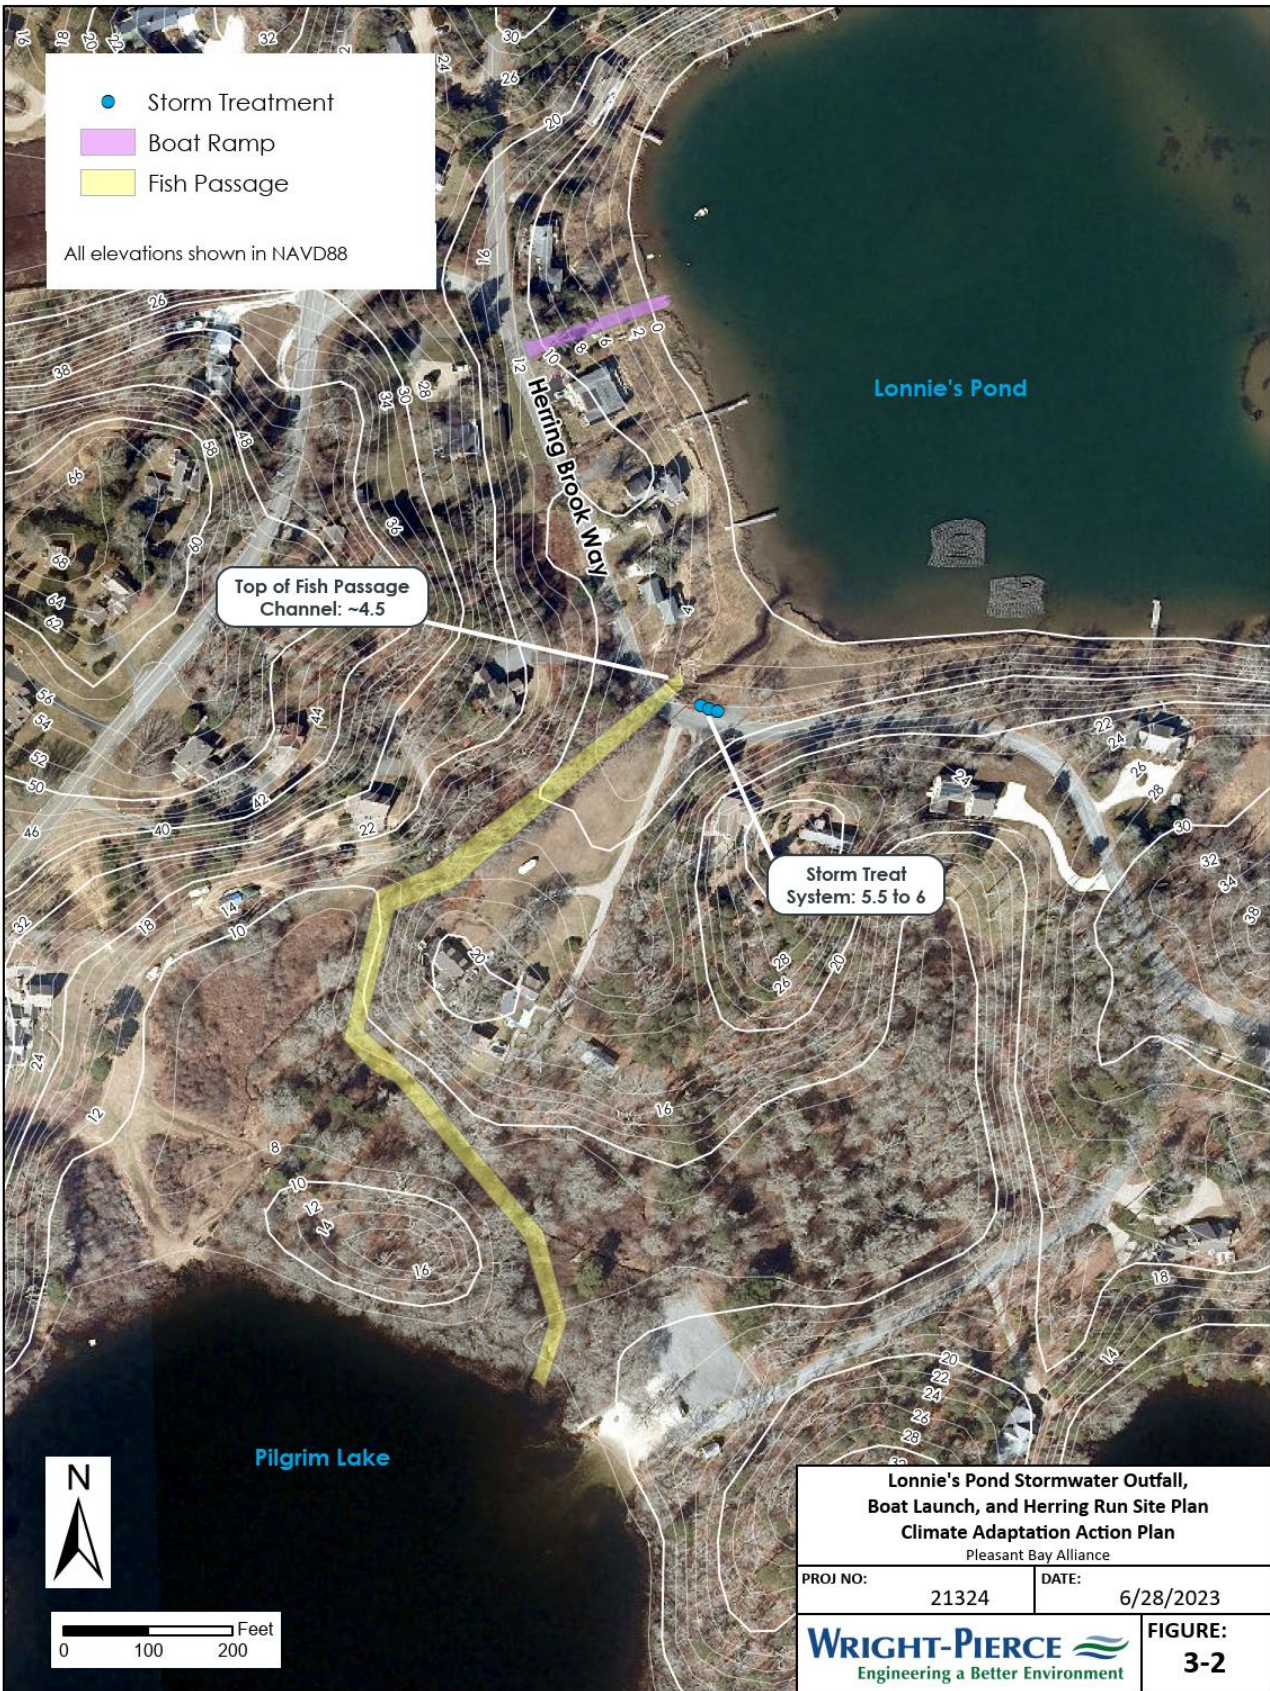
The beginning of the herring run is a concrete channel located below Herring Brook Way. This portion of the run already experiences high water impacts, where the water spills over the concrete channel walls, depositing fish on the exterior of the fishway. With future increases in sea level and more intense storms, it is likely that these problems will worsen. The herring run is also aging and is planned to be rehabilitated or upgraded in the coming year.

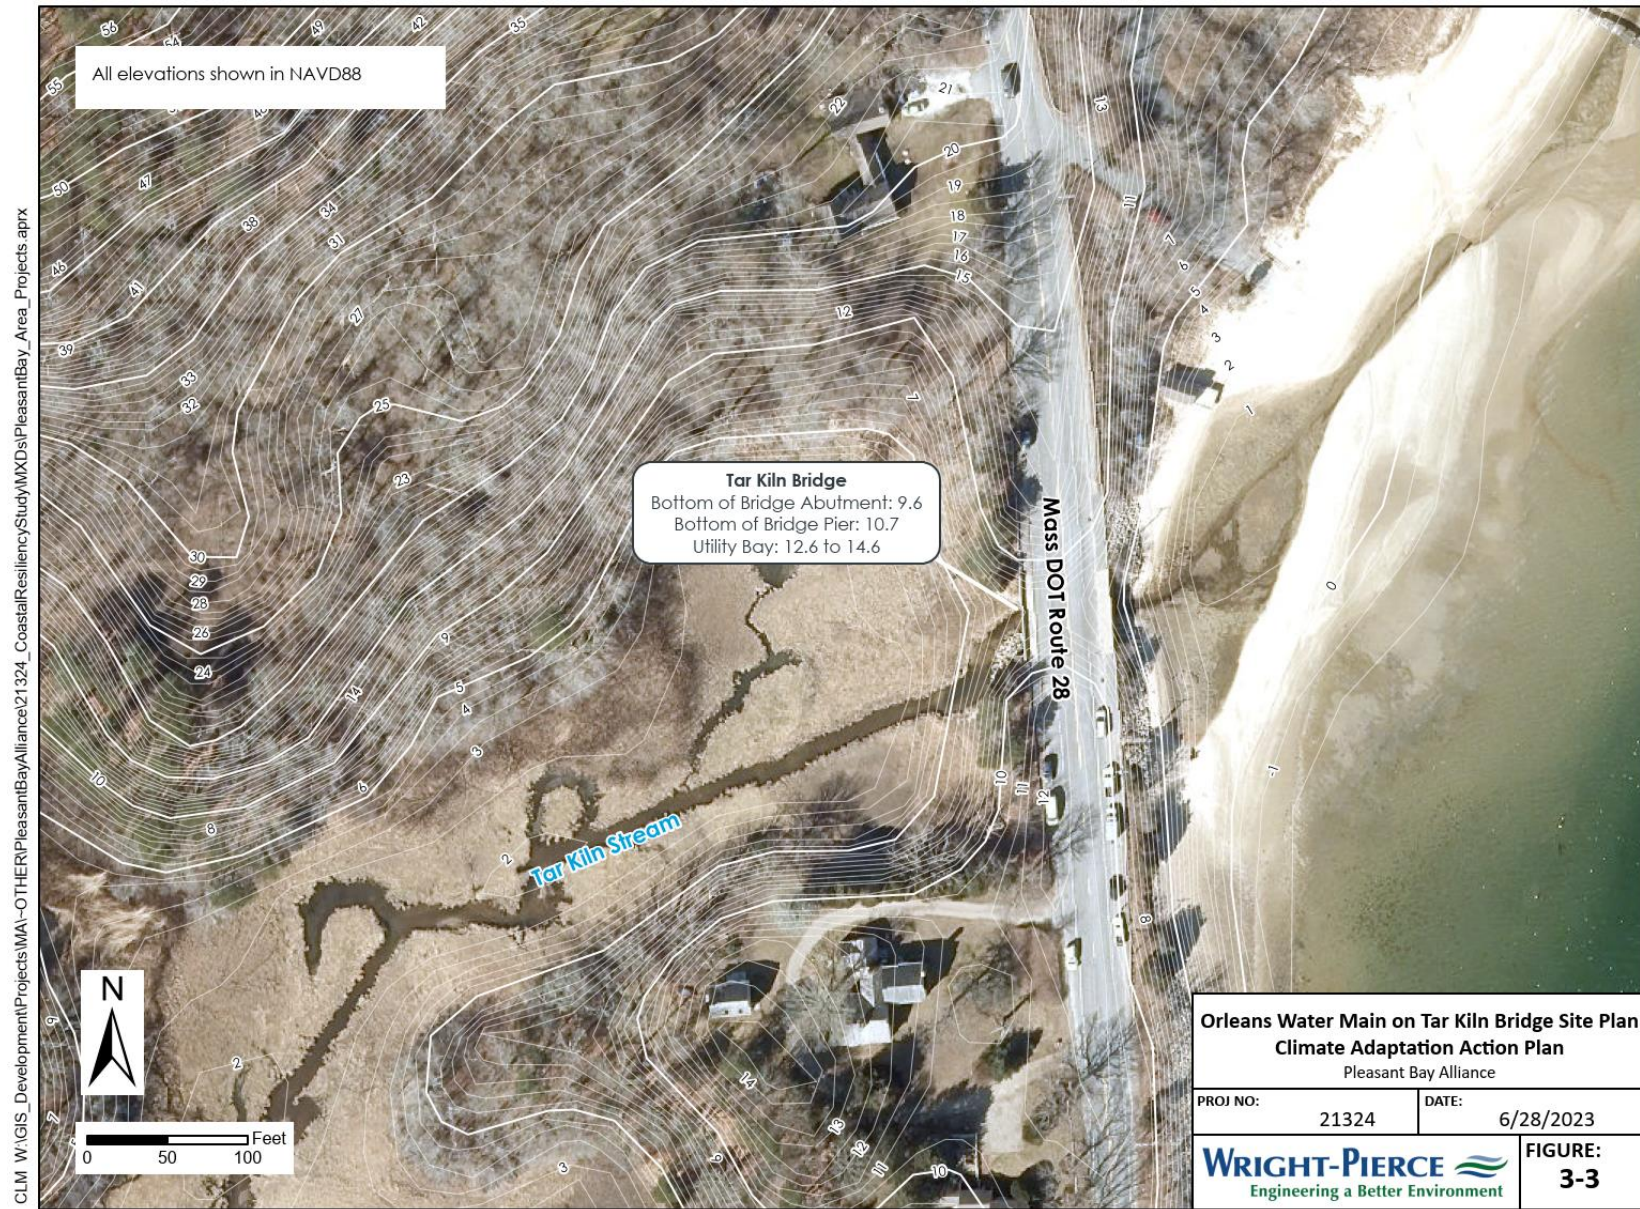
The pipe and pipe support elevations vary across the length of the bridge but are, at the lowest point, 12.6 feet (NAVD88). The bridge abutments are located at elevation 9.6 (NAVD88). For this reason, it is anticipated that the greatest risk to the infrastructure would be the condition of the existing pipe and any corrosion occurring within this extreme saline environment that could reduce the expected lifetime of the pipe material. However, as sea levels rise, the frequency of inundation will increase, and the bridge could see impacts from more frequent storm events. The storm surge at this location could exacerbate the corrosion of the pipe but is not anticipated to pose a significant threat to the structural integrity of the pipe or pipe supports because the pipe is supported within a utility bay tucked up above the bridge piers and abutments. Waves would travel across the underside of the bridge and would have a significant amount of their energy dispersed prior to reaching the protected pipe location. In general, if the bridge structure or road approaches were damaged by intense storms, the pipe could also be impacted. The analysis of bridge structural integrity was outside of the scope of this analysis.
