2016 Post-Construction Monitoring of the Muddy Creek Restoration Project Harwich and Chatham, Massachusetts

Applied Coastal Research and Engineering, Inc. 766 Falmouth Road, Suite A-1 Mashpee, MA 02649

January 10, 2017

Prepared for: Towns of Harwich and Chatham, MA

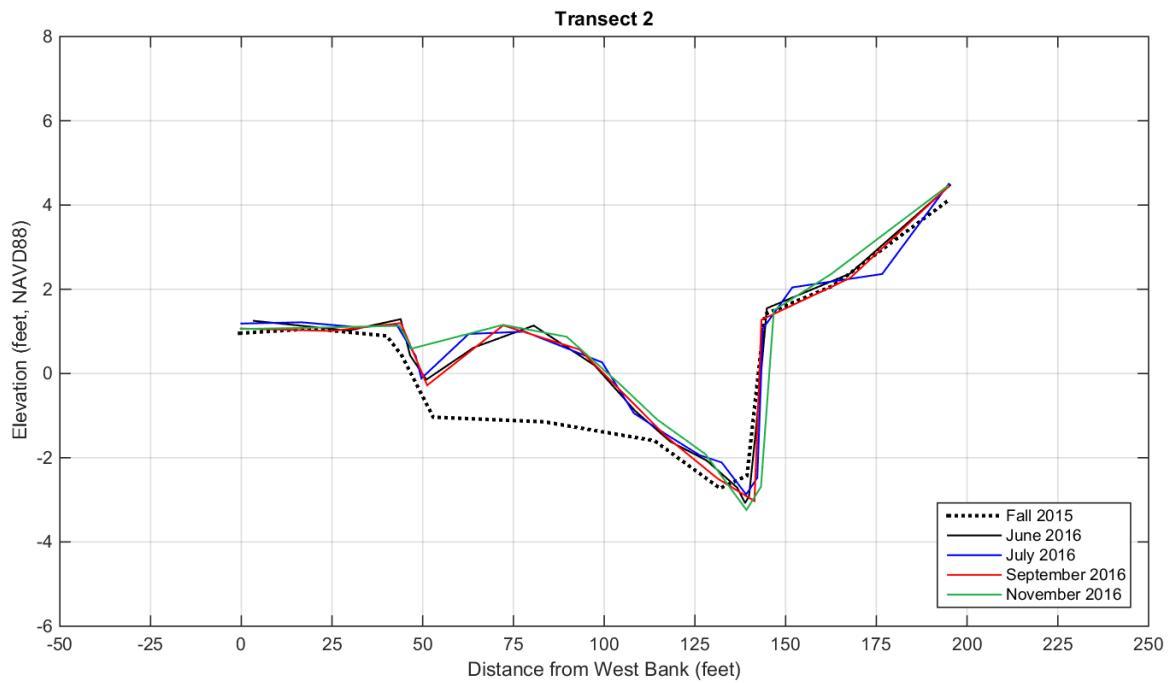
Figure 9. Cross-channel monitoring Transect 2. Distance are relative to the West Channel Bank and datum elevations are given relative to NAVD88.

Transect 1 (Figure 8) shows approximately a 3-foot increase in channel depth and shift southward of the main conveyance pathway along the southern edge of the channel. The increase in depth around the outside of the bend has resulted in bank being undercut and loss of salt marsh along the edge of the marsh plain. The channel position and depth has been relatively stable over the post-construction monitoring surveys and is expected to remain so with some minor adjustment as the system continues to respond to the changes in tidal flow and winter storms. Transect 2 (Figure 9) had a large amount of deposition on the inside of the channel bend which is predominately fine to medium grained sand. Transects 3 and 4 (Figures 10 and 12. respectively) had similar trends, the outside bend of the channel deepened due to the increase in flow, while the inside of the channel cross section accreted sediment. The channel geometry at Transect 10 (Figure 11) has the same characteristics as Transects 3 and 4 which are downstream and upstream. The channel bottom at Transect 5 (Figure 13) accreted due to sediment deposition. During both the flood and ebb tide, sediment was deposited in response to the flow velocities decreasing as the channel straightened and widened. Transect 11 (Figure 14) reflects the channel geometry upstream of the bridge at Transect 6 (Figure 15). The main conveyance channel in centered in the cross section, aligned with the bridge opening.

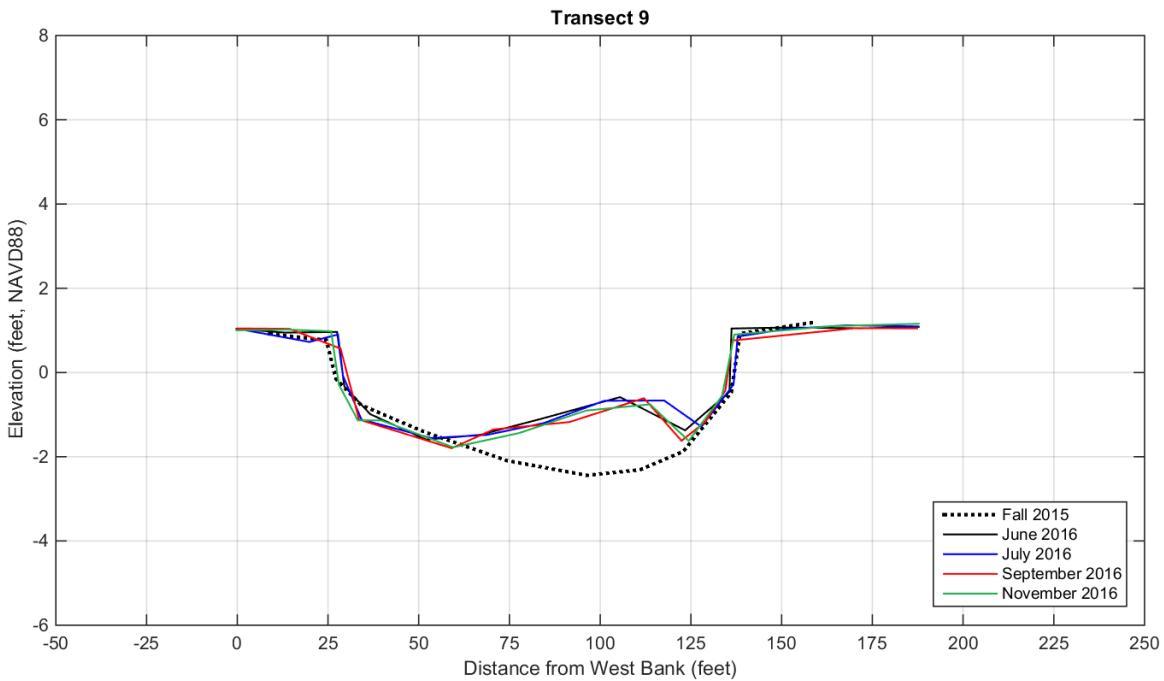
Figure 18. Cross-channel monitoring Transect 9. Distance are relative to the West Channel Bank and datum elevations are given relative to NAVD88.

Beginning with Transect 1, shown in Figure 8, and proceeding through Transect 9, shown in Figure 18, the plots of the channel transects show that channel geometry responded quickly to the increased tidal flow associated with installation of the bridge. A majority of the channel geometry alterations were along the outsides of channel bends and the deposition of sediment on the inside of bends as well as changes in the location of shoaling. Channel geometry has remained relatively stable over the four post-

and is a response to the increased flood tides. A similar response was observed at Transect 7 (Figure 16), the southern channel widened and deepened along the marsh edge due to the increase in the flood tide volume and velocity. Transect 8 (Figure 17) remain stable and did not show any significant transitions in channel geometry, while Transect 9 (Figure 18) accreted as the flood tide shoal extended and transitioned upstream due to the scouring of channel sediment immediately upstream of the bridge.
